# INSPECTION REPORT

18218 Rolling Meadow Way #45, Olney, MD 20832

Date of Inspection: 1/15/2022 Time: 9:00 AM

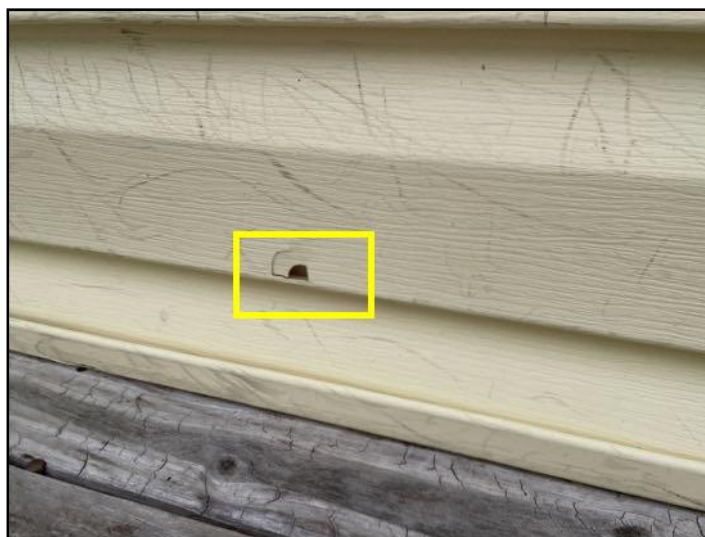
- Vinyl siding damage observed. Recommend repair or replacement of damaged section to keep moisture and insect intrusion.

Hole

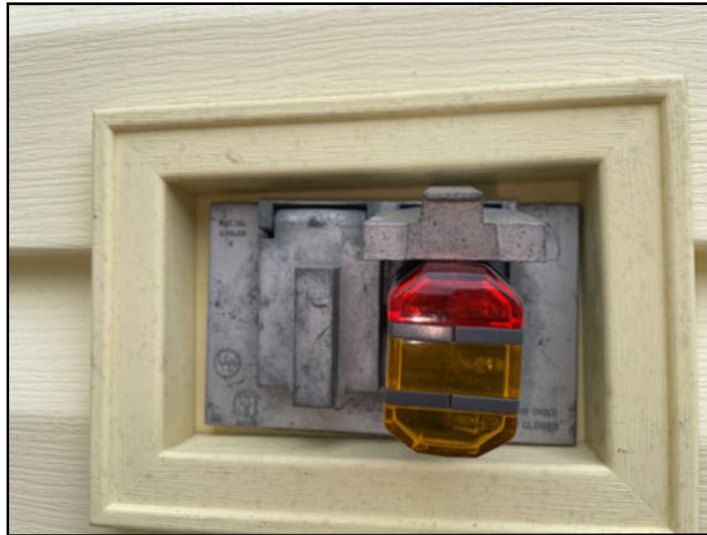
• Exterior outlet was not operational. Recommend repair or replace by a licensed electrician.

No power

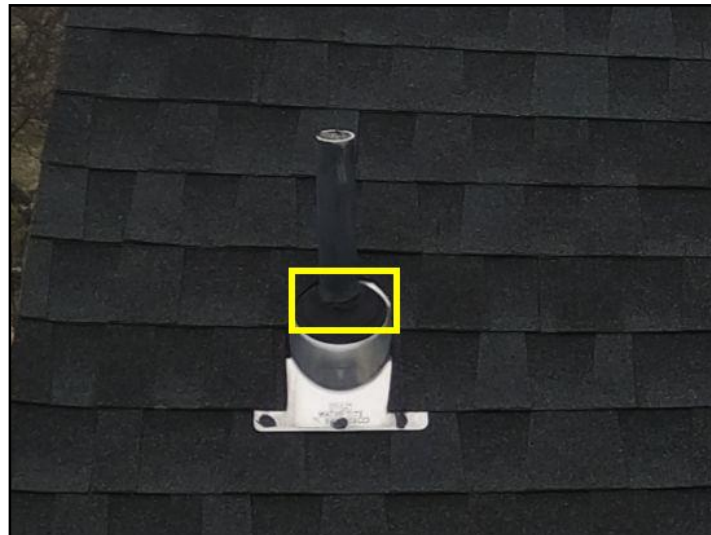
- Deteriorated vent stack collar observed. Recommend repair or replace as needed.

Deteriorated collar

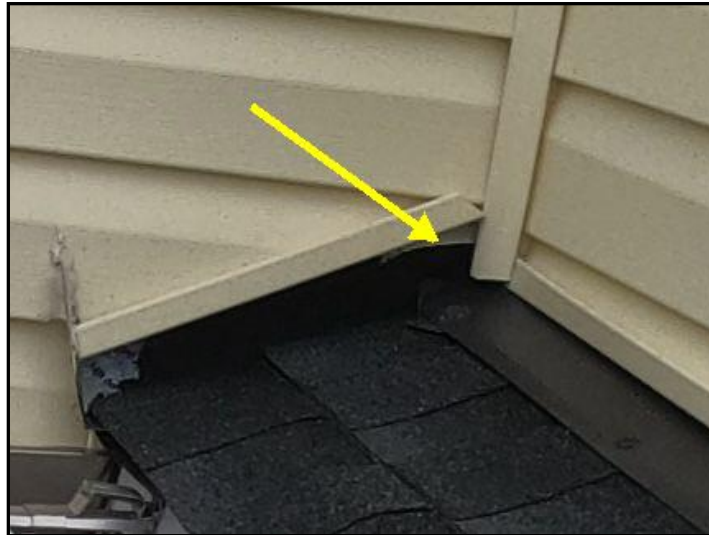
- Sidewall flashing appeared to be installed incorrectly. Recommend review and repair by a qualified contractor or roofing specialist.

Not under siding

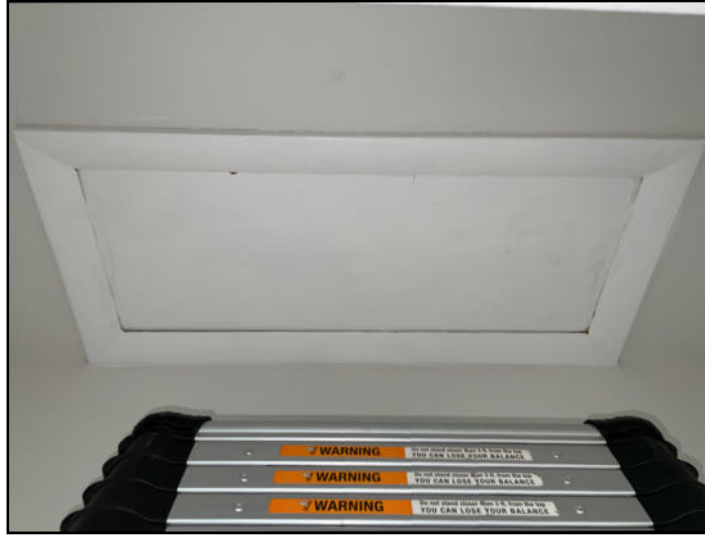
- Bedroom closet.
- Attic access was difficult to reach due to shelving placement. Hatches must be readily accessible. Recommend exploring ways to create unobstructed access.

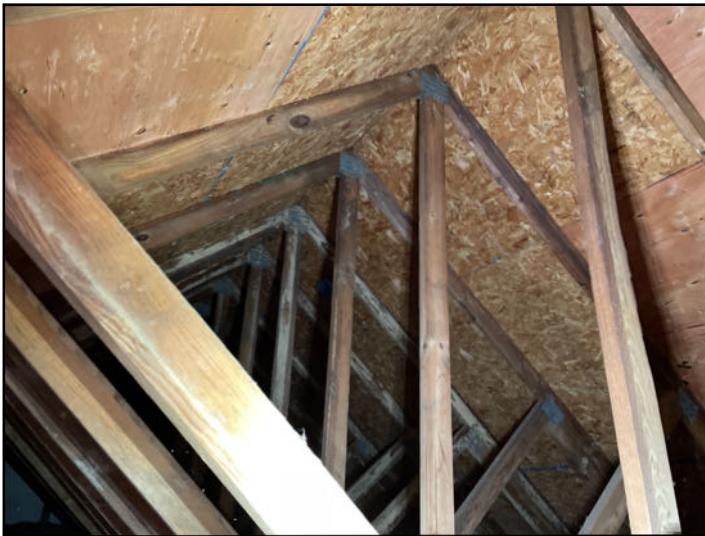
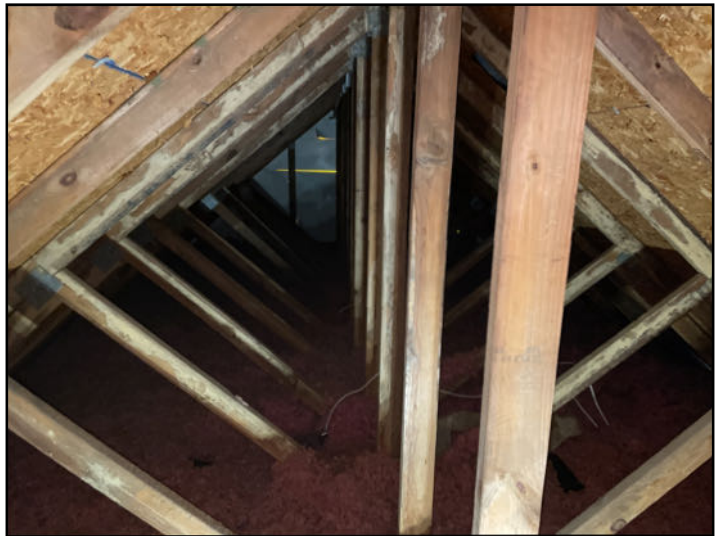
- Large holes and/or gaps in firewall observed. Recommend repair for safety.

Gaps in firewall

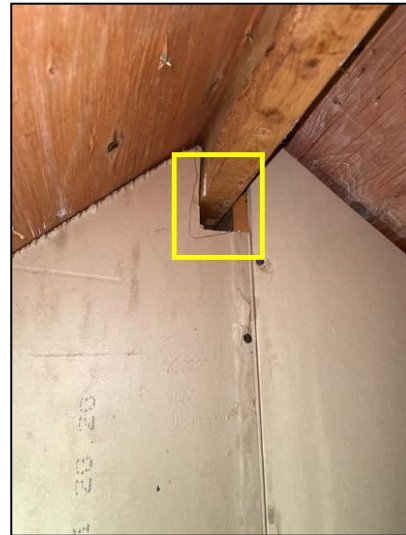
Gap in firewall

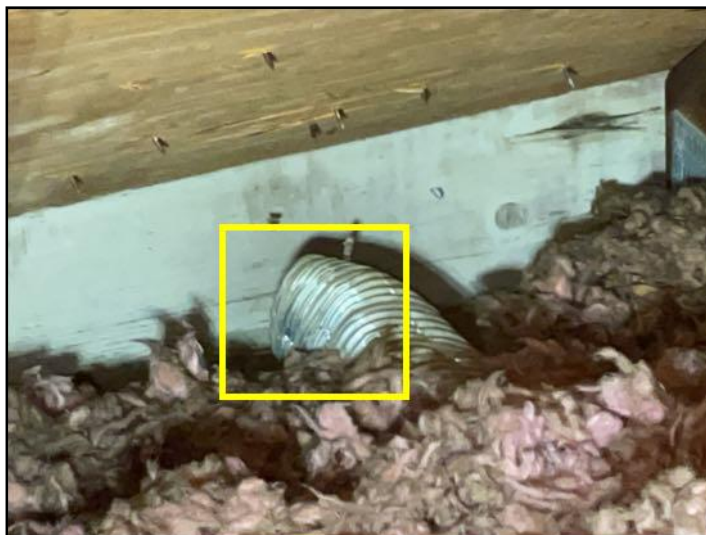
- Exhaust fan duct appeared to be terminating in attic. Have duct routed to exterior to minimize moisture and possible development of mold.

Not exterior vented

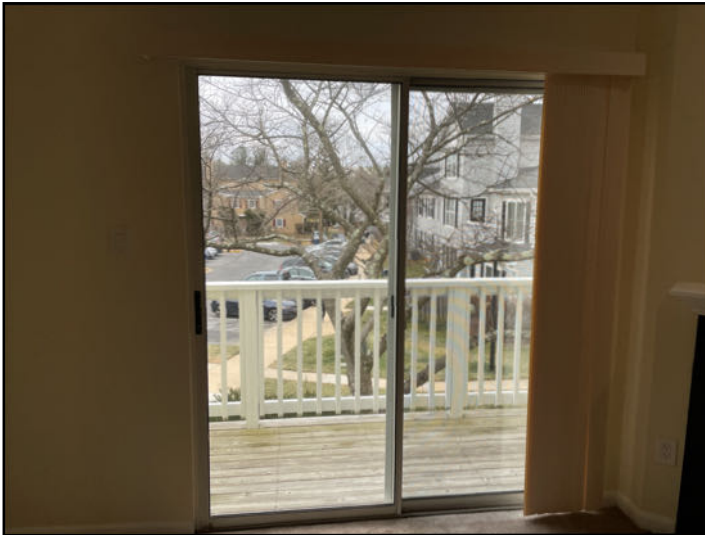
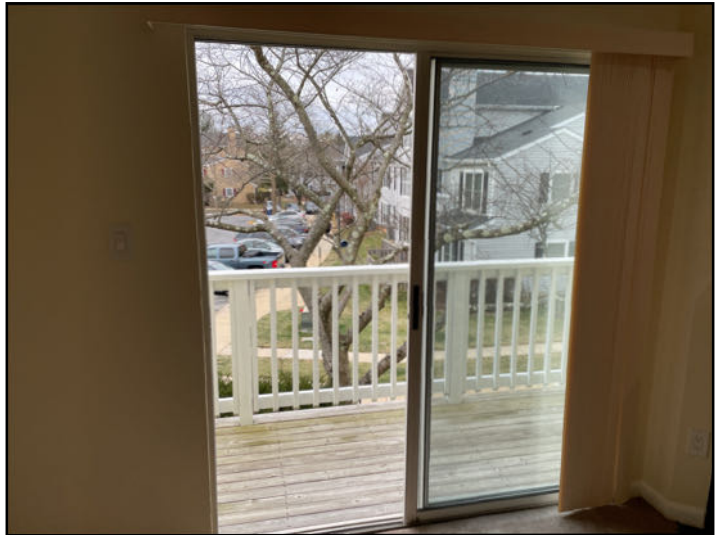
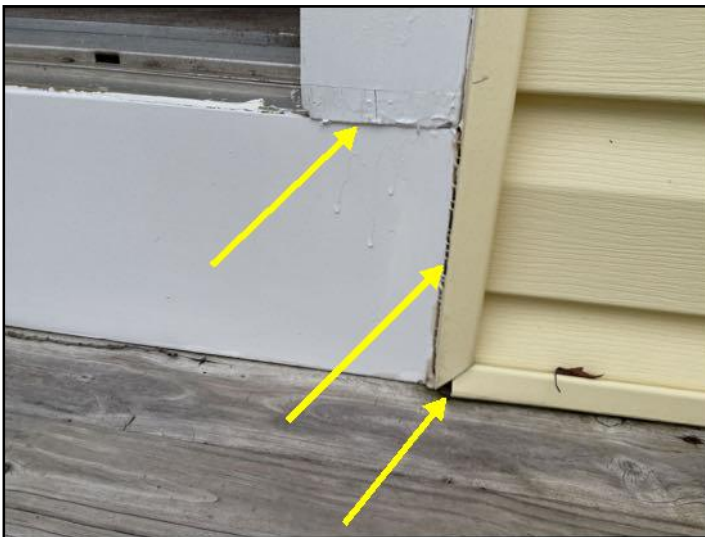
- Gaps and cracks noted around the door frame. Recommend caulk or seal as needed.

Gaps

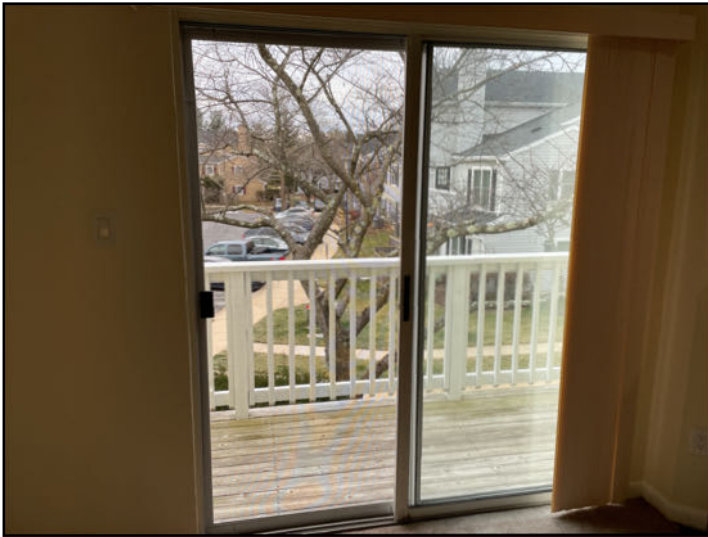
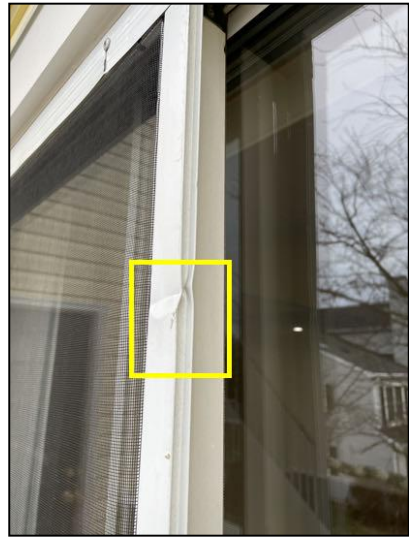
- Sliding screen door was bent but still functional. Repair or replace as needed.

Dented

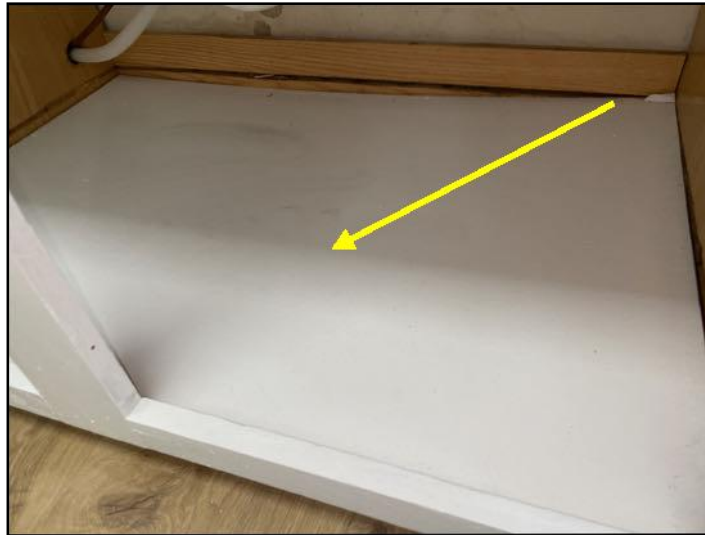
- **Warped cabinet base noted under sink. No moisture indicated on moisture meter. Recommend repair or replace as needed.**

Warped base

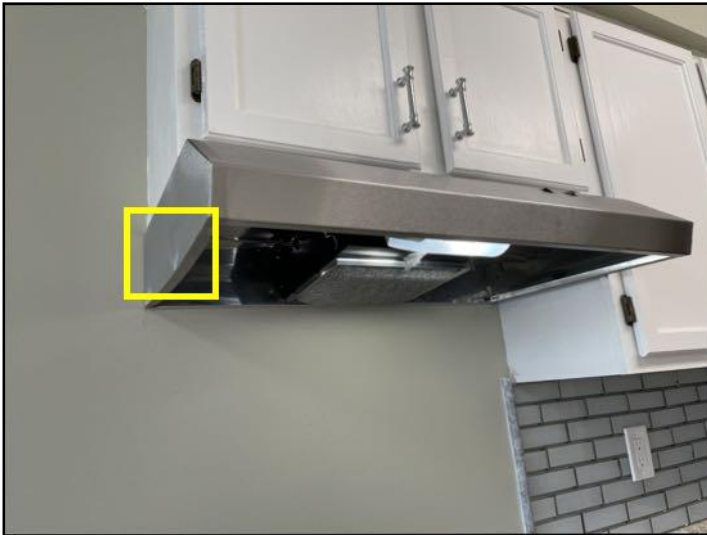
- Vent hood appeared to be dented. Recommend replacing as needed.
- Vent louvers were covered at time of inspection. Recommend removing cover to allow vent to operate properly.

Dent

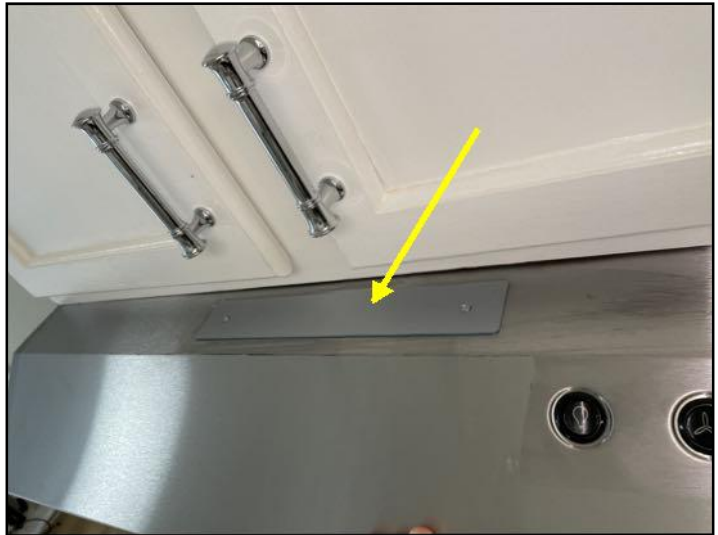
Vent covered

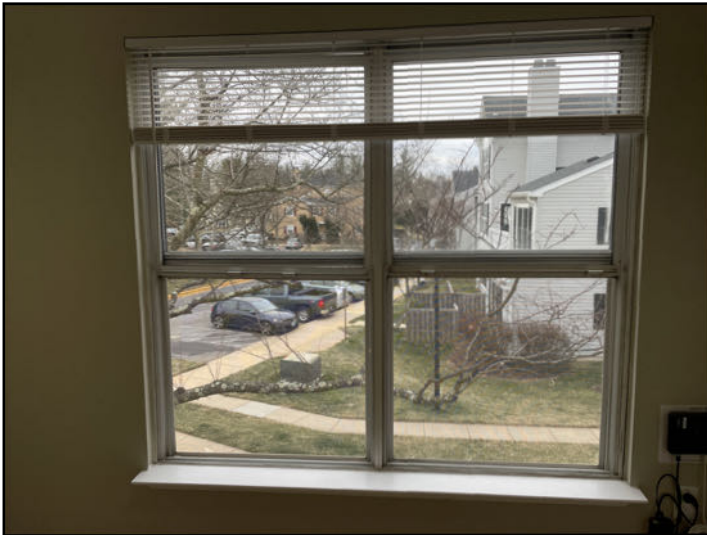
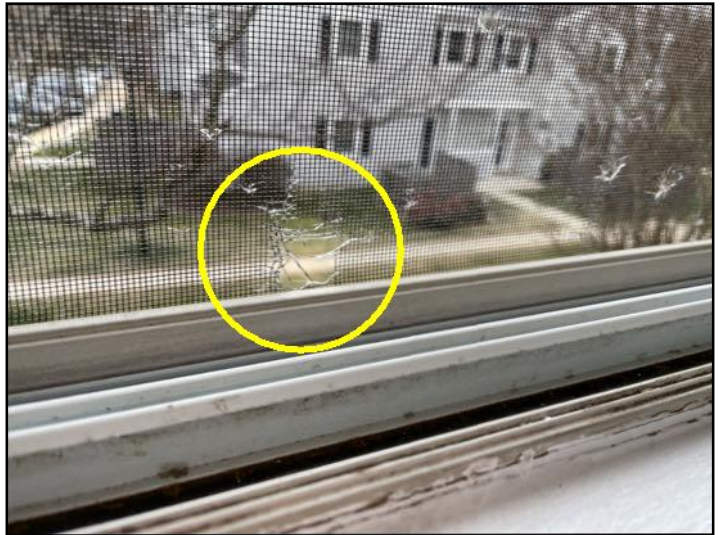
- **Improve:** Windows were original, older type. Consider upgrading to double pane, thermally insulated, newer efficient type.
- **Windows didn't latch due to misalignment or improper installation. Recommend repair or replace as needed.**
- **Deteriorated caulk noted. Recommend sealing or repair as needed.**
- **Damaged screens observed. Repair or replace as needed.**

Torn screen

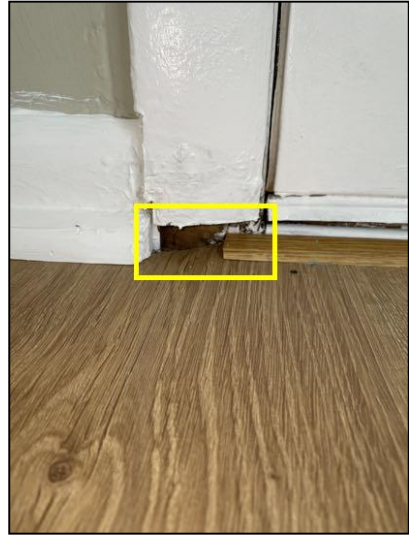
Observations:  
 • Gaps and cracks noted around the door frame. Recommend caulk or seal as needed.

Gap

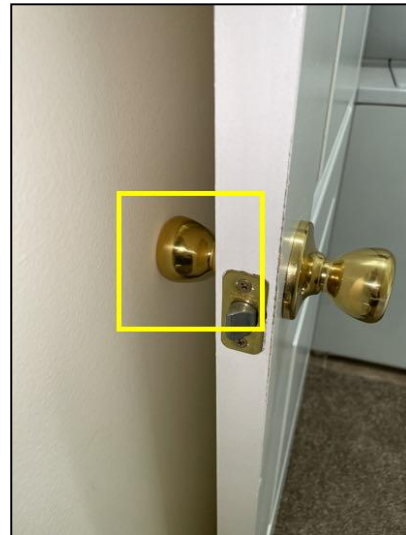
- Door stop was missing. Recommend installing door stop to avoid wall and/or door damage.

Wall contact

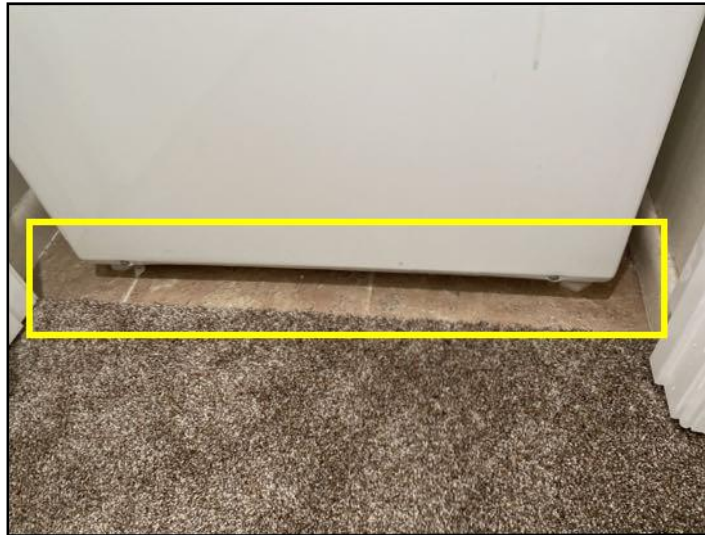
- Overflow pan was missing at washer. Recommend installing to prevent damage to floor or subfloor.

Missing overflow pan

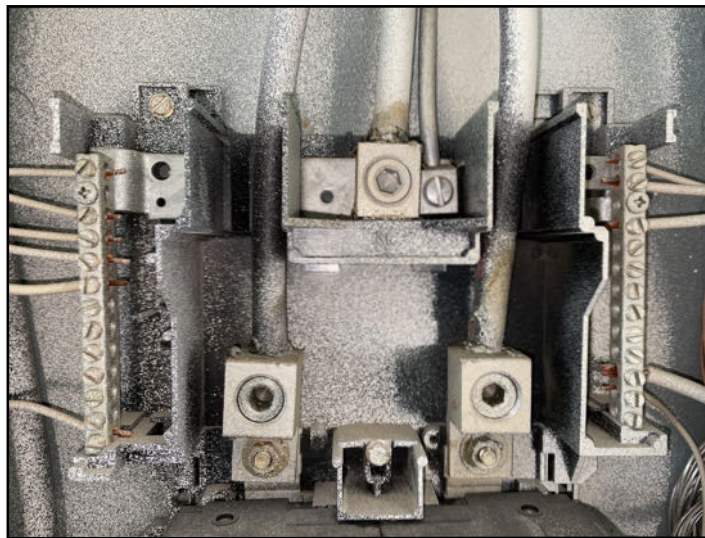
• Some wiring was painted, perhaps during wall construction, and appeared to be white (neutral) rather than black (hot). Recommend cleaning or labeling wiring as needed for safety.

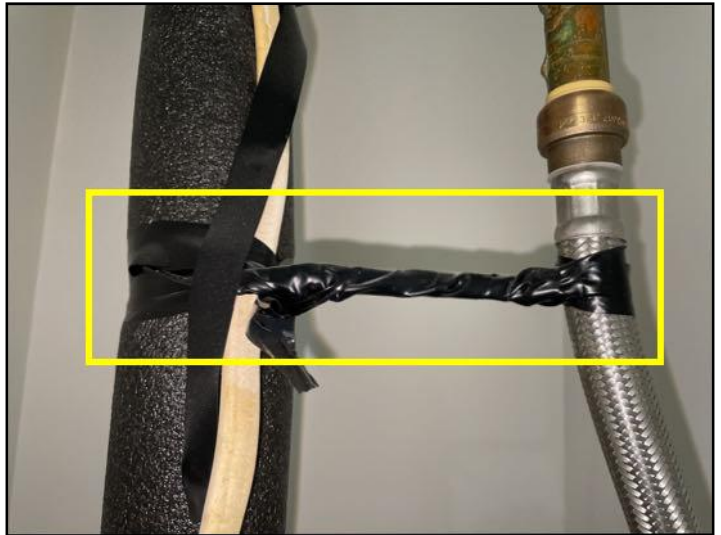
- Electrical tape observed as support for water supply hose. Recommend repair by a licensed plumber using approved pipe supports and/or clamps.

Unconventional support

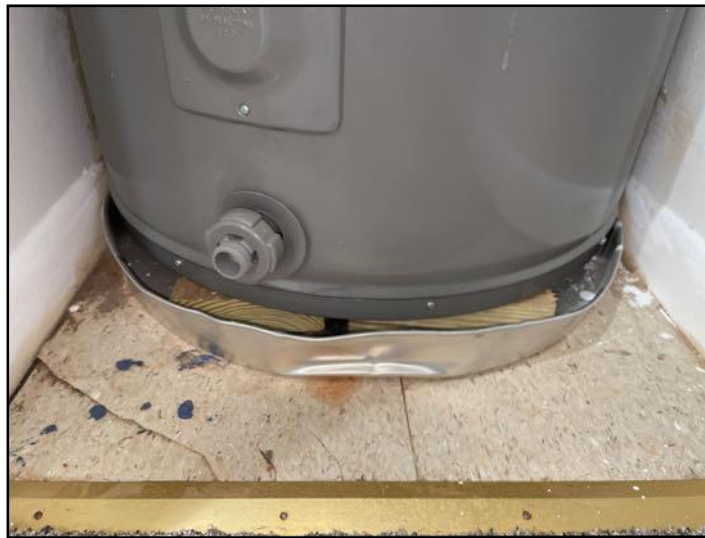
- Unable to view entire overflow pan. Drain not visible. Recommend ensuring overflow pan has drain. Repair or replace pan as needed.

No visible drain on pan

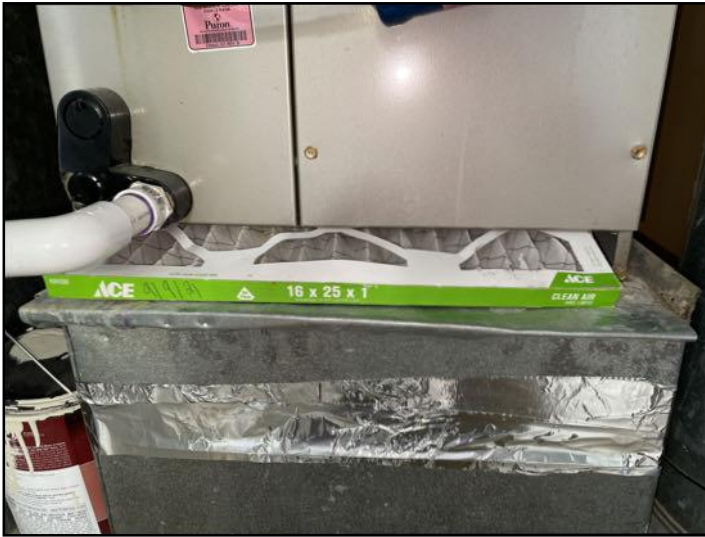
- The filter was dirty and oversized. Recommend replacement.

Filter location

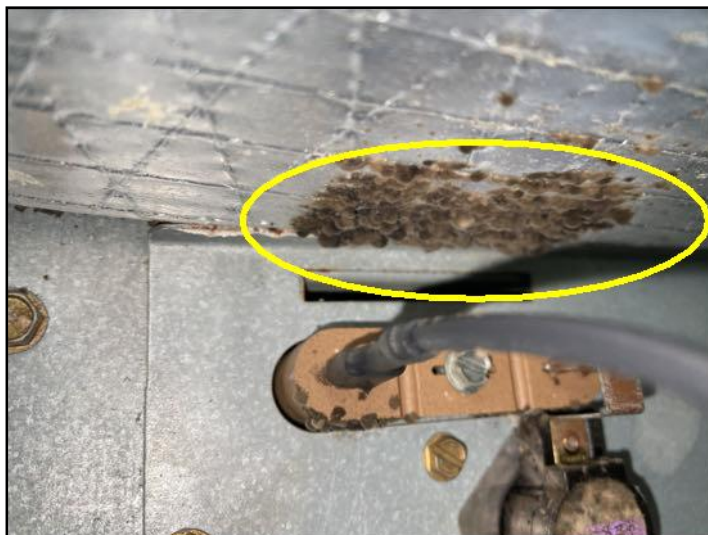
- Some grime was noted inside the enclosure. Recommend cleaning by a HVAC specialist.

Dirty

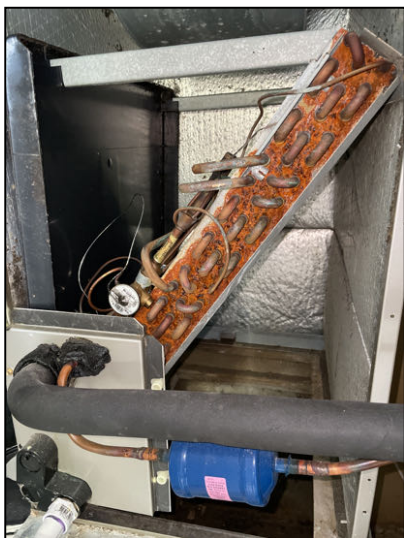
• Dust and corrosion noted in unit. Service by HVAC specialist is recommended.

Dusty

Corrosion

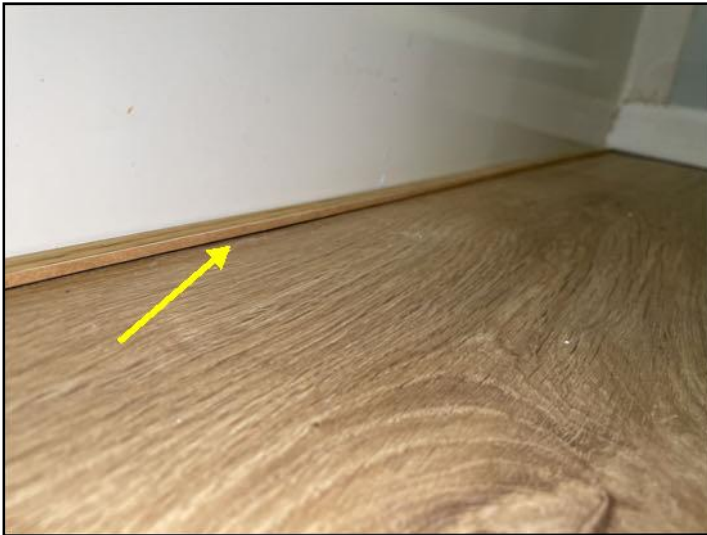
- Gaps observed around floor perimeter. Recommend sealing voids to prevent water intrusion to subfloor.

Gap

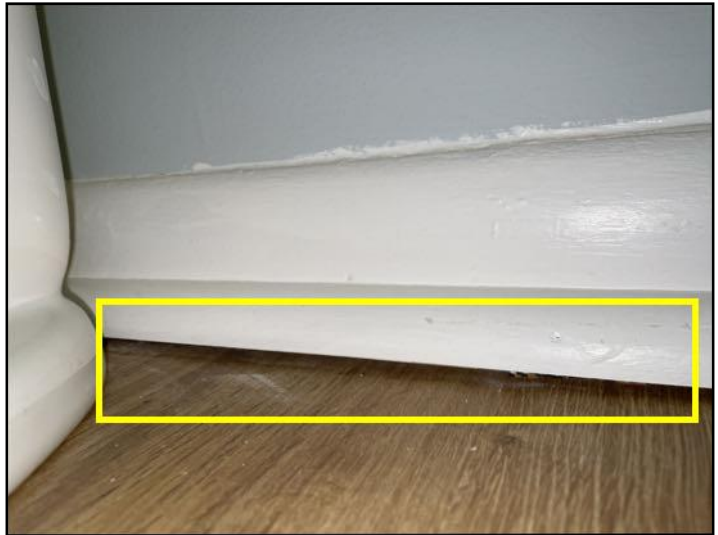
Gap

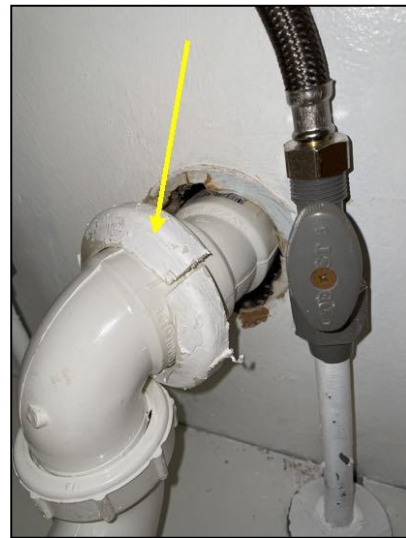
- Loose and broken escutcheon observed. Recommend repair and seal with caulk.

Loose and broken escutcheon

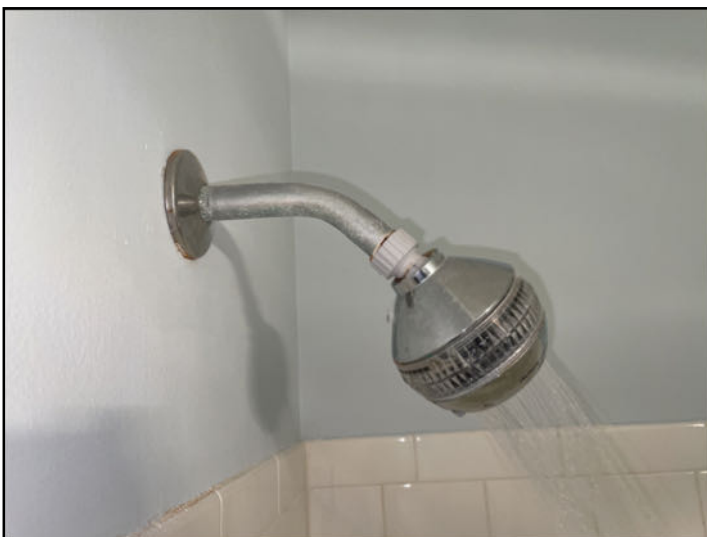
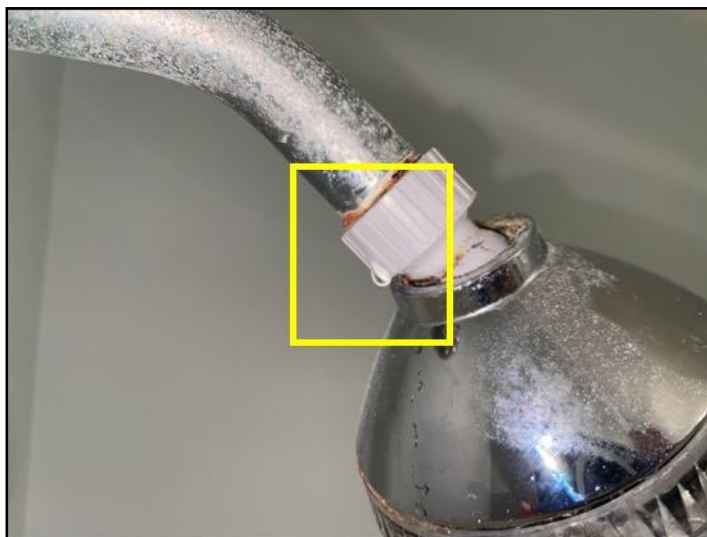
- Shower head leaked. Recommend repair.
- Shower diverter did not engage completely. Repair or replace as needed.

Leaked

Diverter leaked

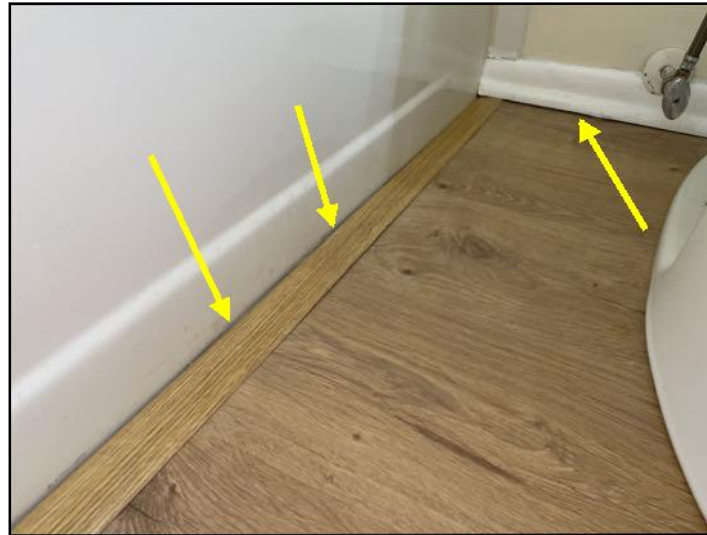
- Gaps observed around the floor perimeter. Recommend sealing all gaps to prevent water intrusion to subfloor.

Gaps

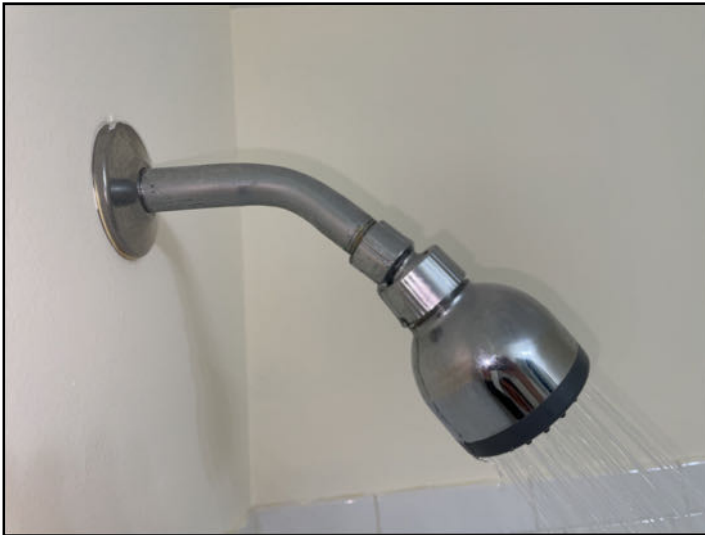
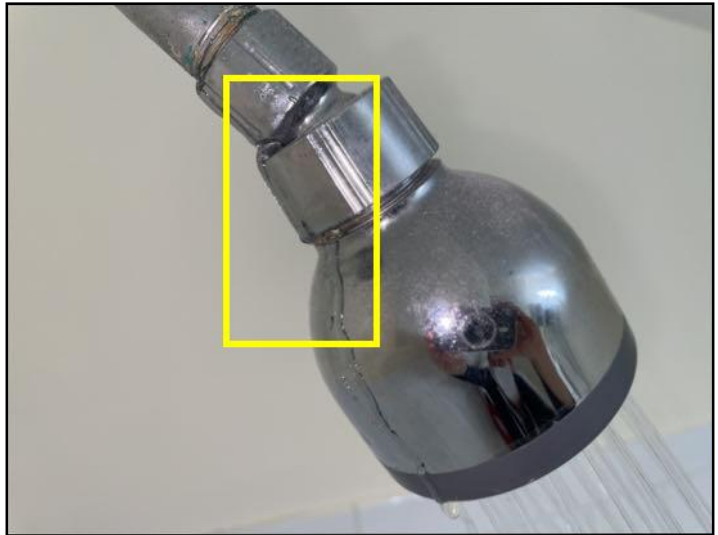
Observations:  
• Shower head leaked. Recommend repair.  
• Shower diverter did not engage completely. Repair or replace as needed.

Leaked

Diverter leaked

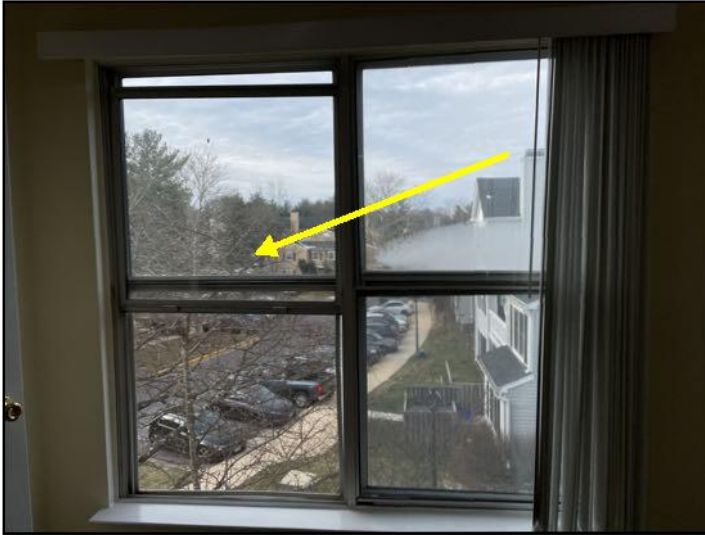
- Some windows were difficult to open. Repair as needed.
- Broken or cracked glass pane noted. Repair or replace as needed.
- Damaged screens observed. Repair or replace as needed.

Difficult to open

Loose screen

Cracked pane

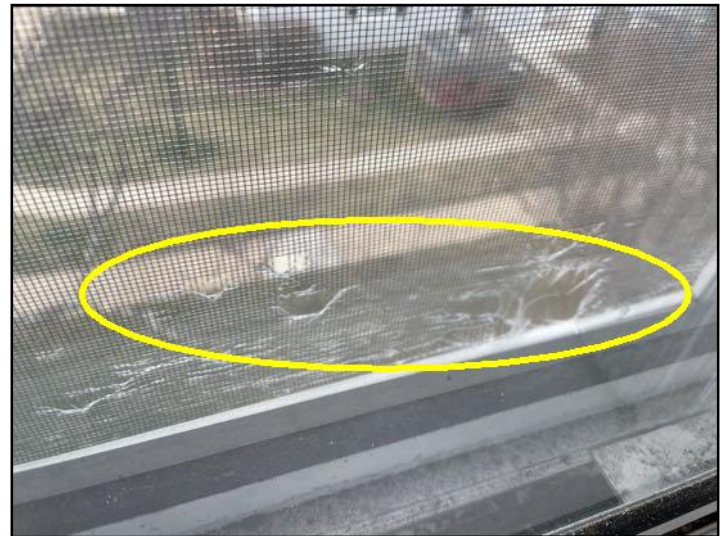
Torn screen

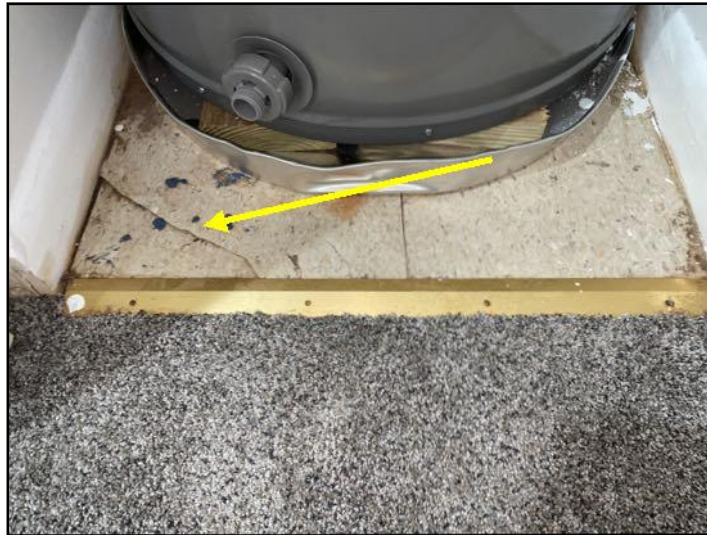
- Broken tile observed in water heater closet. Recommend repair or replace as needed.

Cracked tile

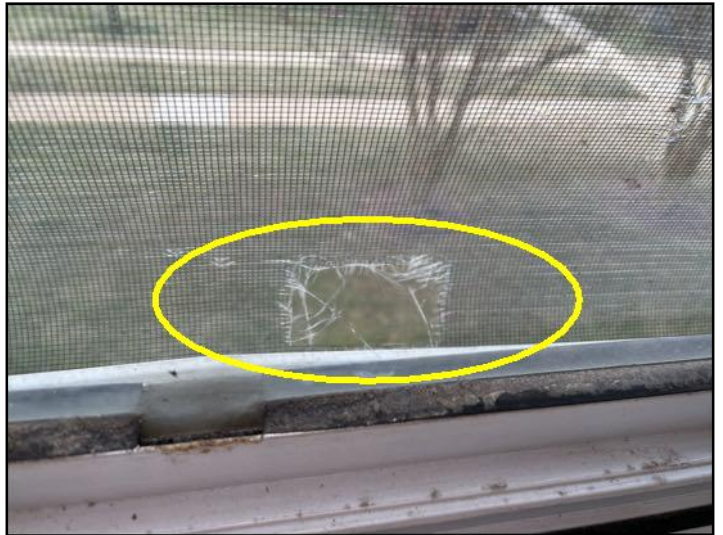
- Damaged screens observed. Repair or replace as needed.
- Deteriorated glazing bead observed. Recommend repair or replace as needed.

Damaged screen

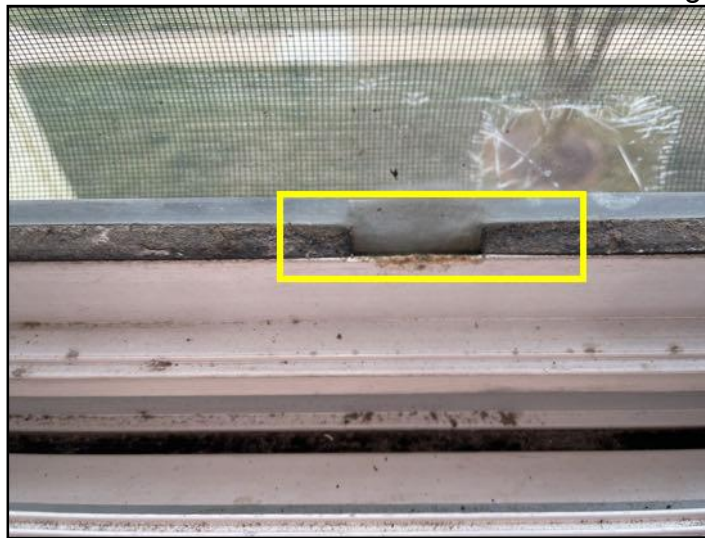
Deteriorated glazing bead
