INSPECTION REPORT

10000 Sample Street, Sample MD 10000
Inspection prepared for: Sample Client
Real Estate Agent: Sample Agent

Date of Inspection: 12/20/2021 Time: 9:00 AM
Year Built: 2021 Size (sqft): 2800
Weather: Clear 25 to 30 degrees F
Order ID: 9086

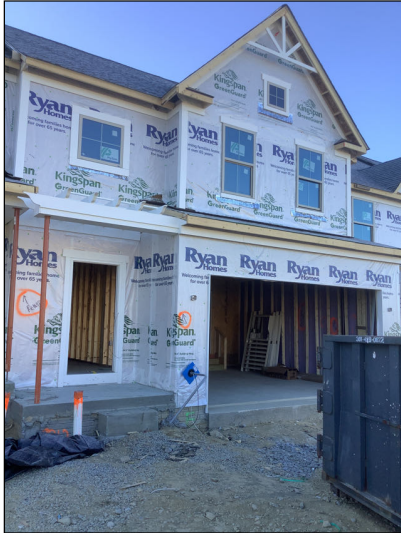
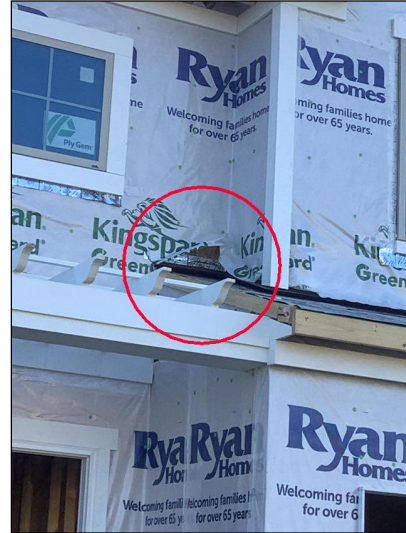
Page 10 Item: 1	House Wrap Condition	• House wrap missing tape noted in the front of the structure, repair as needed.
-----------------	----------------------	----------------------------------------------------------------------------------

- House wrap missing tape noted in the front of the structure, repair as needed.

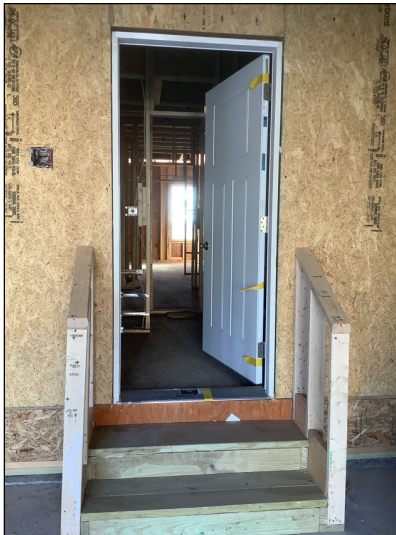
Page 16 Item: 5	Fire Door	• No auto closure present. Recommend installing an auto closure for safety.
-----------------	-----------	-----------------------------------------------------------------------------

- **No auto closure present. Recommend installing an auto closure for safety.**

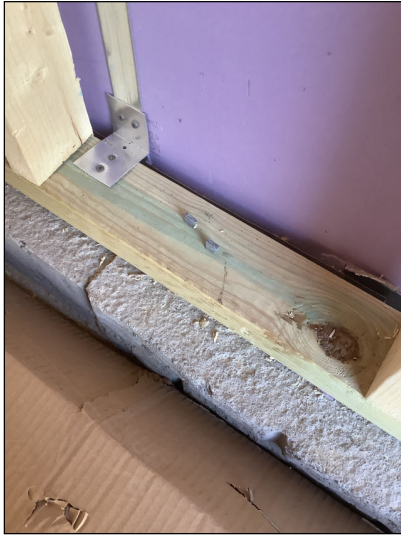
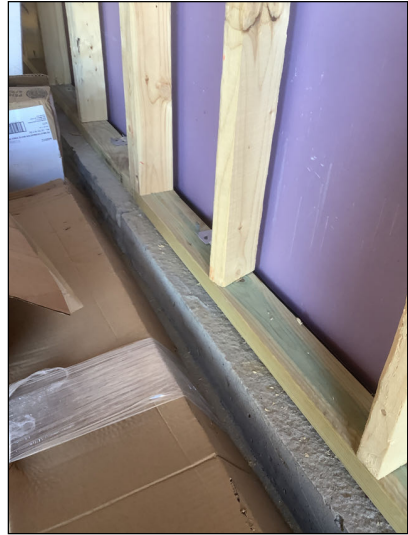
Page 17 Item: 7	Anchor Bolts	• The builder used masonry or "cut" nails to attach the bottom plates to the foundation wall. We recommend adding retrofit style anchor bolts as necessary.
-----------------	--------------	-------------------------------------------------------------------------------------------------------------------------------------------------------------

- The builder used masonry or "cut" nails to attach the bottom plates to the foundation wall. We recommend adding retrofit style anchor bolts as necessary.

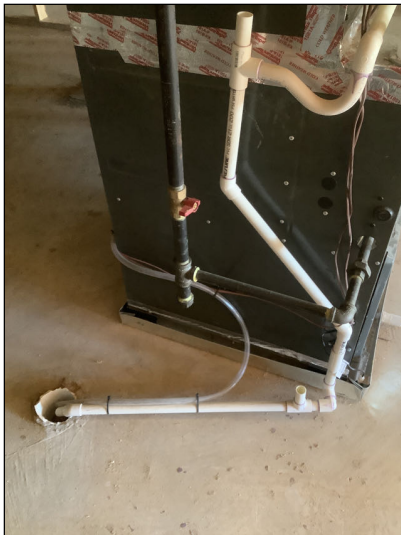
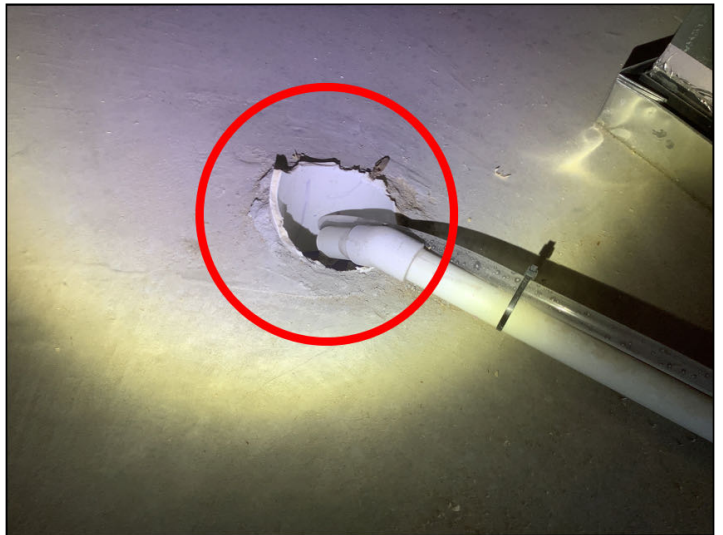
Page 26 Item: 6	Plumbing	• Floor drain not properly cut, sharpened/pointed edges noted, possible trip hazard, repair as needed.
-----------------	----------	--------------------------------------------------------------------------------------------------------

- Floor drain not properly cut, sharpened/pointed edges noted, possible trip hazard, repair as needed.

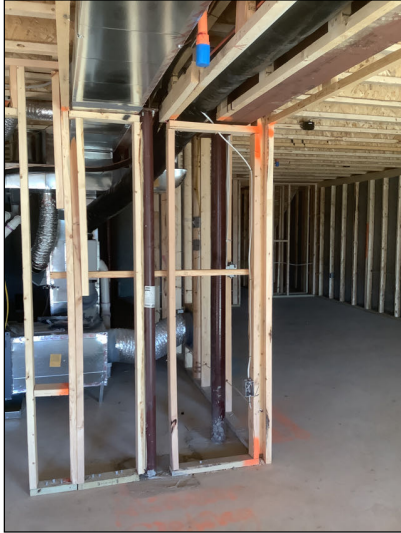
• Steel column top flanges are not properly bolted to the steel beams. Recommend tightened/installed bolts as needed.

- Steel column top flanges are not properly bolted to the steel beams. Recommend tightened/installed bolts as needed.

Loose bolts

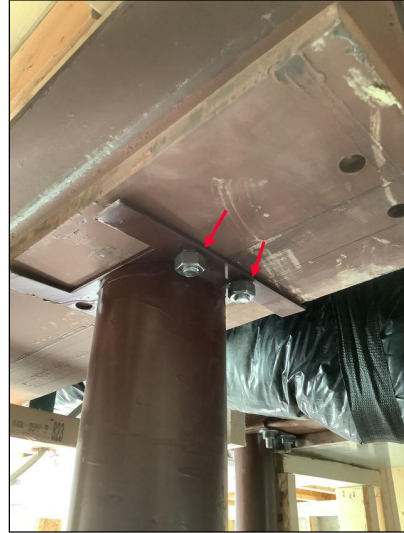
Missing bolts
