INSPECTION REPORT

10000 Roof Sample Rd, Sample, VA 10000

Date of Inspection: 1/10/2022 Time: 1:00 pm

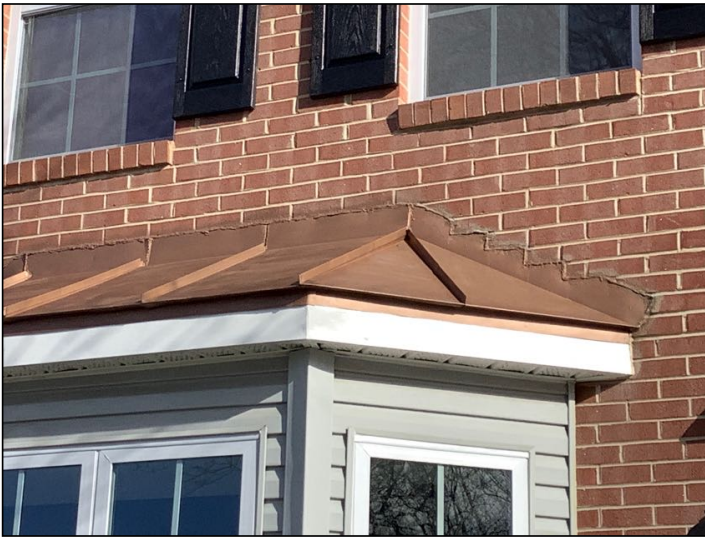
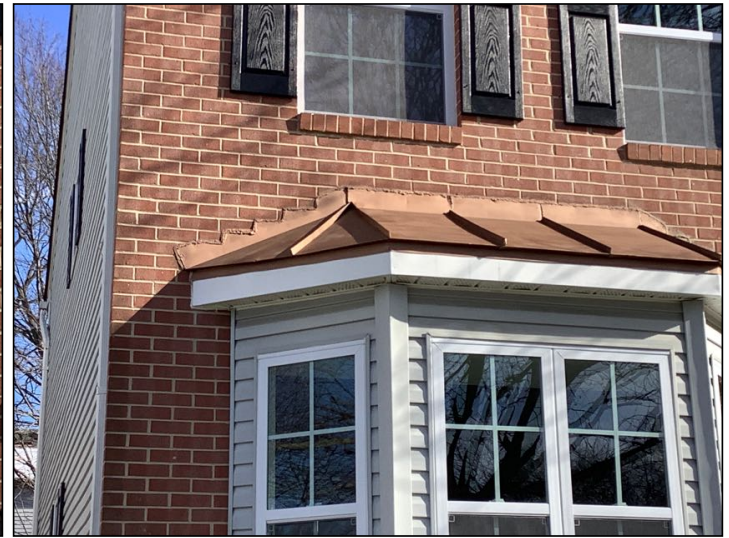
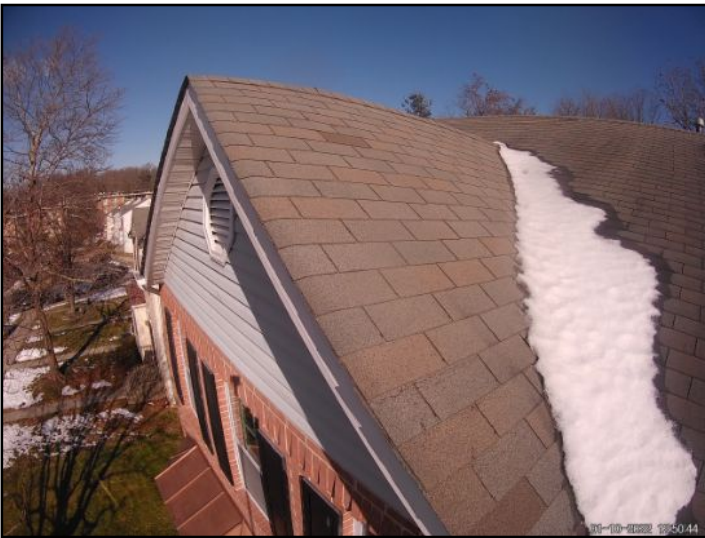
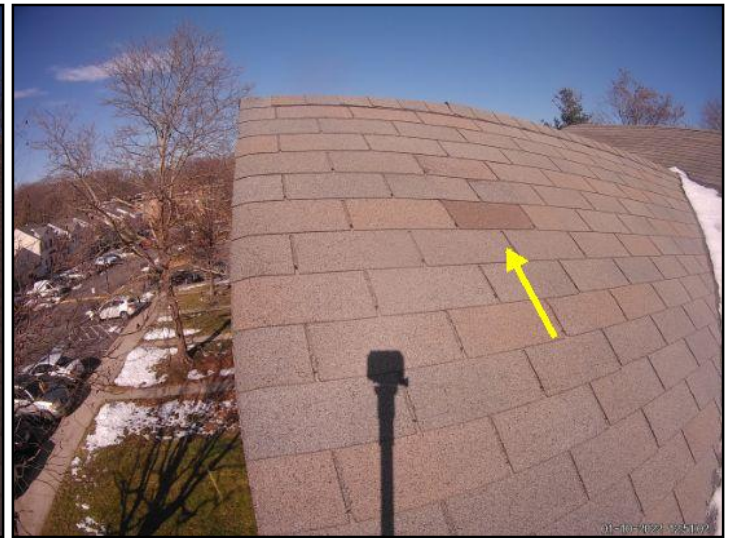
Repairs noted at roof

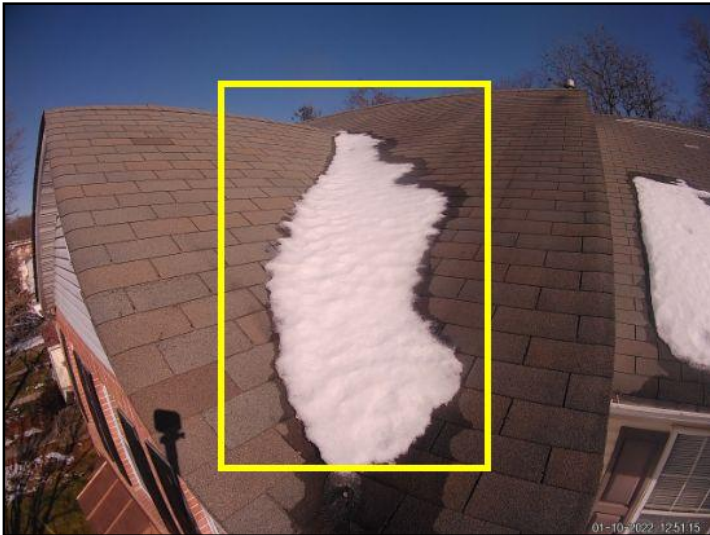
Some portions of roof were not visible at time of inspection

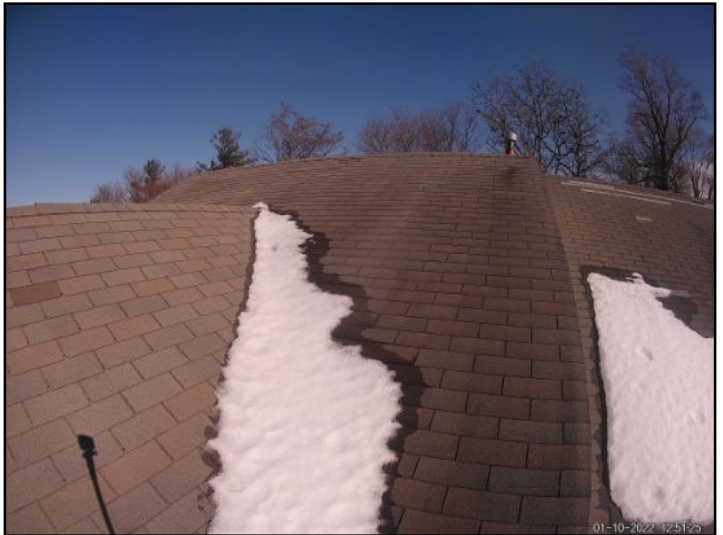
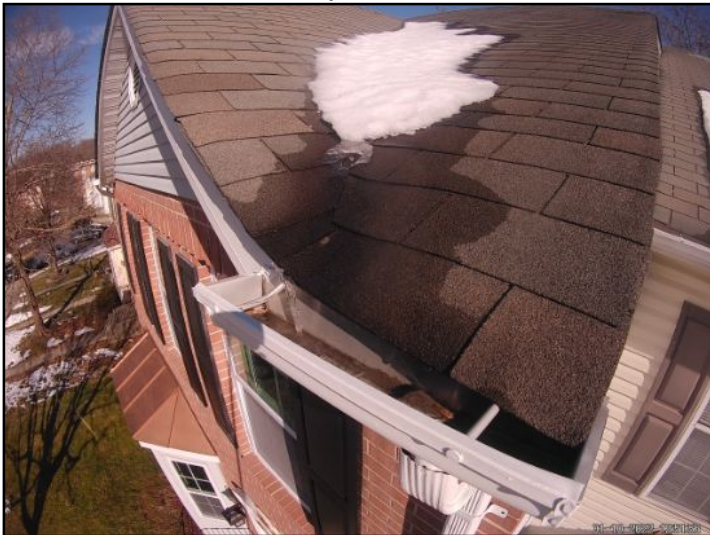
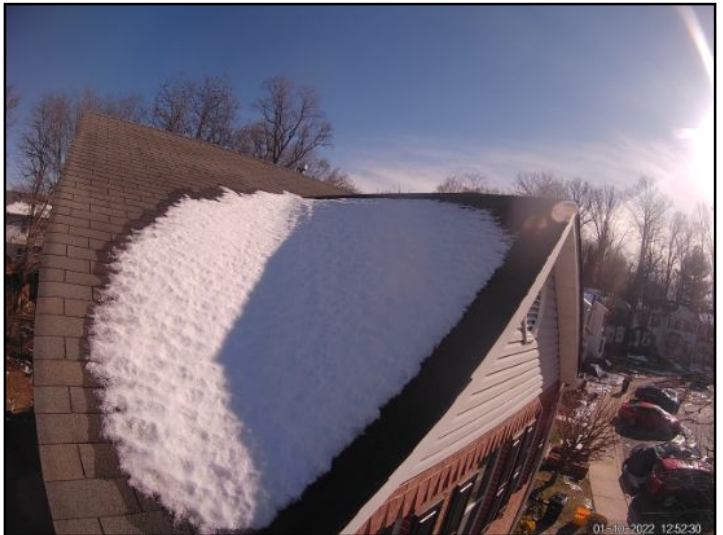
Some area of roof were not visible at time of inspection

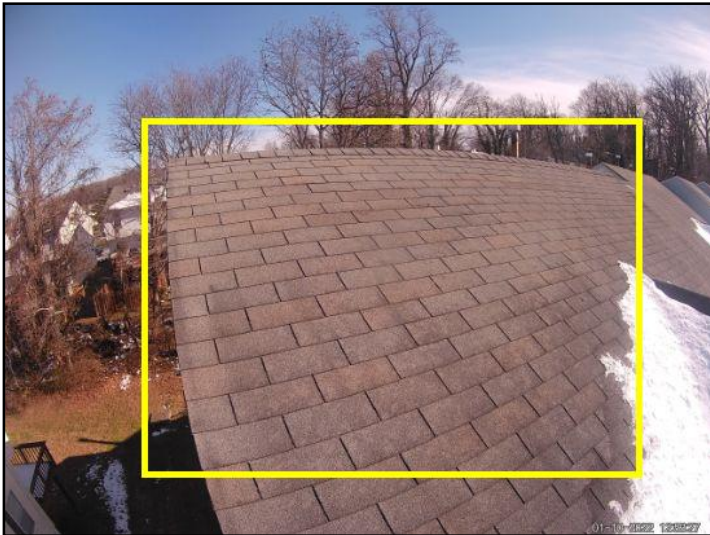
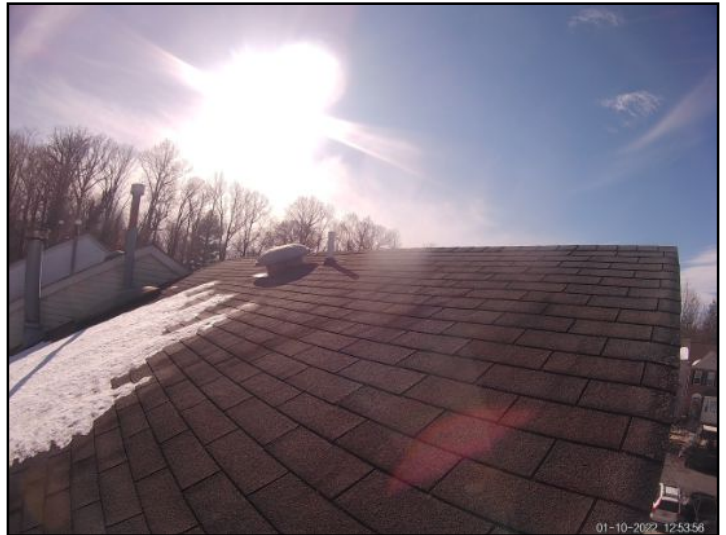
Aged/weathered shingles noted throughout

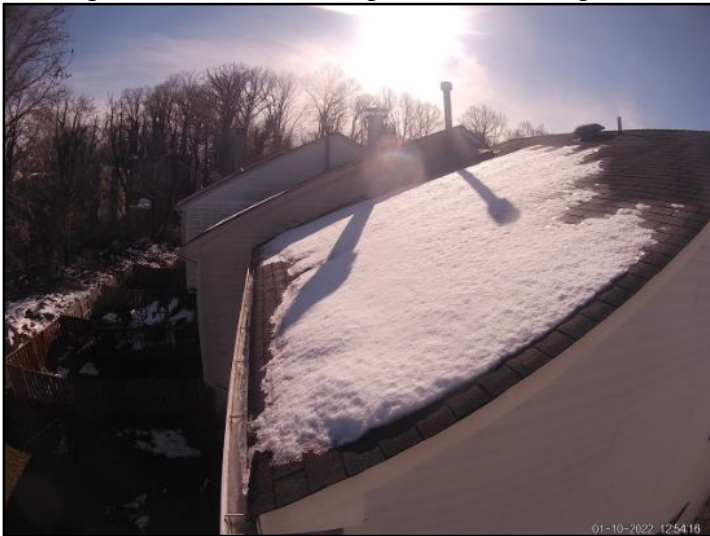
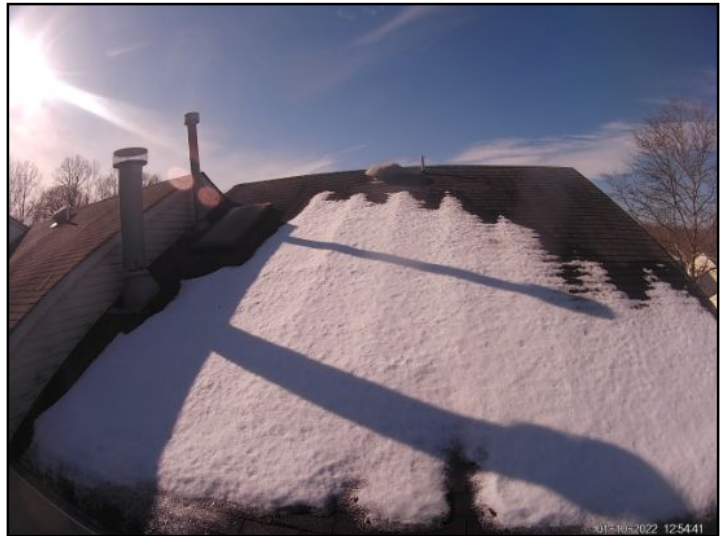
Some areas of roof were not visible at time of inspection

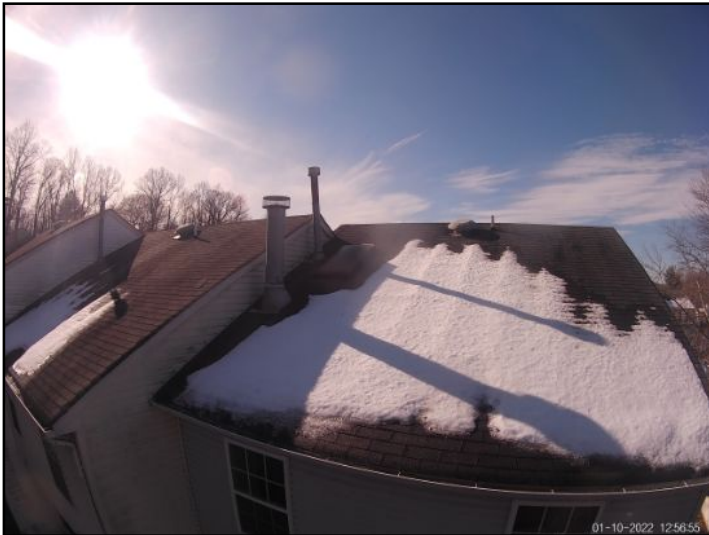
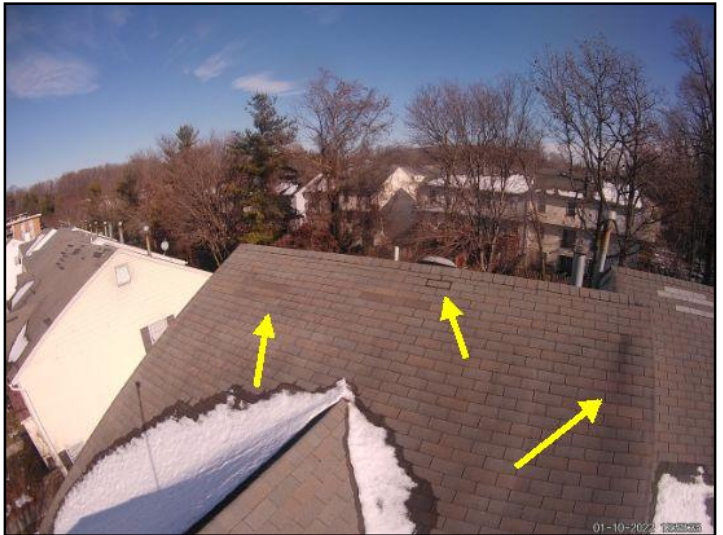
Repairs and stained/weathered shingles noted throughout roof

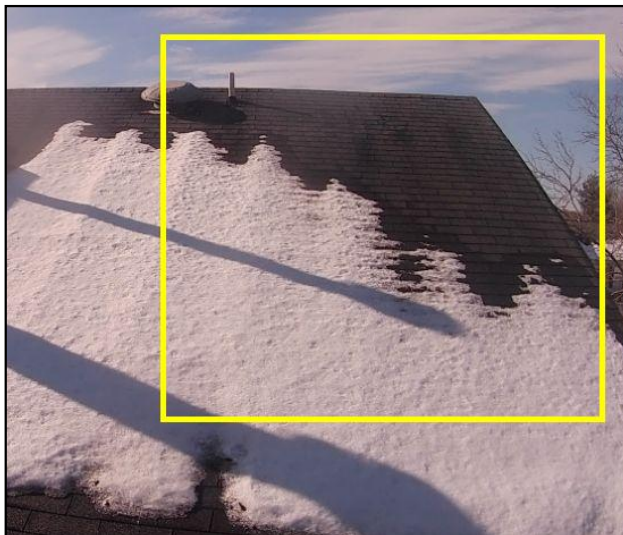
Aged, weathered, shingles noted throughout

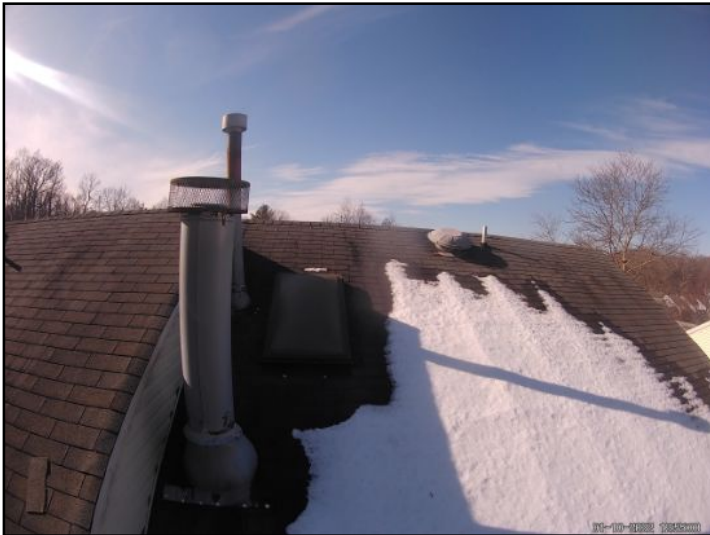
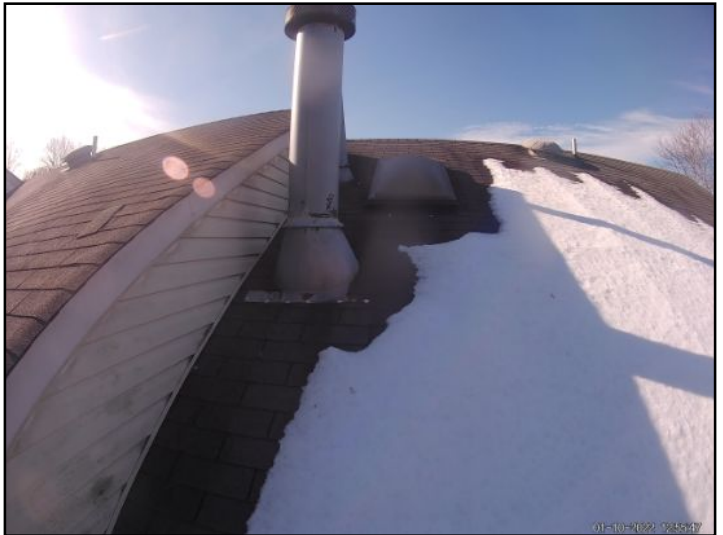
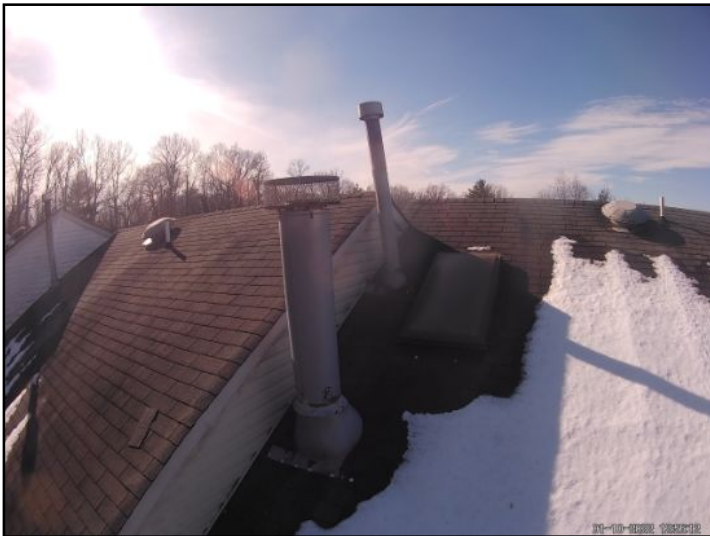
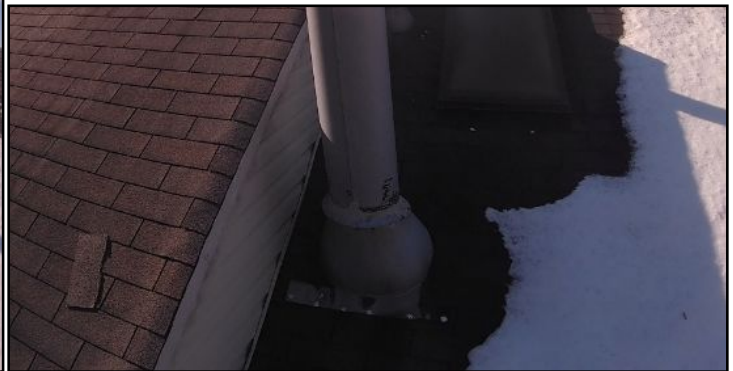
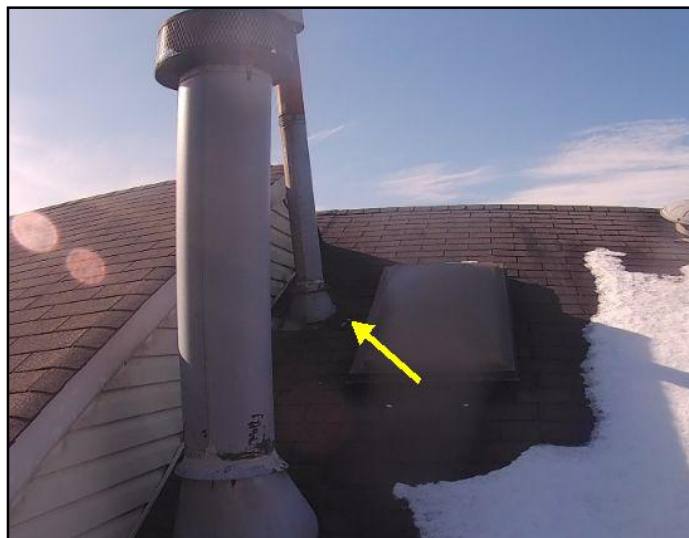
7. Furnace Flue

Rust/deterioration noted at flue flashing boot. Recommend repair/replacement as needed by roofing specialist.

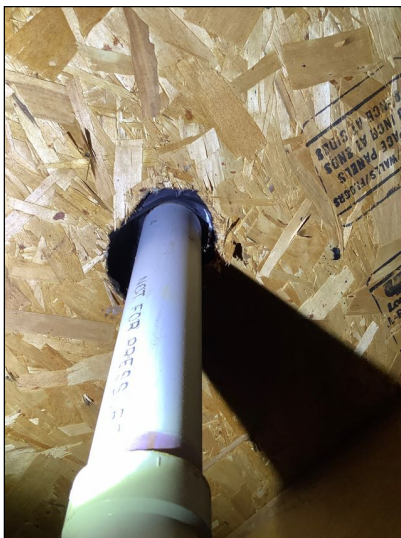
Outside light can be seen around plumbing vent pipe(s) penetration(s) through roof sheathing due to failed boot flanges.

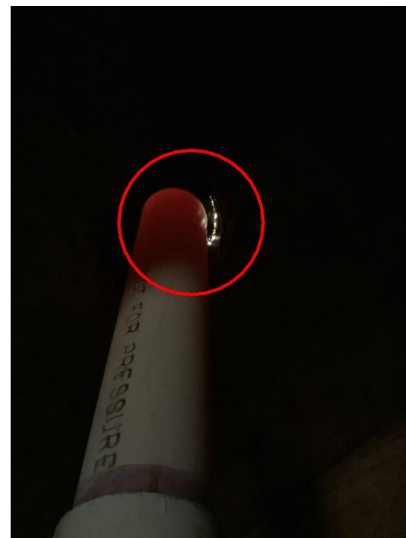
Visible daylight around the plumbing stack pipe observed. Recommend repair as needed by a roofing specialist.
