INSPECTION REPORT

10000 Four Point Sample Rd, Sample, VA 10000

Inspection prepared for: Sample Client

Date of Inspection: 11/18/2021 Time: 1:30 pm

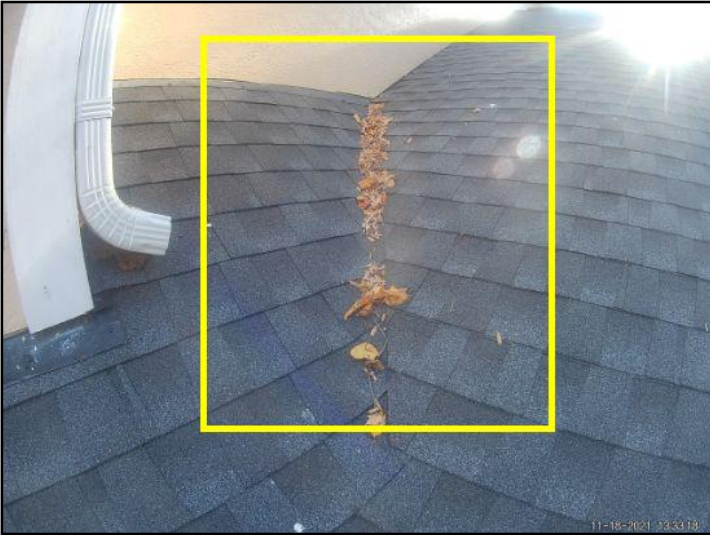
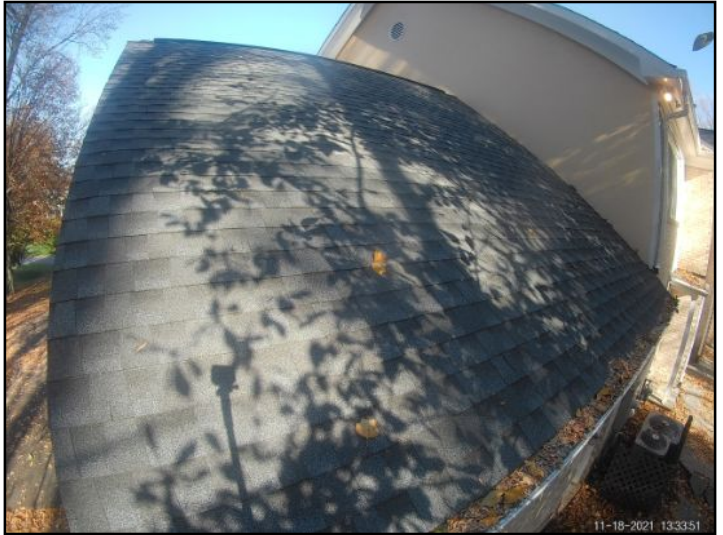
- New roof was installed in 2021 according to the owner. Recommend inquiring who replaced roof and if there are any transferable warranties.
- Clean roof areas: Significant amounts of organic debris evident.

Clean roof areas: Significant amounts of organic debris evident.

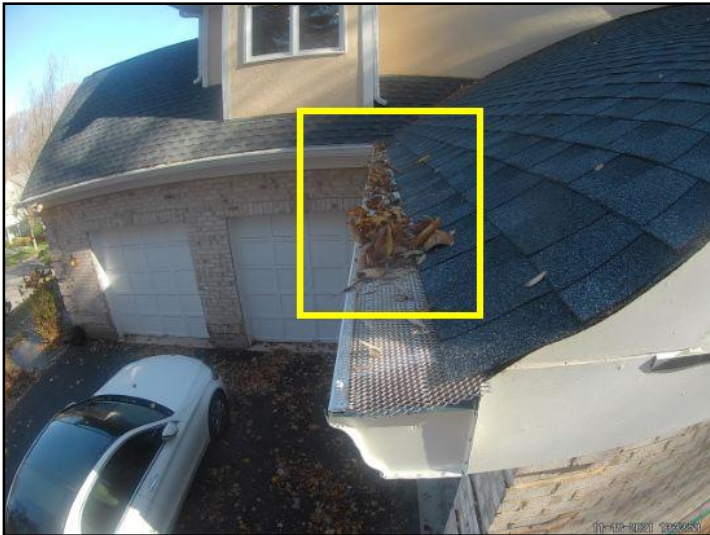
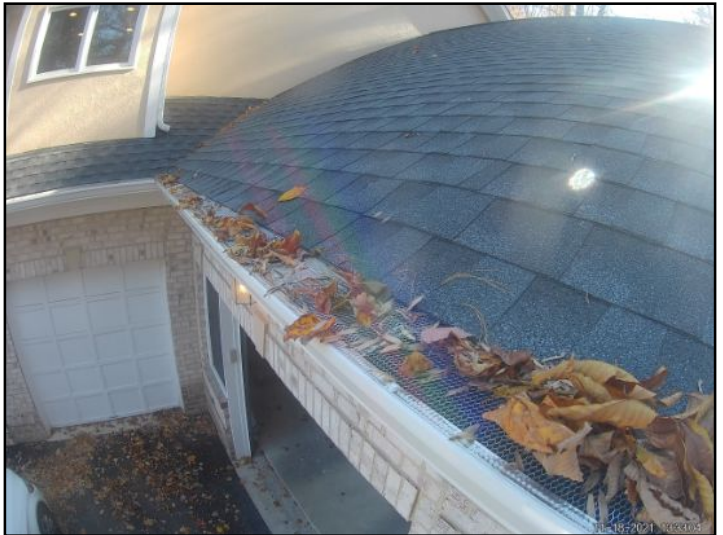
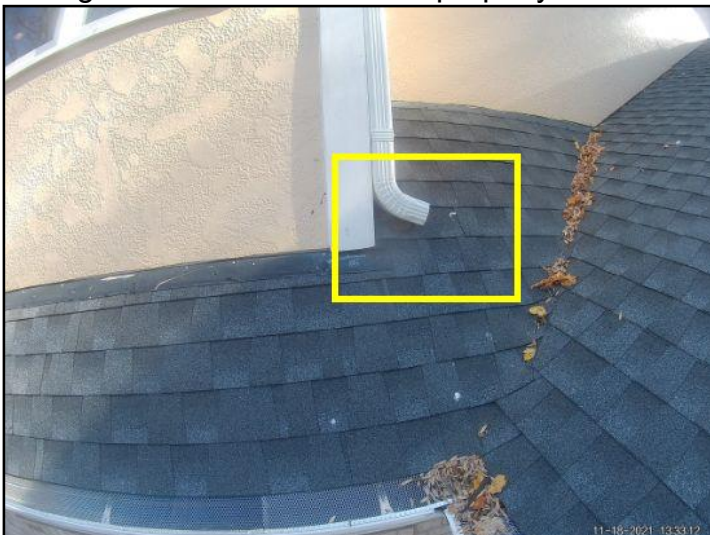
Debris noted in gutters. Recommend cleaning gutters so that water can properly drain.

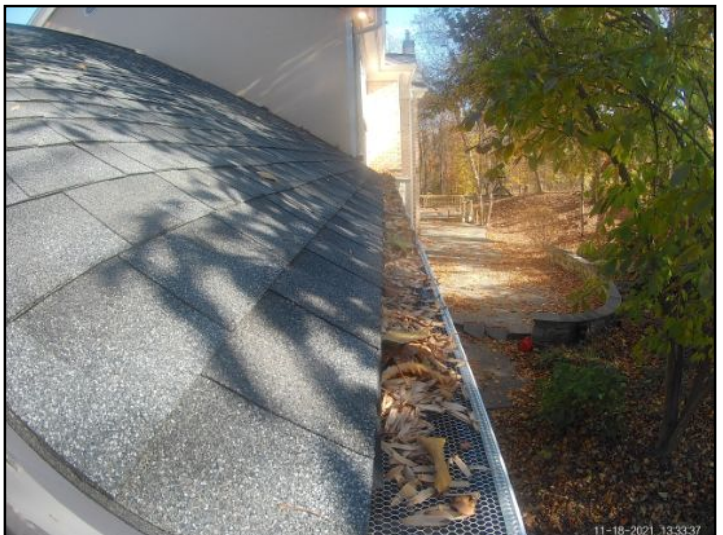
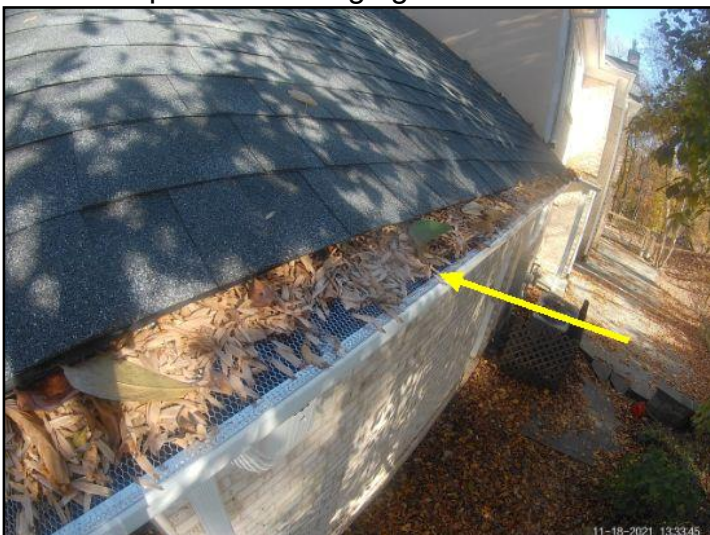
Downspout/s discharging on roof observed.

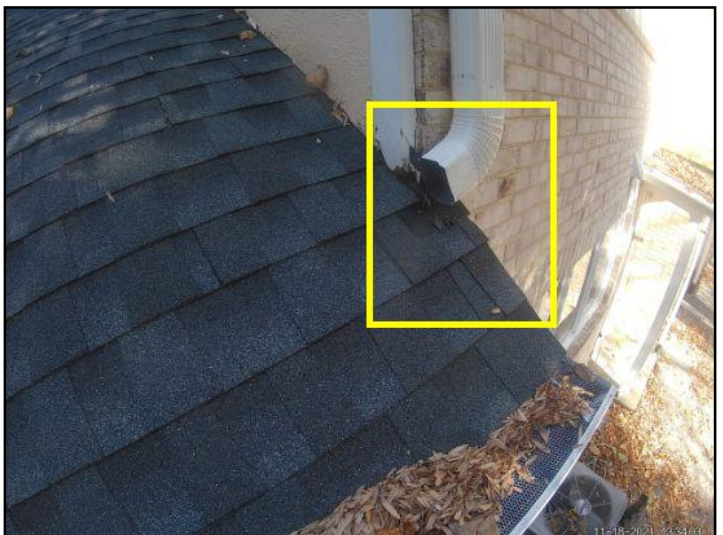
Debris noted in gutters. Recommend cleaning gutters so that water can properly drain.

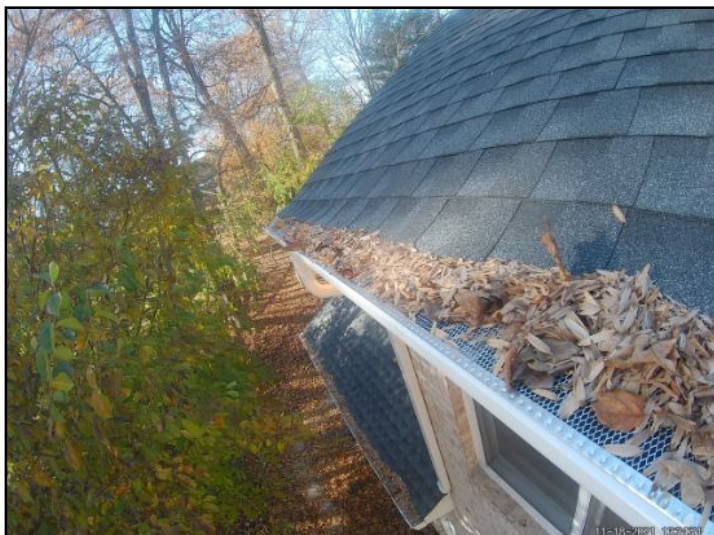
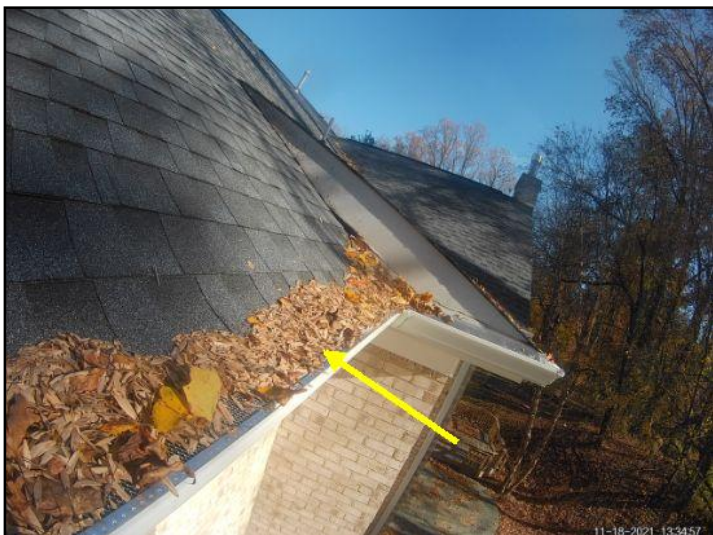
Downspout/s discharging on roof observed.

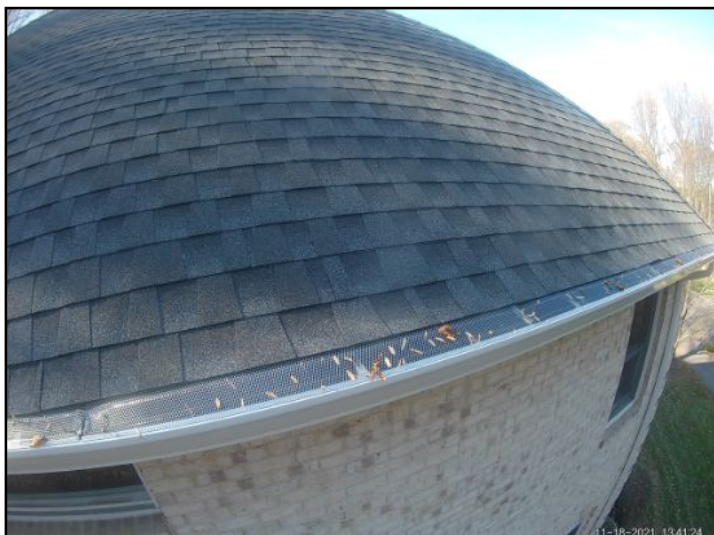
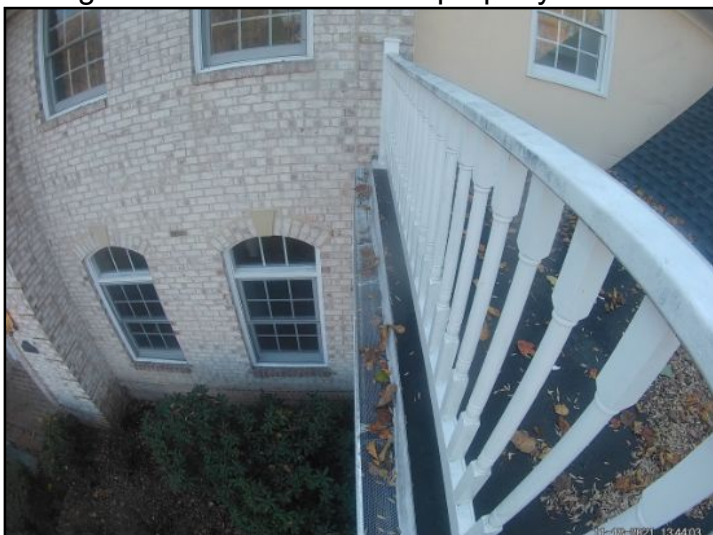
Debris noted in gutters. Recommend cleaning gutters so that water can properly drain.

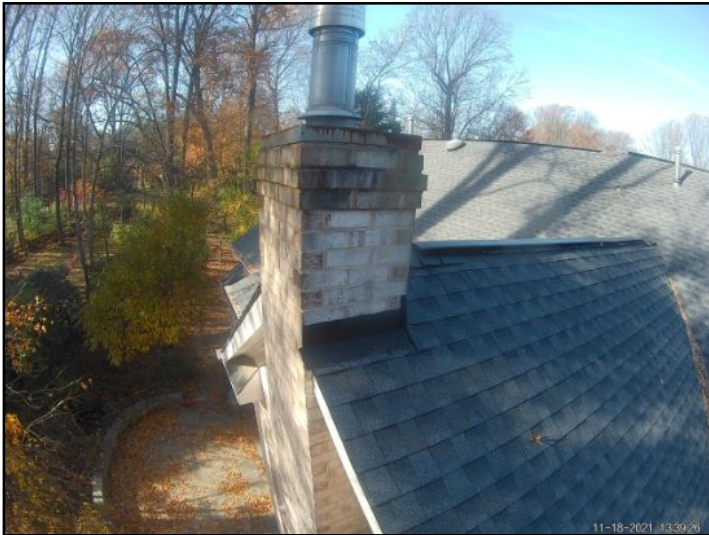
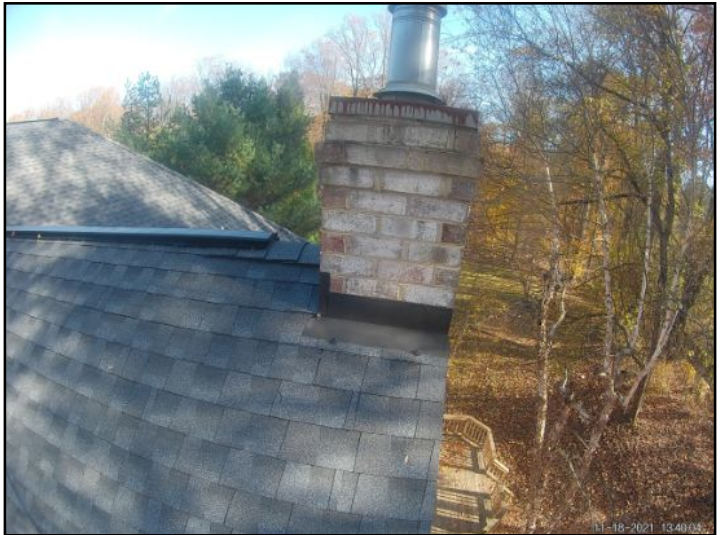
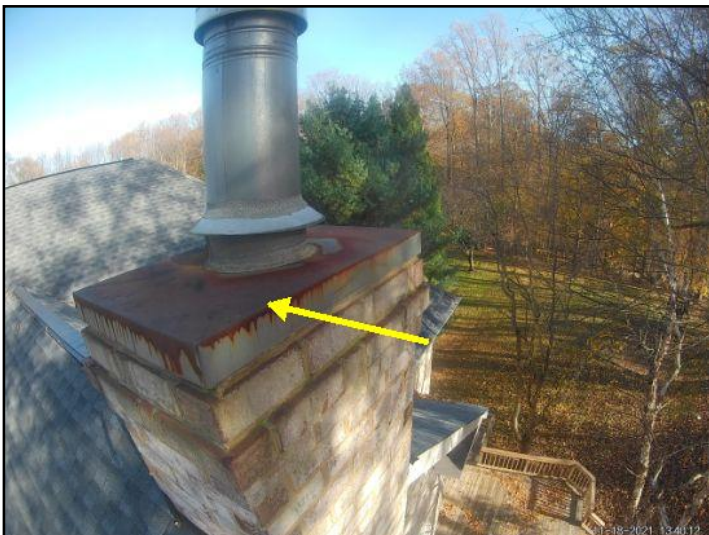
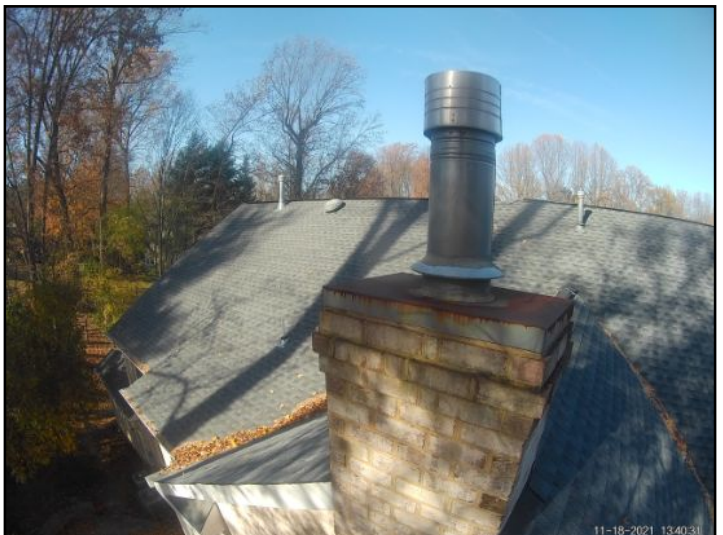
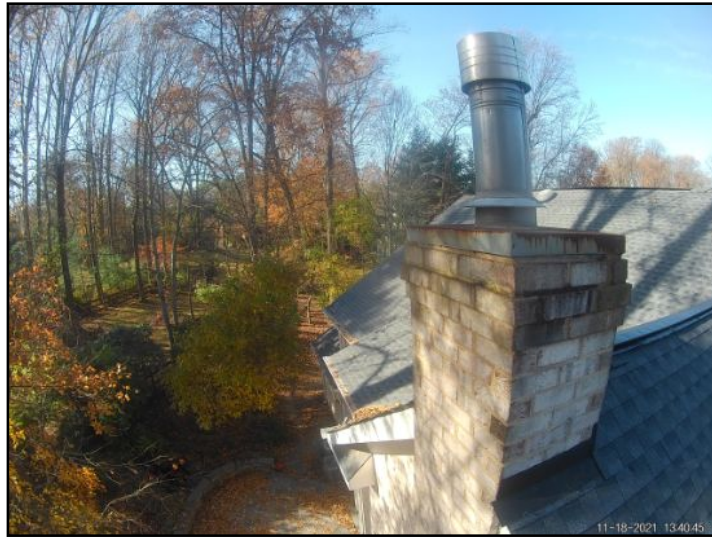
- Chimney rain cap is severely rusted/deteriorated. Recommend painting to preserve its remaining life.

Chimney rain cap is severely rusted/deteriorated. Recommend painting to preserve its remaining life.

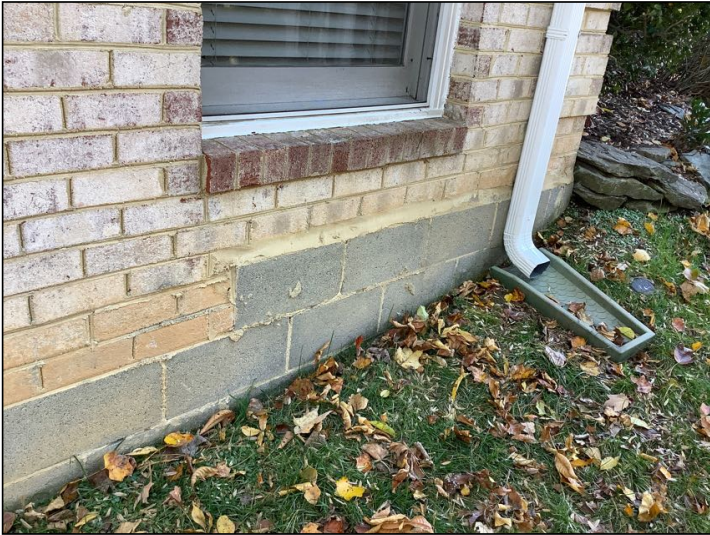
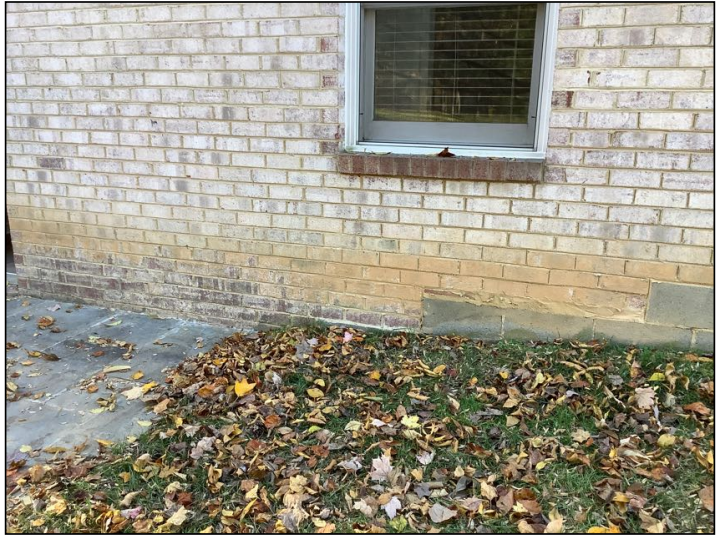
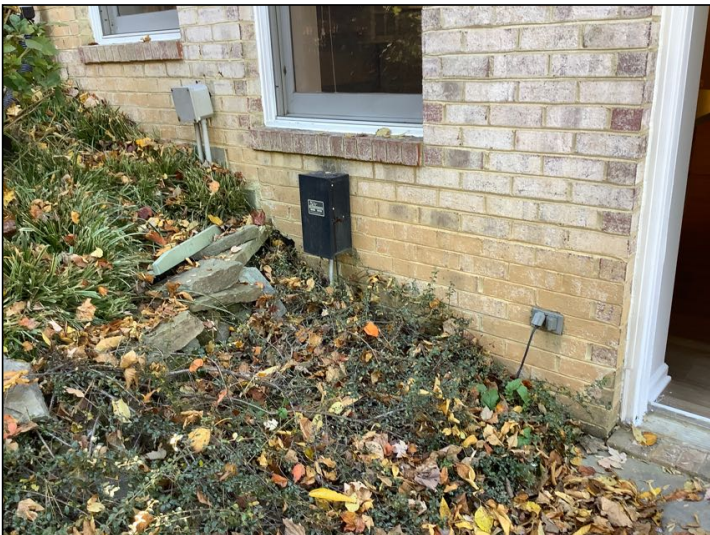
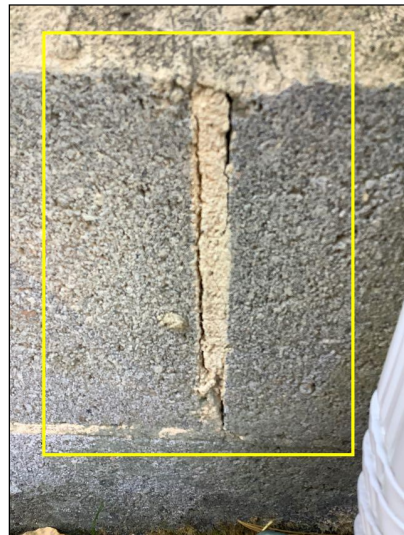
Cracks/deteriorated mortar observed. Recommend sealing/re-pointing as needed to prevent moisture intrusion.

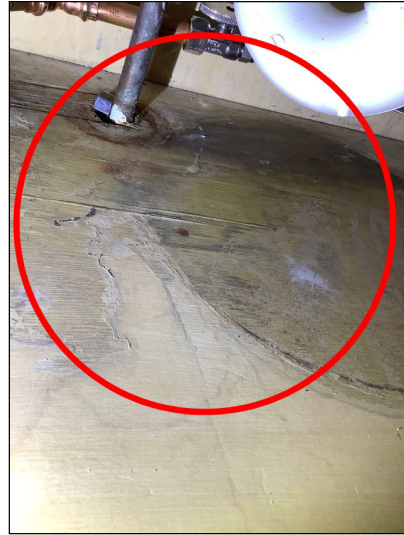
Evidence of previous/past leak noted, it is dry at the time of the inspection.

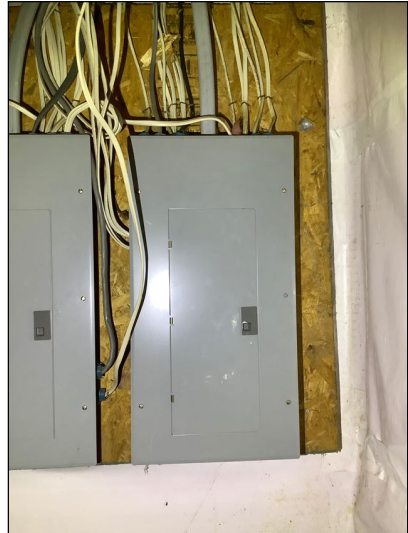
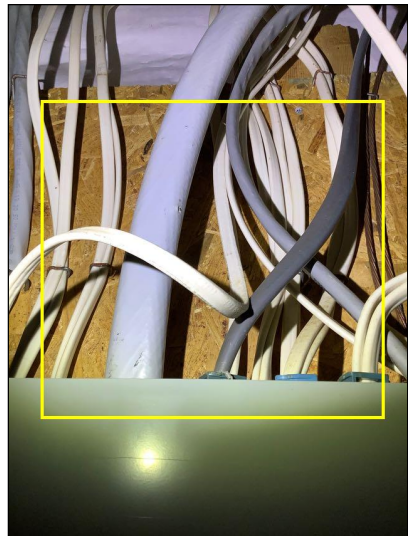
Unsecured wires entering panel

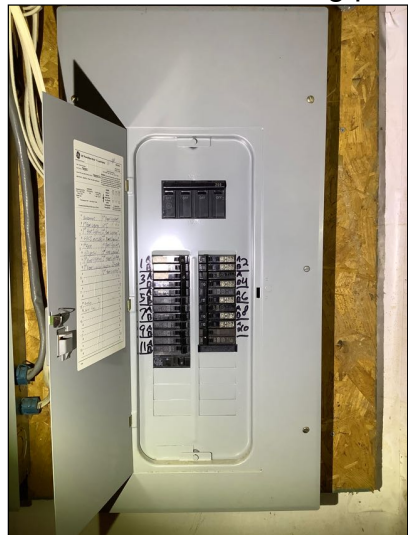
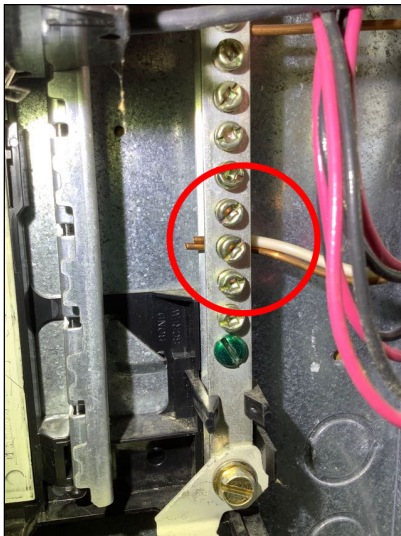
Double tapped neutral wire observed at bus bar

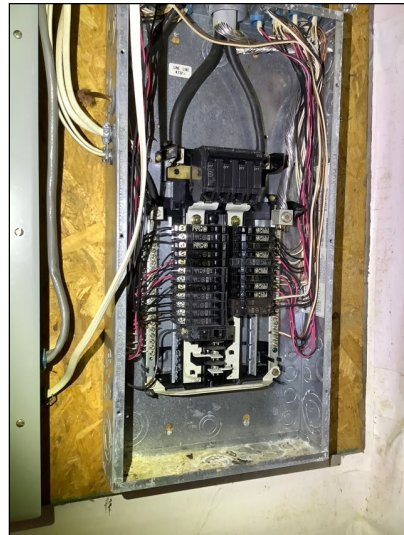
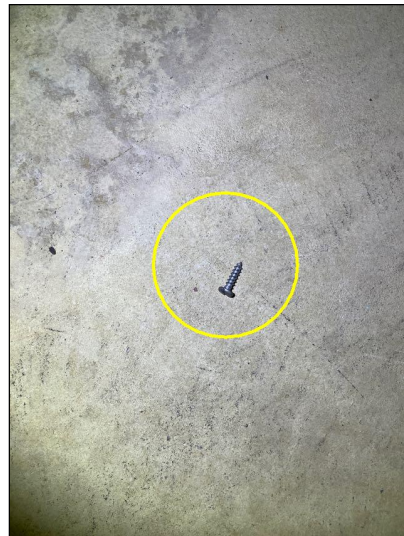
Sharp-pointed metal screws hold panel cover in place. These are a potential hazard as they may puncture wire insulation and electrify panel box, becoming a shock or electrocution hazard. These screws should be replaced with approved, flat-tipped screws.

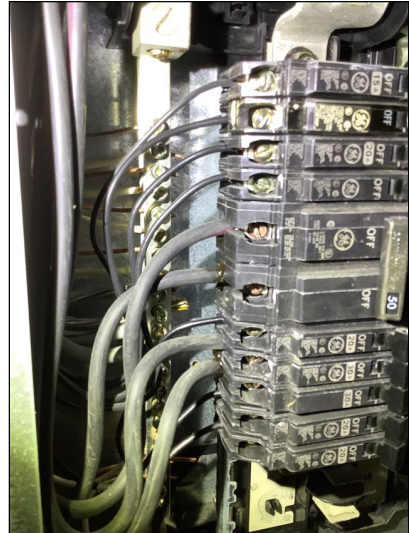
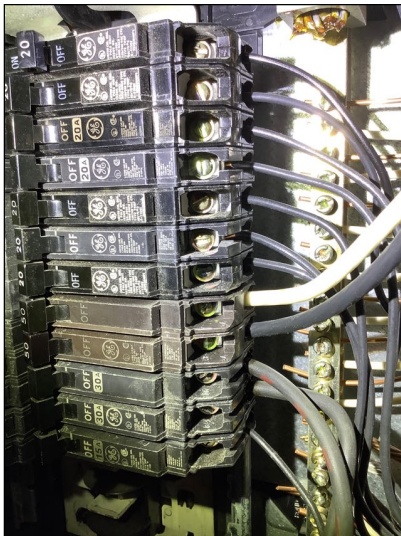
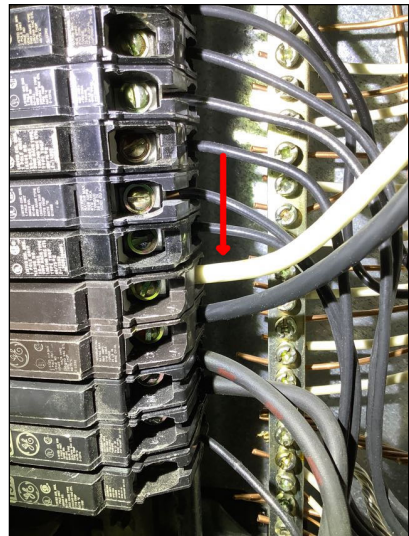
White wire connected to hot breaker switch, white wires are designated to neutral bus connection, replace or label as needed.

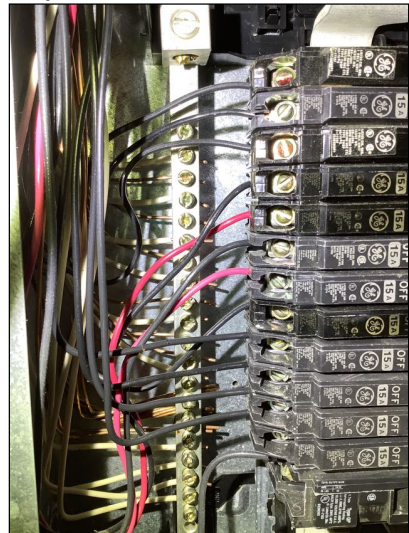
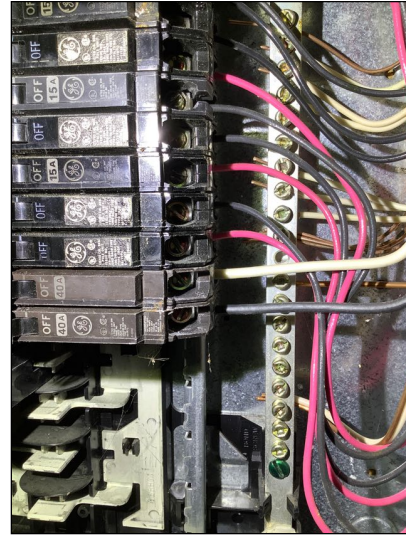
White wire connected to hot breaker switch, white wires are designated to neutral bus connection, replace or label as needed.

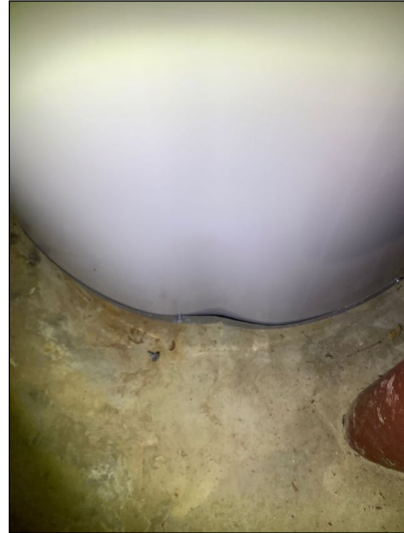
- The water heater enclosure is bent due to prior damage.

Dents observed throughout water heater enclosure

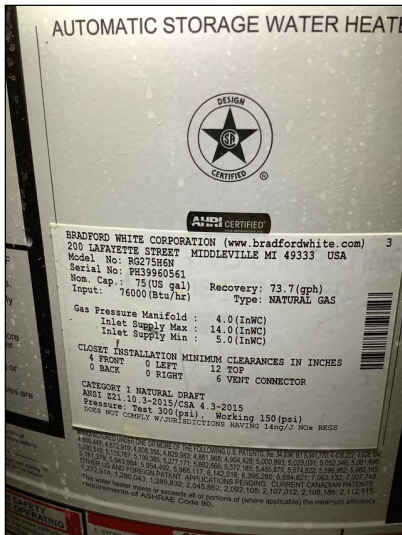
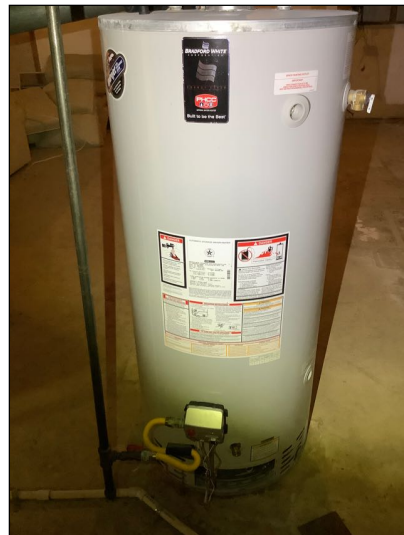
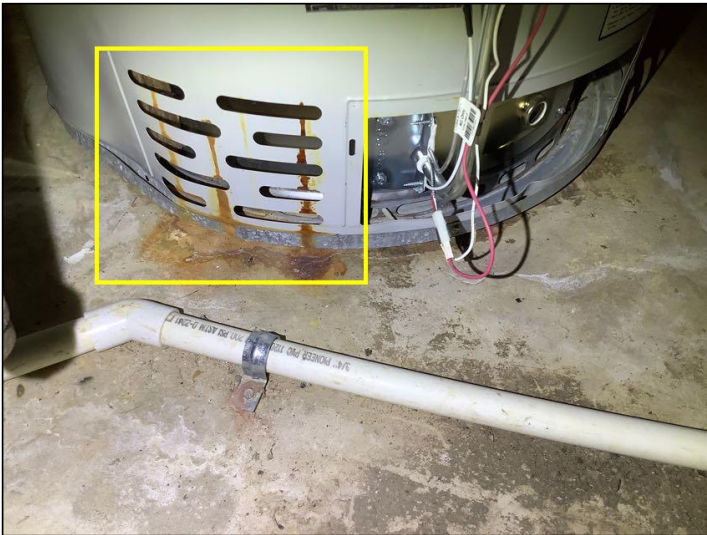
Rust noted at water heater enclosure

- Manufacture date: 2017. Life expectancy around 10 years.
- Water temperature 123 degrees @ Kitchen sink
- **Rust observed at water heater enclosure. Recommend repair/replacement by licensed plumbing contractor.**

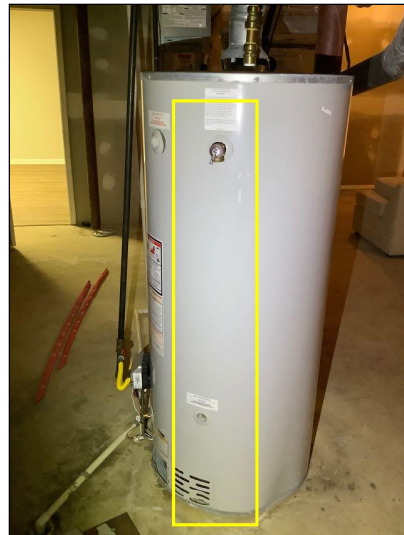
- Missing overflow discharge pipe noted. This is a potential scalding concern as water can discharge improperly. Recommend installing the proper type of relief extension to discharge within 6" from the floor.

Extension missing from water heater TPRV

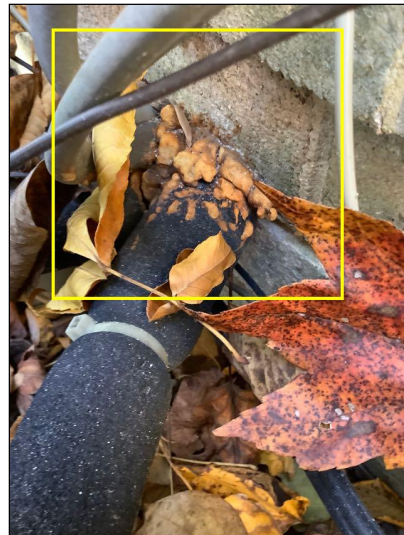
Deteriorated sealant at the pipe wall penetration, repair/seal as needed.

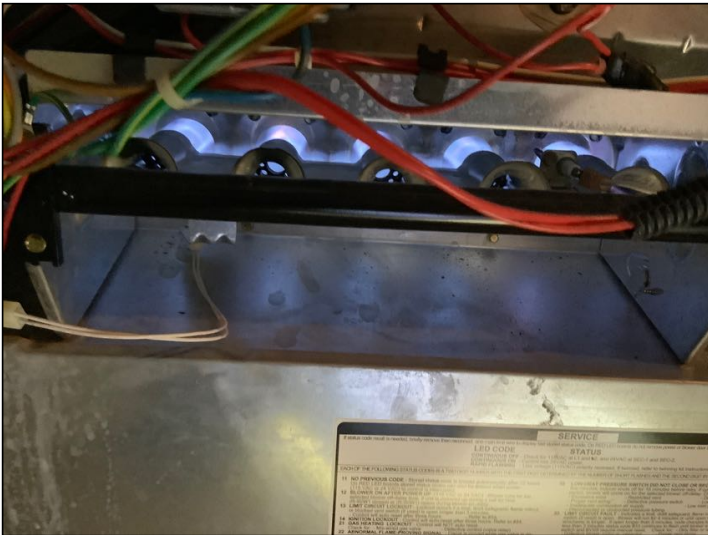
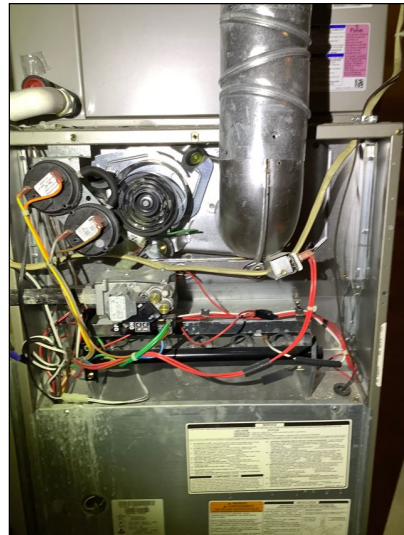
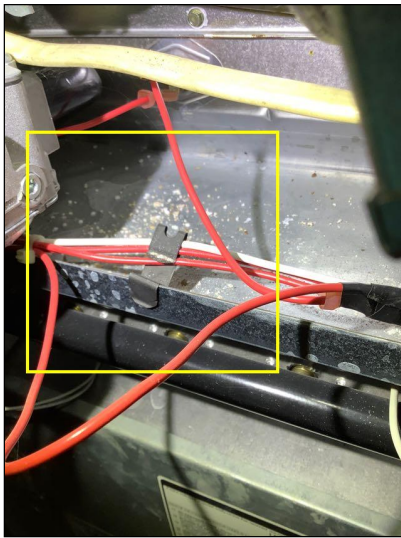
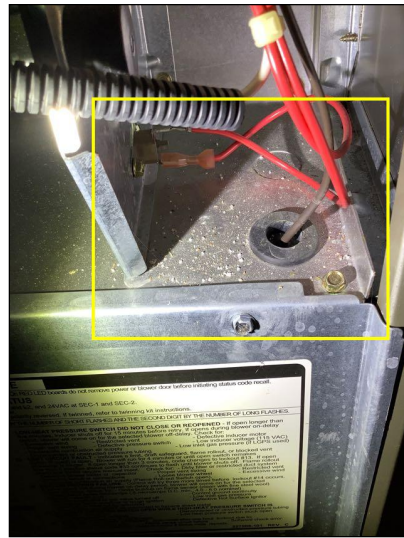
Dust and debris observed in unit. Recommend having furnace cleaned and serviced by licensed HVAC tech to ensure proper performance.

The furnace is dirty and there are no records of prior service. Recommend having furnace cleaned and serviced by licensed HVAC tech to ensure proper performance.

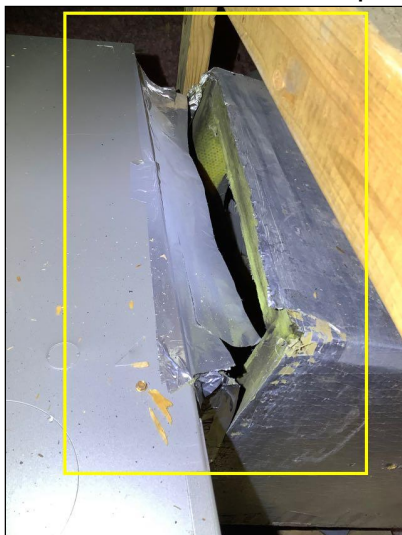
Return air vent detached at furnace in attic

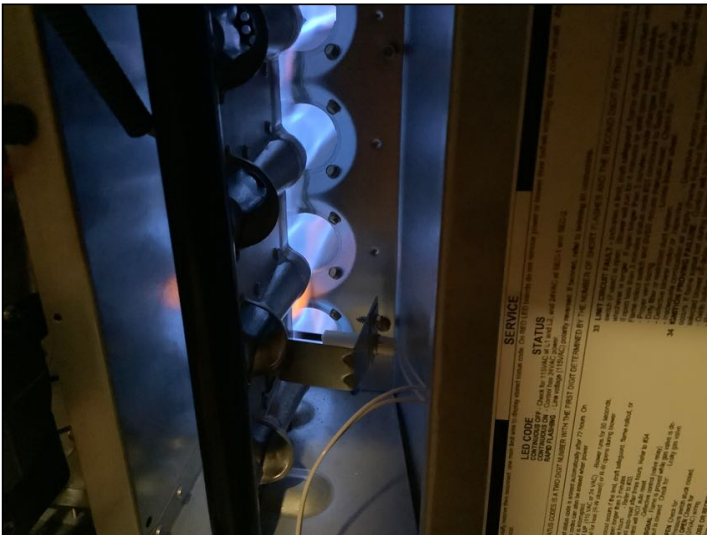
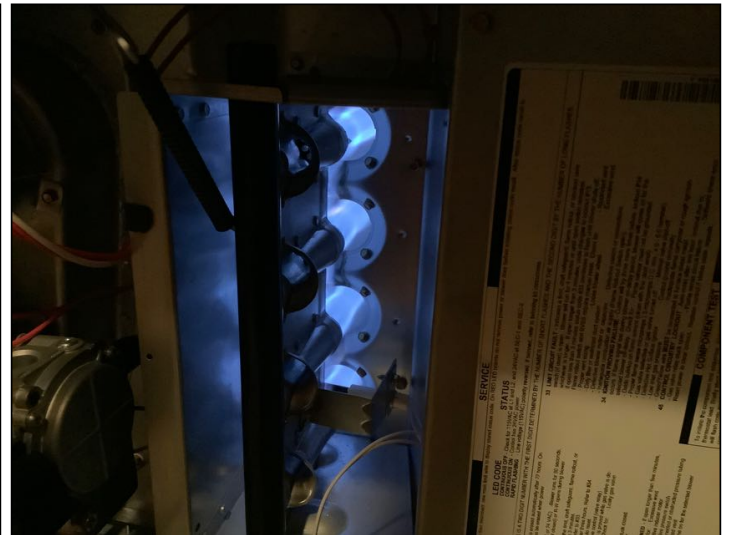
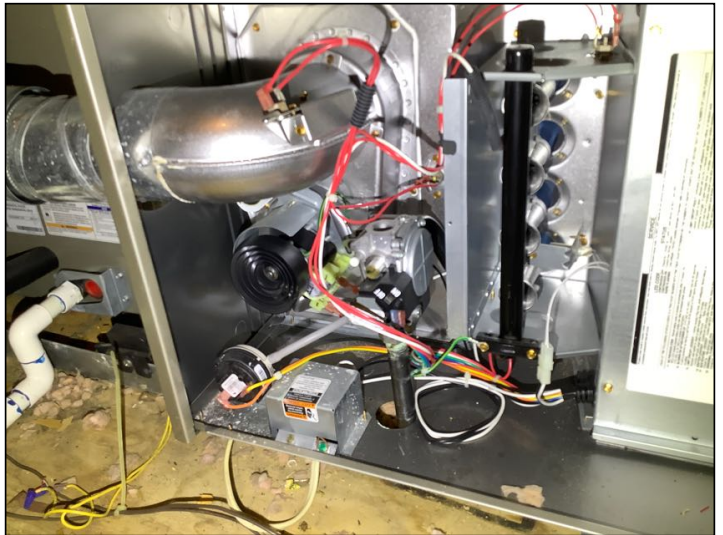
Burner Flames with orange/red pulses, this an indication of incomplete combustion. Recommend servicing the unit by a certified HVAC specialist.

The air handler is dirty and appears to have a bio growth (mold like substance), we recommend testing for mold.

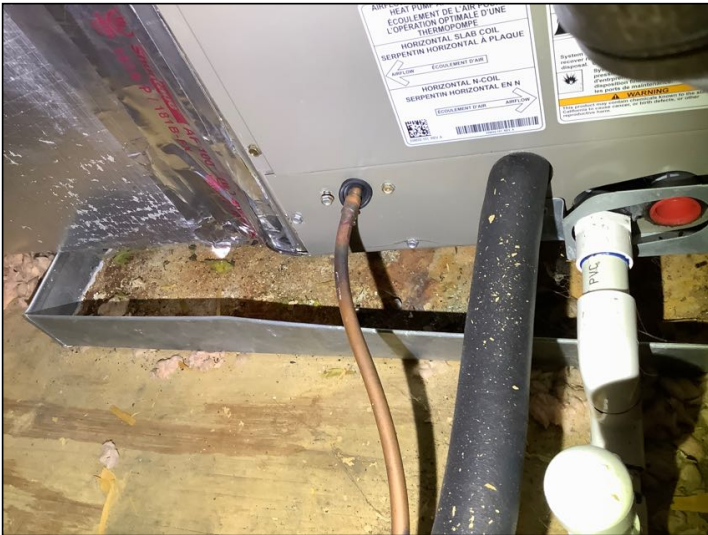
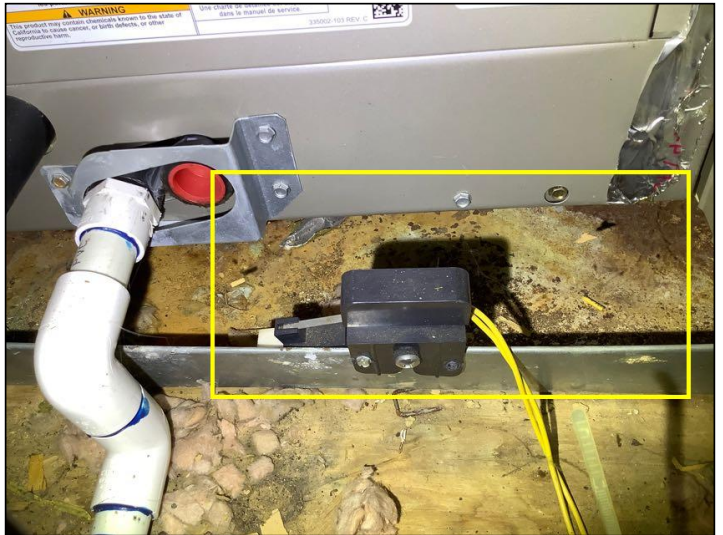
The heater base shows signs of water damage. Possible prior water intrusion.

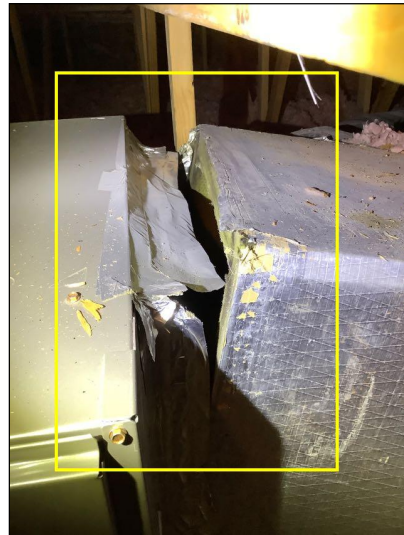
- Return air appears to be detached/leaking at unit. We recommend sealing or patching the ductwork in these areas.

Return air vent detached at furnace in attic
