INSPECTION REPORT

10000 Sample Street, Sample City VA 10000

Date of Inspection: 5/7/2022 Time: 2:00 PM

Note: Inspection of damaged area of roof

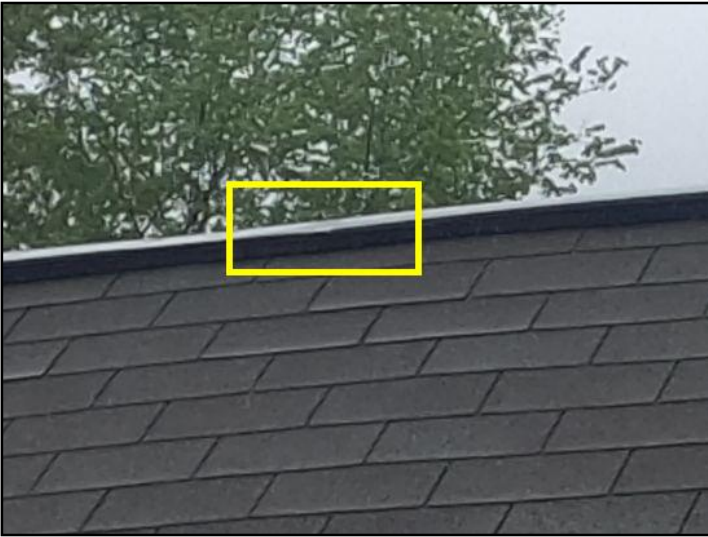
- Roof may be the original installation and approaching the end of its useful life. Recommend having a licensed roofing specialist evaluate for repair/replacement as needed.
- Ridge vent appeared damaged at approximate location of leak observed in the attic. Recommend repair.
- Broken and missing shingles observed in several areas. Recommend repair by roofing specialist.

Appeared bent

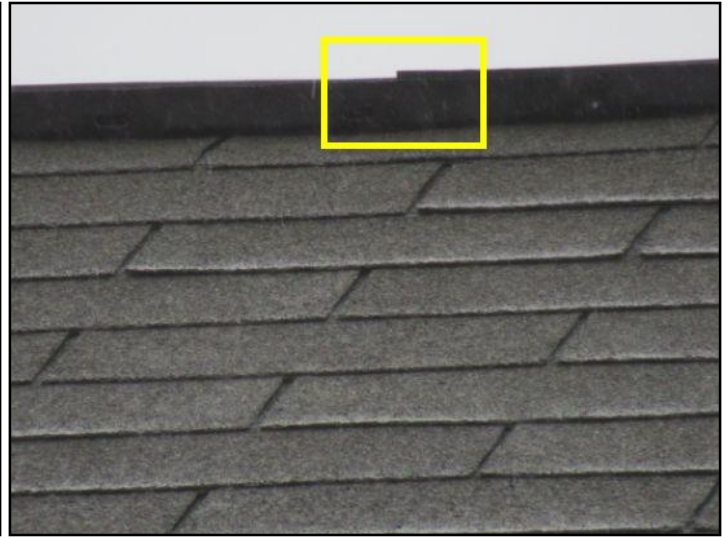
Appeared bent

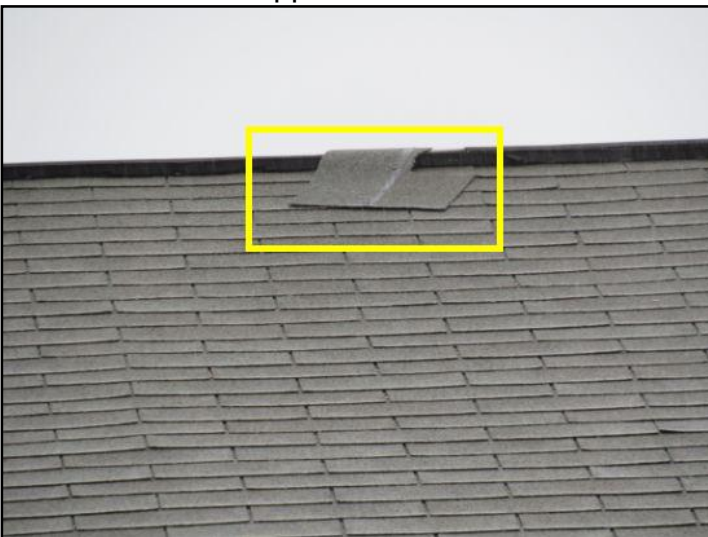
Loose shingle

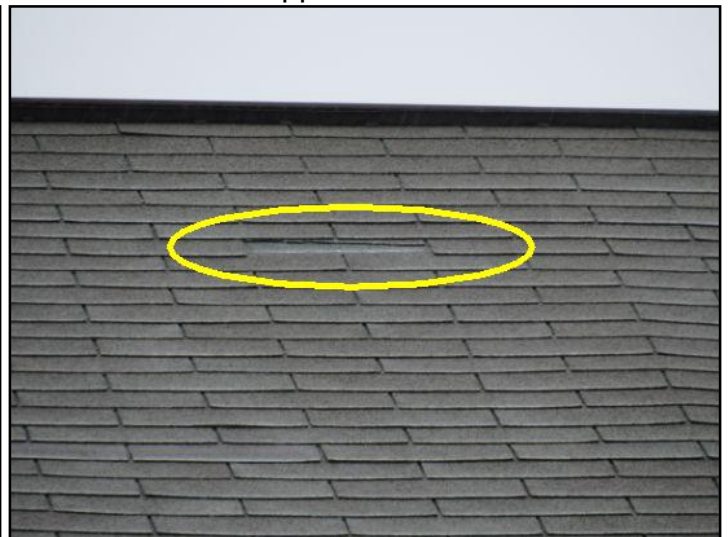
Broken/missing shingle

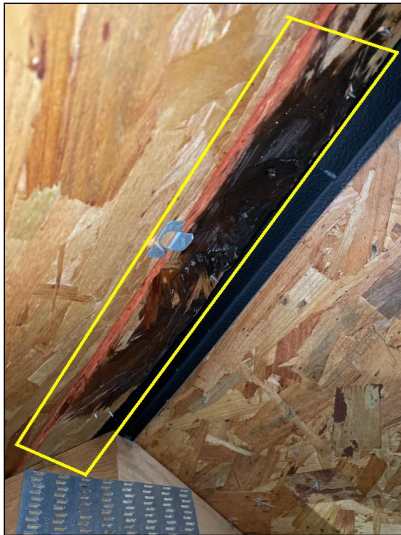
- Observations:
- Stained and swollen sheathing observed near ridge vent. Wet to touch with water presence confirmed by moisture meter. Recommend repair.
 - Drywall directly beneath ridge vent leak was stained. Corresponding area of hallway ceiling was damaged. Recommend repairs.

Swollen and wet

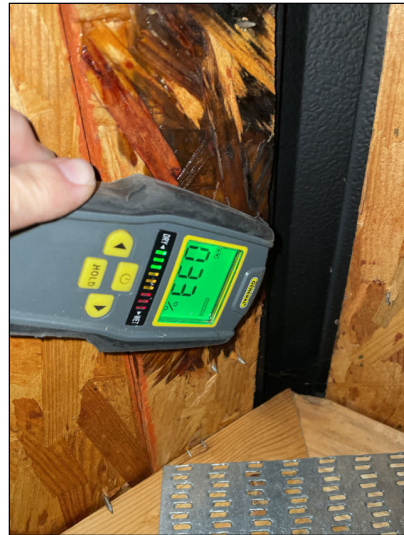
Moisture indicated

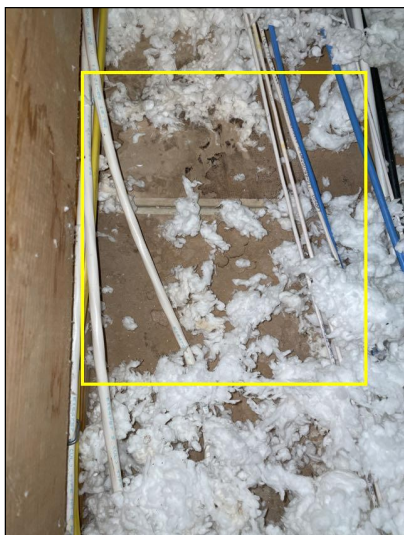
Stained drywall/hallway ceiling

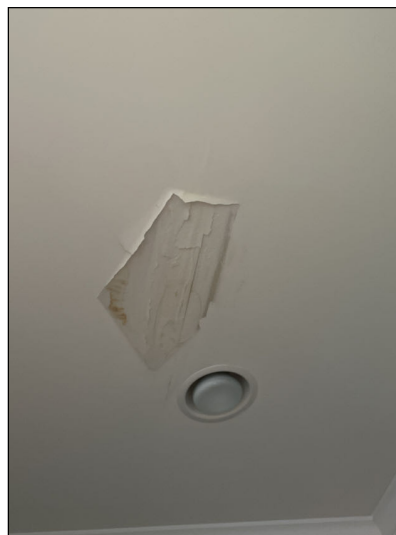
Damaged ceiling in hallway

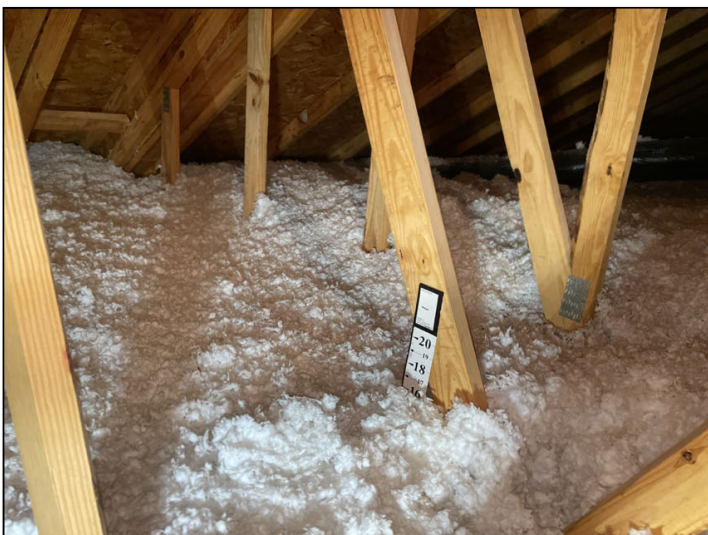
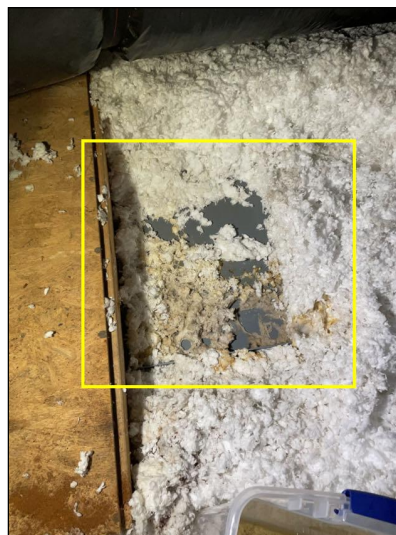
- Insulation was stained and wet directly beneath leak at ridge vent.
- Recommend replacing damaged insulation.

Wet insulation

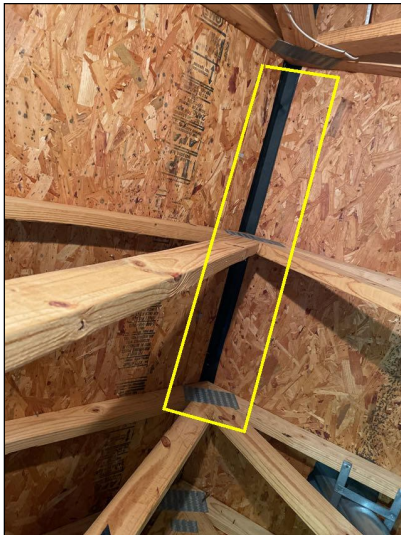
Ridge vent

- Soffit and ridge vent.
- Thermostatically controlled attic fan.
- Appeared functional.

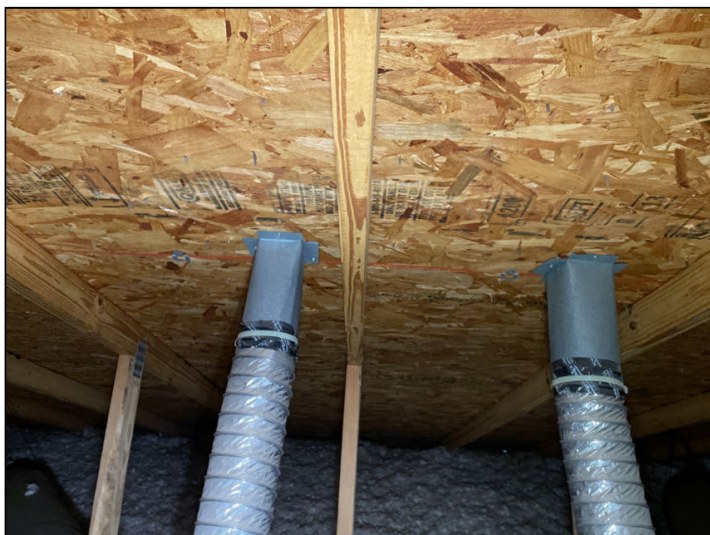
Exhaust vents

Observations:
 • Functional. No deficiencies noted.

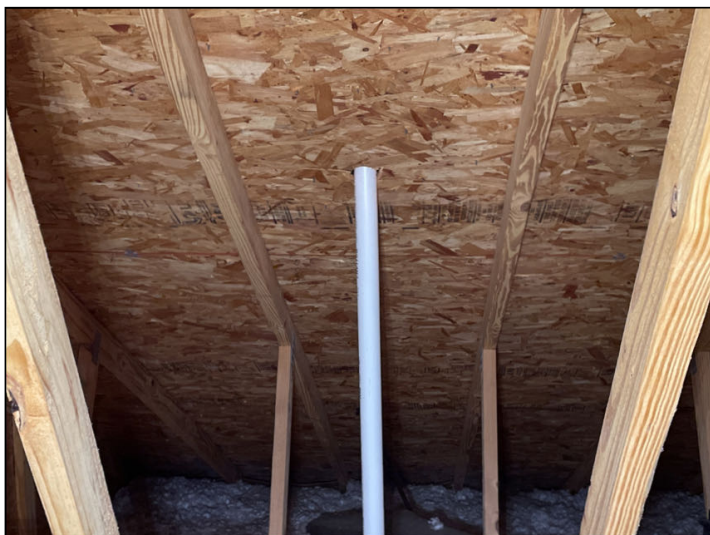
Plumbing vent

- **PVC** plumbing vents
- No deficiencies noted in plumbing vent piping at the time of the inspection.

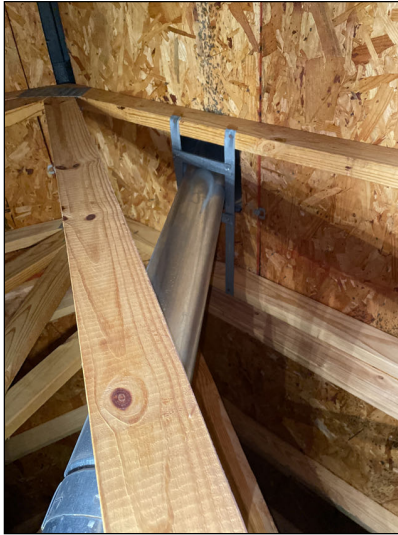
Furnace flue

- Double wall metal B-Vent pipe noted.
- Appeared functional.
