# INSPECTION REPORT

10000 Sample St, Sample VA 10000  
Inspection prepared for: Sample Client  
Real Estate Agent: Sample Agent

Date of Inspection: 12/30/2021 Time: 8:00 AM  
Year Built: 2002 Size (sqft): 2135  
Weather: Raining 45 to 50 degrees F  
Order ID: 9577

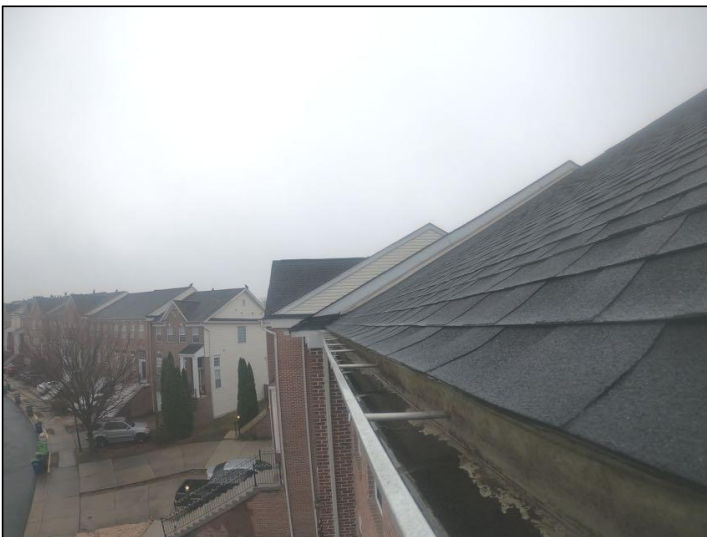
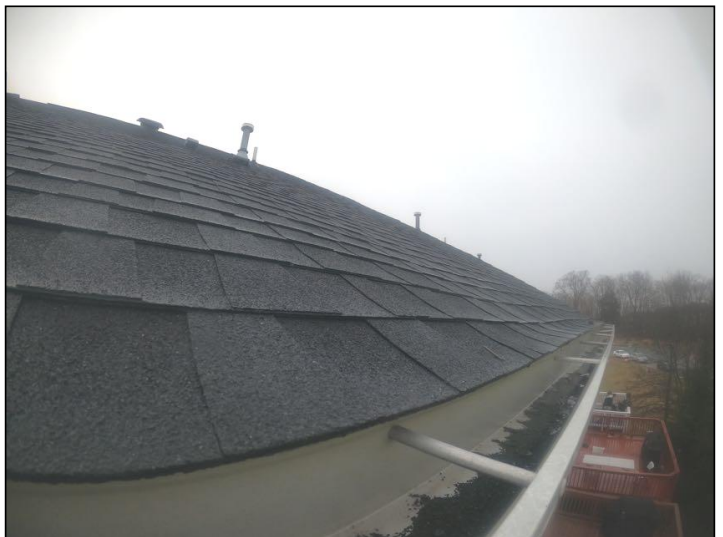
### 2. Gutter

- Roof aggregate and granules noted in the gutter system, Recommend cleaning the gutter.

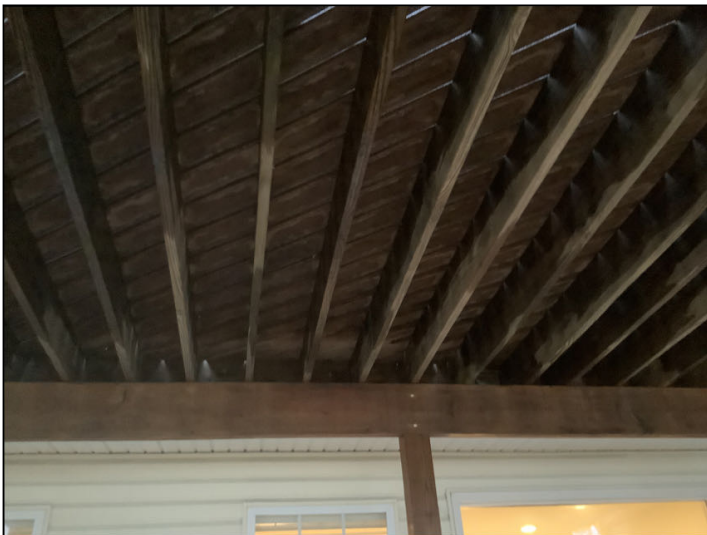
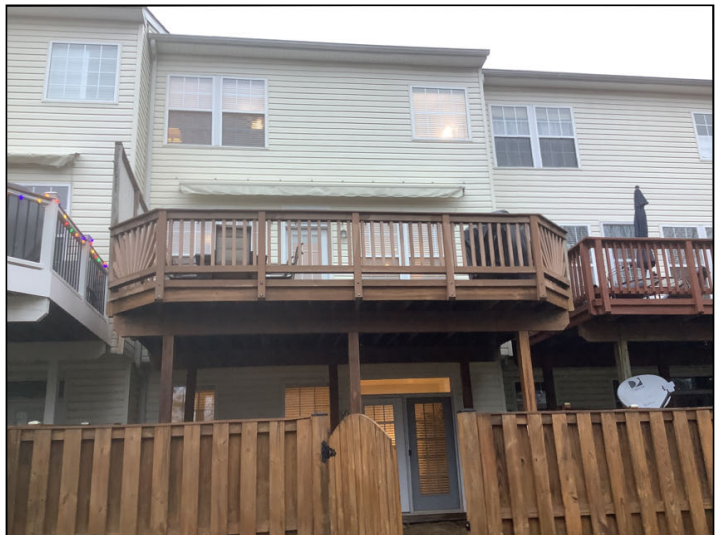
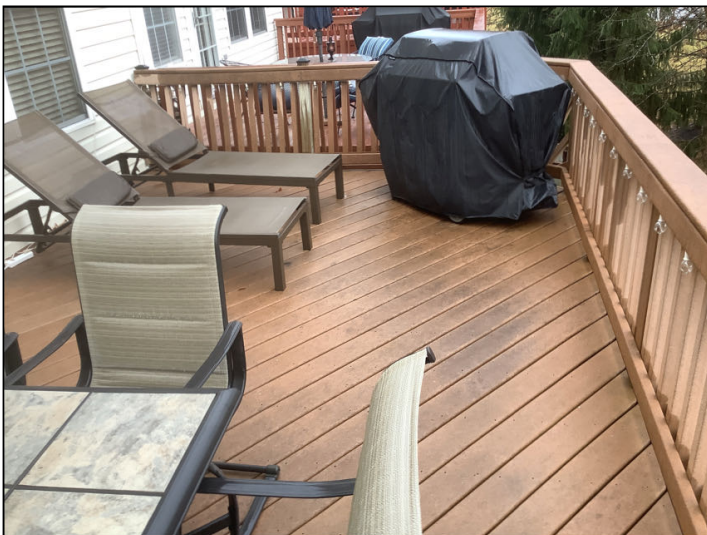
Uneven deck boards

- **MAINTENANCE:** Whether treated or not, it is important to keep a wood deck surface free of all forms of fungal growth and debris that retains moisture and will cause the deck to eventually rot. Recommend cleaning and resealing the deck annually. Cleaning can be accomplished by scrubbing the deck with a sodium-hypochlorite (bleach) and Tri-Sodium-Phosphate (TSP) deck wash and then rinsing with a pressure washer. Finally, a wood deck should be re coated with a high quality deck sealant.
- One or more deck posts are bow, damaged and/or out of plane. Recommend consulting with a deck specialist for further evaluation and repair/replace as needed.

Page 17 Item: 4	Deck	<ul style="list-style-type: none"> <li>• One or more deck posts are bow, damaged and/or out of plane. Recommend consulting with a deck specialist for further evaluation and repair/replace as needed.</li> </ul>
Page 18 Item: 5	Stairs & Handrail	<ul style="list-style-type: none"> <li>• Loose/wobbly guardrails noted. Repair as needed.</li> </ul>

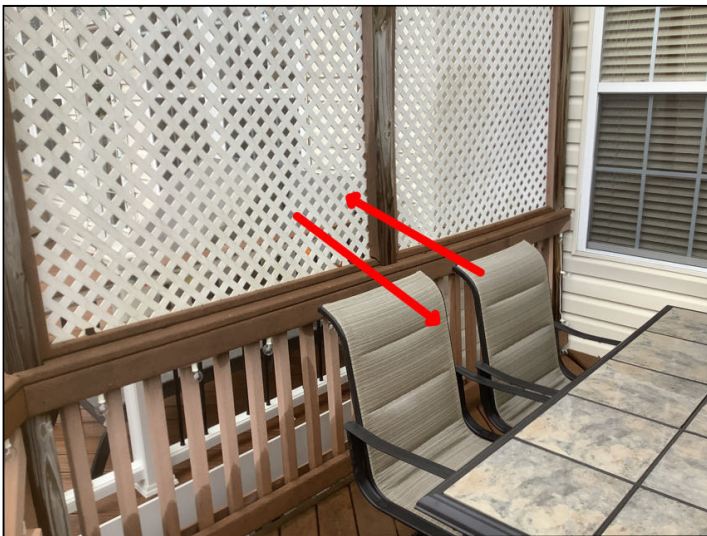
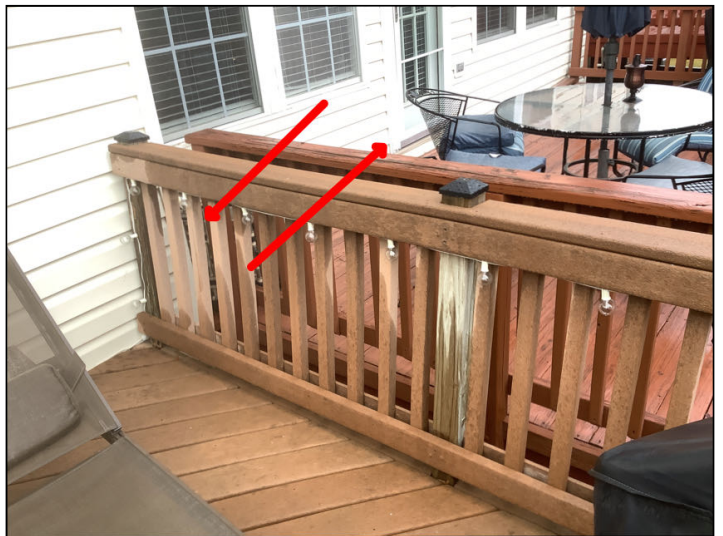
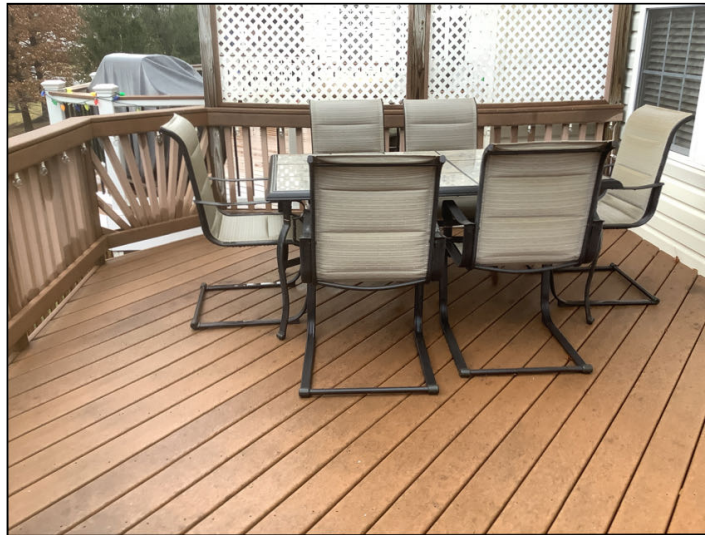
- Loose/wobbly guardrails noted. Repair as needed.

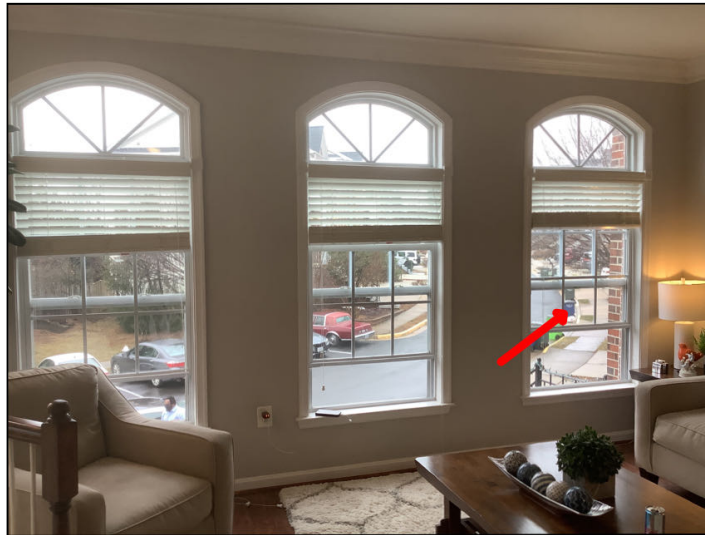
Difficult to operate

Materials: Single Hung Windows • Vinyl • double pane  
 Observations:  
 • Window difficult to operate at one or more locations. Recommend review and repair as needed by qualified window contractor.

Page 27 Item: 6	Window Condition	<ul style="list-style-type: none"> <li>• Window difficult to operate at one or more locations. Recommend review and repair as needed by qualified window contractor.</li> </ul>
-----------------	------------------	---

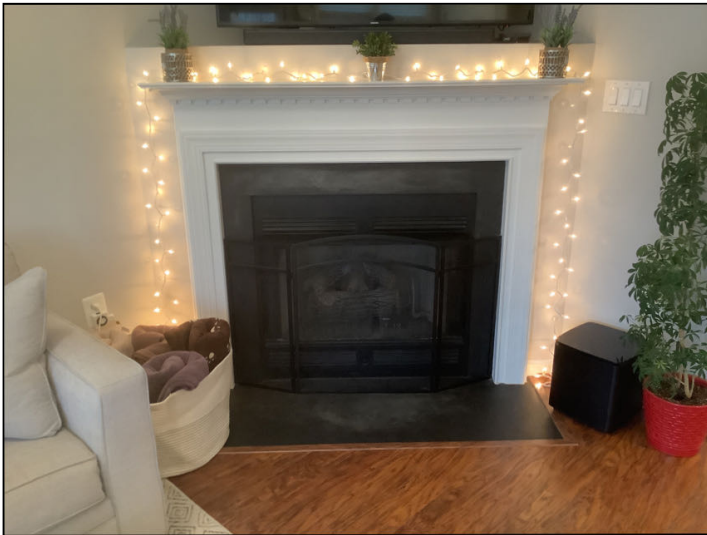
- The fireplace appears to be in fair visual condition. Was not operated because the gas pilot was turned off.

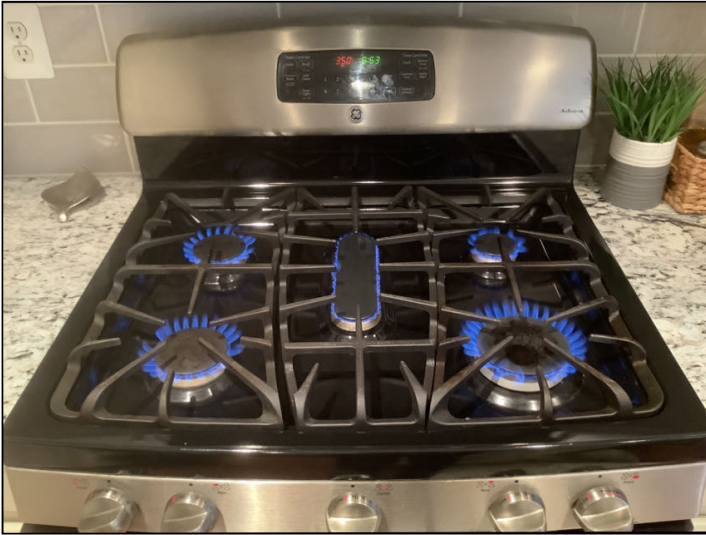
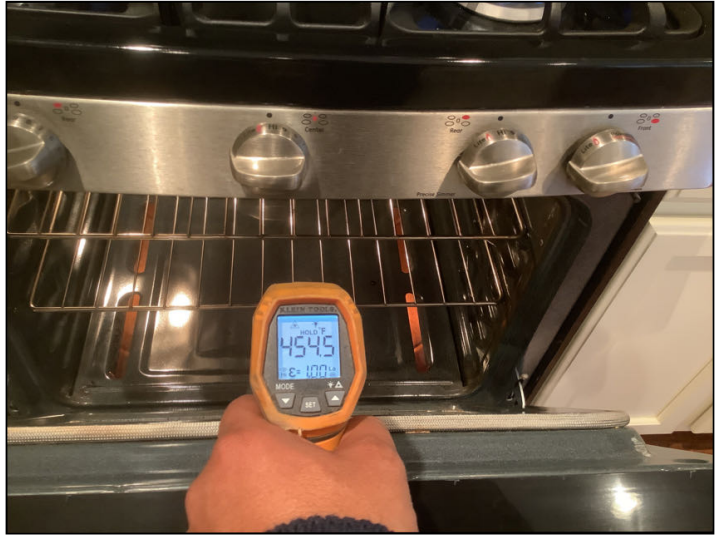
- Oven: gas burners
- The burners operated properly when tested.
- Oven(s) operated when tested.
- Anti-tip bracket is missing from range installation. See label inside oven door. All free-standing, slide-in ranges include an anti-tip device that is essential for the safe operation of the range. It provides protection when excess force or weight is applied to an open oven door. Carried by home building centers.
- **Range missing anti -tip bracket. Recommend installing the anti - tip bracket for safety.**

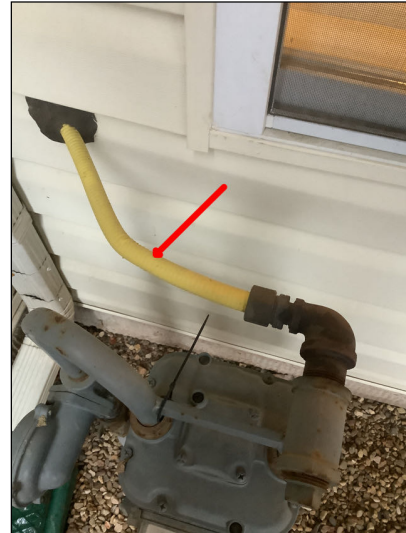
- Appeared in good shape at the time of inspection.
- **CSST** gas pipes bonding and grounding was not visible at the time of the inspection, recommend insuring proper bonding and grounding of the CSST pipe by a certified electrician or plumber.

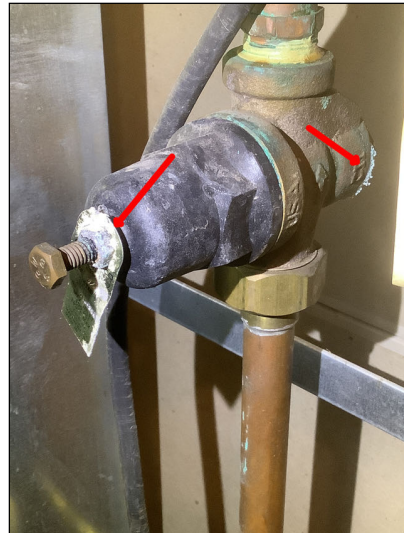
- There is corrosion present around the pressure regulator no leaks noted at the time of the inspection, monitor for worsening condition.

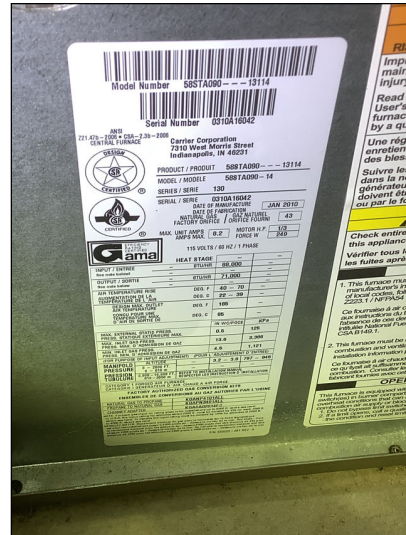
MFD 2010

- Unit appeared to operate properly using normal operating controls at the time of inspection.
- Manufacture date:(2010). Life expectancy around 20 years.
- HVAC system service date was over 12 months or not being able to be determined. We recommend the HVAC system be serviced and cleaned by a licensed HVAC specialist.

Page 57 Item: 4	Heater Condition	<ul style="list-style-type: none"> <li>• HVAC system service date was over 12 months or not being able to be determined. We recommend the HVAC system be serviced and cleaned by a licensed HVAC specialist.</li> </ul>
Page 58 Item: 5	Filters	<ul style="list-style-type: none"> <li>• <b>MAINTENANCE:</b> The air filter(s) should be inspected at least monthly and cleaned or replaced as required. Remember that dirty filters are the most common cause of inadequate heating or cooling performance.</li> </ul>

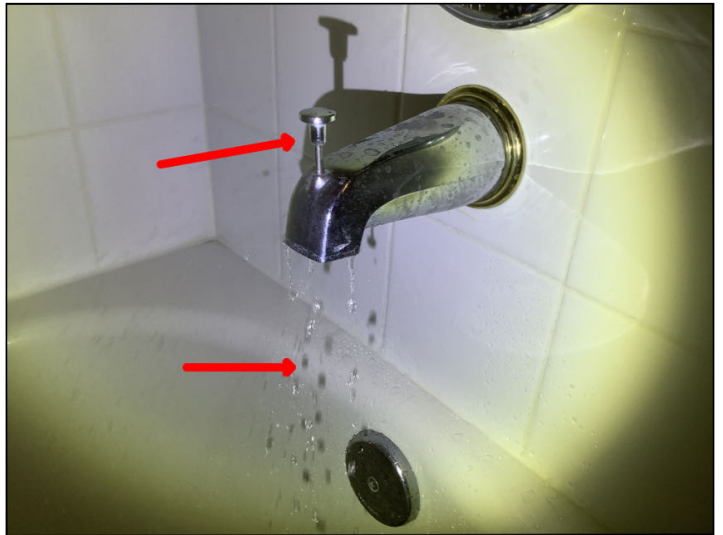
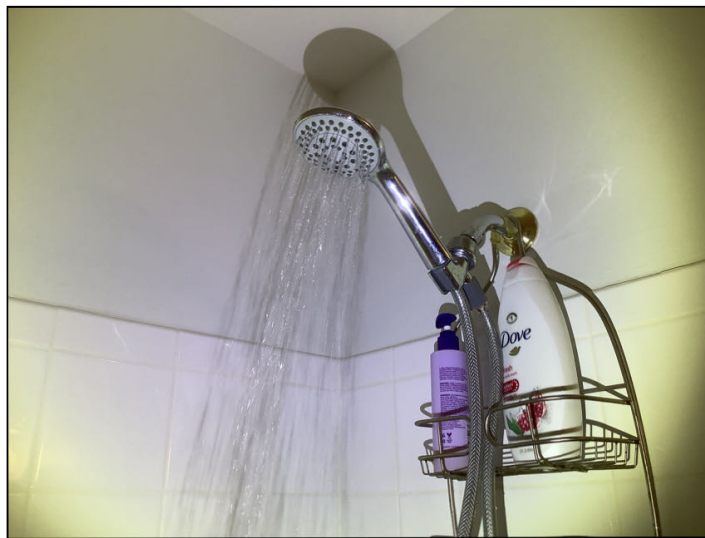
- Functional.
- The escutcheon at the shower head is loose and detached from the wall, repair as needed.
- Shower diverter does not engage completely. Repair or replace as needed.

<b>HVAC Zone 1</b>		
Page 58 Item: 5	Filters	<ul style="list-style-type: none"> <li>The HVAC filter was not present or not located at the time of the inspection. Filters help clean the house air, making the environment more pleasant. Filters also clean the air before it passes through the blower and heat exchanger. This helps to keep HVAC components working efficiently. It is recommended to install a filter and then regular inspection &amp; maintenance is advised.</li> </ul>
<b>Bathroom-01</b>		
Page 62 Item: 3	Doors	<ul style="list-style-type: none"> <li>Door stopper was missing. Recommend installation to avoid unnecessary wall or door damage.</li> </ul>
Page 65 Item: 12	Showers	<ul style="list-style-type: none"> <li>Shower escutcheon is loose, recommend repairing as needed.</li> </ul>
<b>Bathroom-02</b>		
Page 70 Item: 12	Showers	<ul style="list-style-type: none"> <li>The escutcheon at the shower head is loose and detached from the wall, repair as needed.</li> <li>Shower diverter does not engage completely. Repair or replace as needed.</li> </ul>
