INSPECTION REPORT

10000 Sample Road, Sample, MD 10000

Inspection prepared for: Sample Client

Date of Inspection: 1/13/2022 Time: 10:00 AM

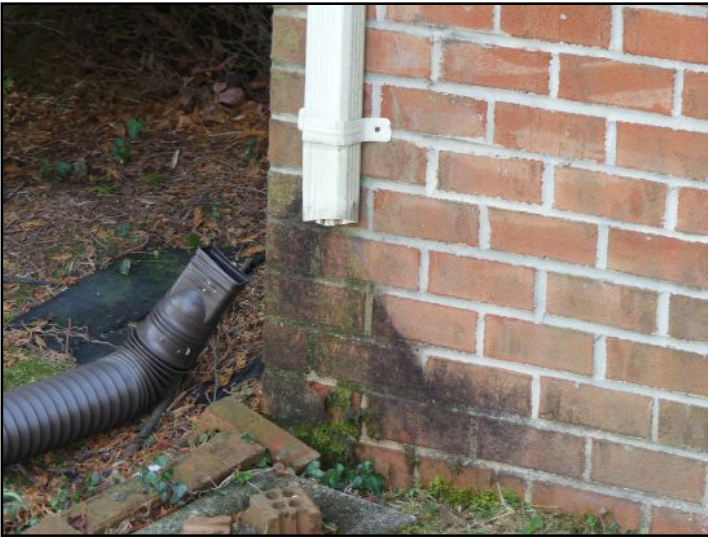
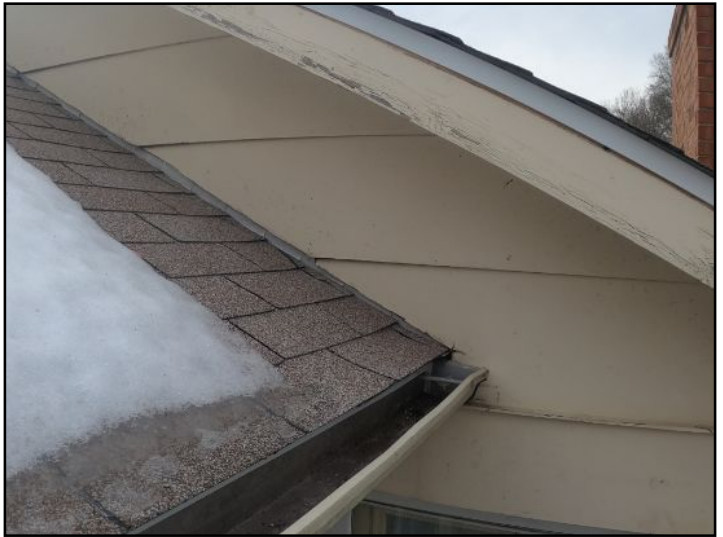
2. Gutter

Observations:
 • Extensions/splash blocks missing or insufficient at one or more downspouts. Recommend installing a 6-foot extension to divert water away from the foundation.

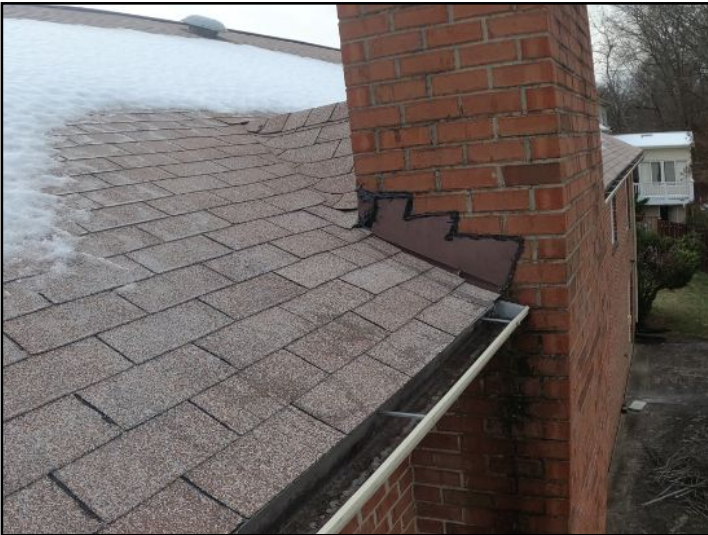
- Previous repairs with mastic material around several flashing, recommend review and repair by a certified roofing specialist.

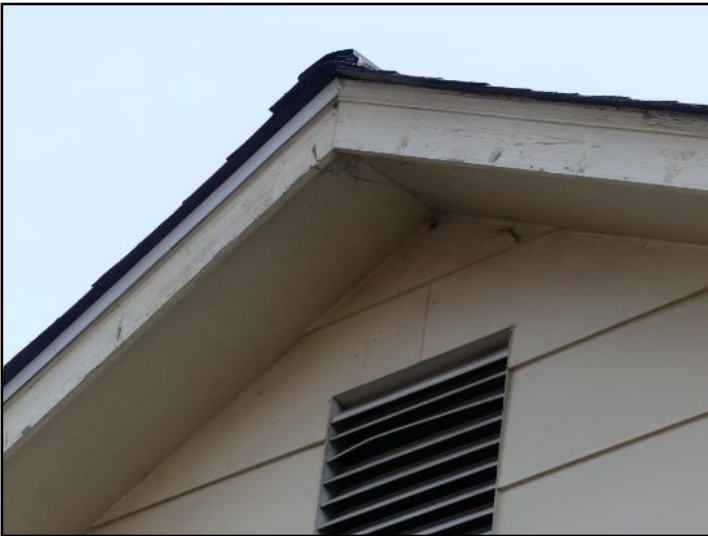
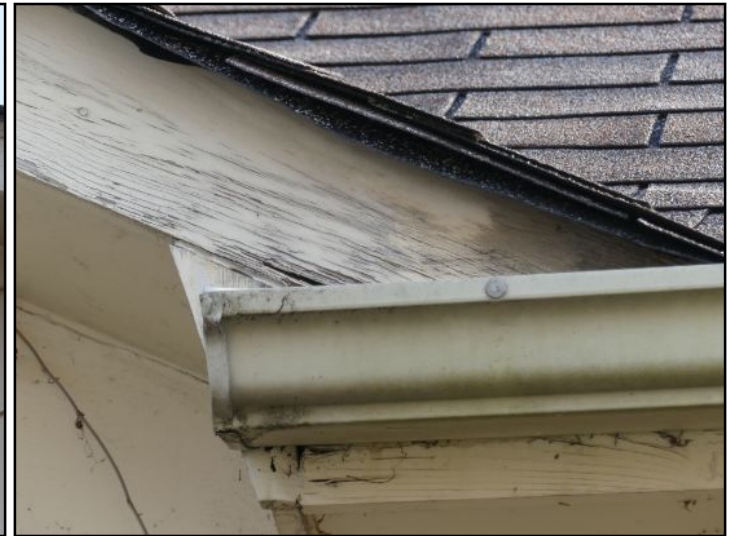
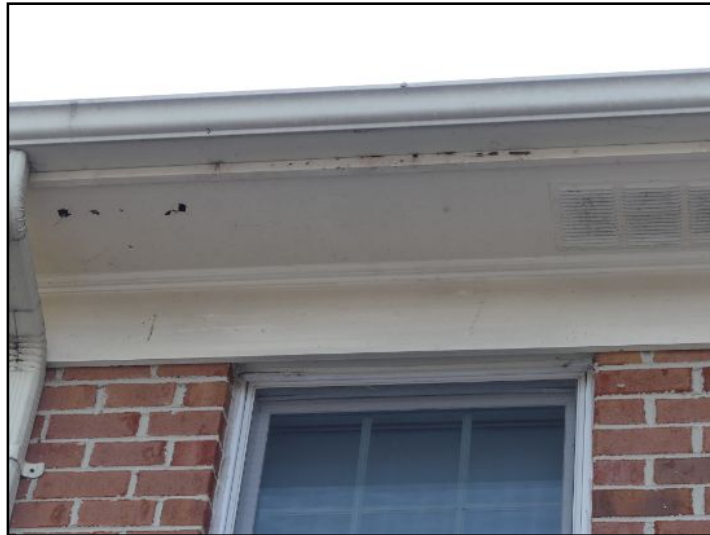
5. Eave and rake

- Rotted wood observed on the dormer rake edge. Recommend repair/replace as needed.

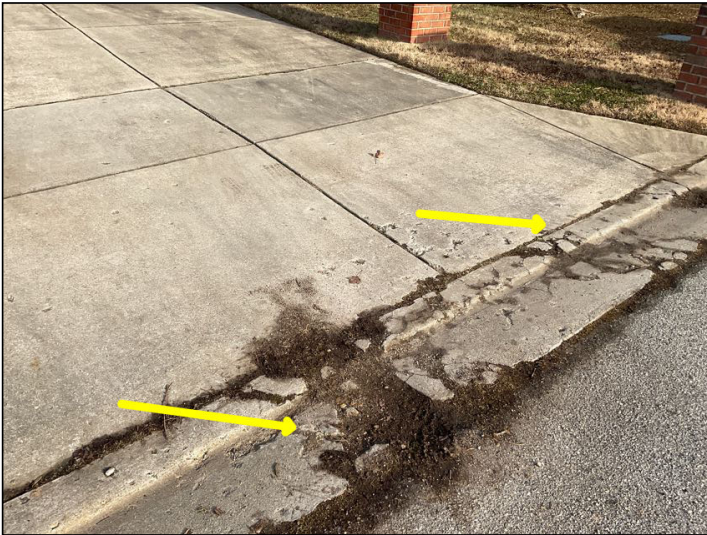
1. Driveway and Walkway Condition

- Uneven slabs at the garage entrance. . This is a potential tripping hazard. Recommend repair and or replacement of the displaced section.

Trip hazard

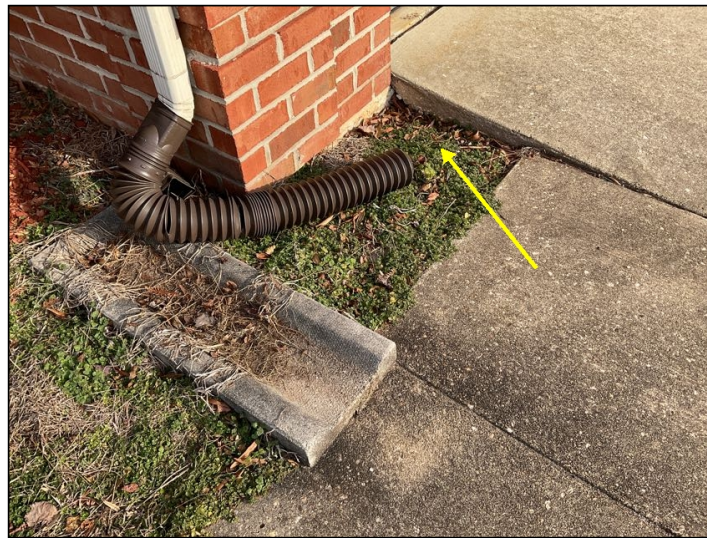
2. Grading

- Several areas by the structure were low or had a negative grade. Recommend repair

Negative grading

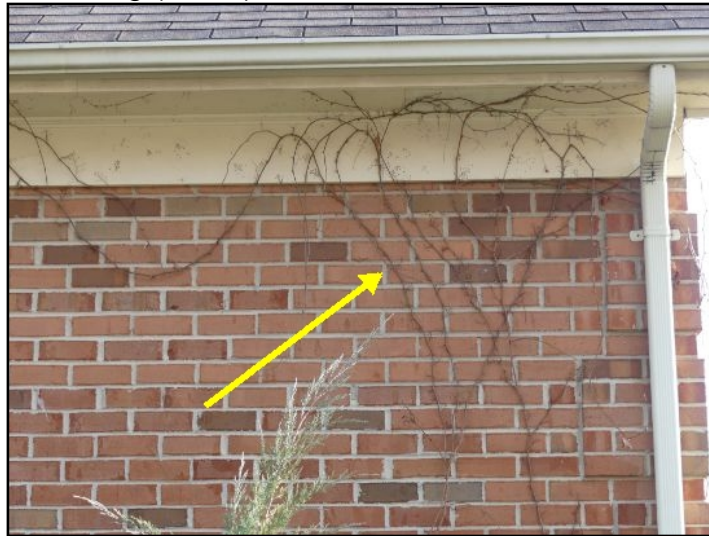
- Maintenance Tip: When landscaping, keep plants, even at full growth, at least a foot (preferably 18 inches) from house siding and windows. Keep trees away from foundation and roof. Plants in contact or proximity to home can provide pathways for wood destroying insects, as well as abrade and damage siding, screens and roofs.
- Prune or remove any plants that are in contact or proximity to home to eliminate pathways for wood destroying insects.

Vegetation on cladding

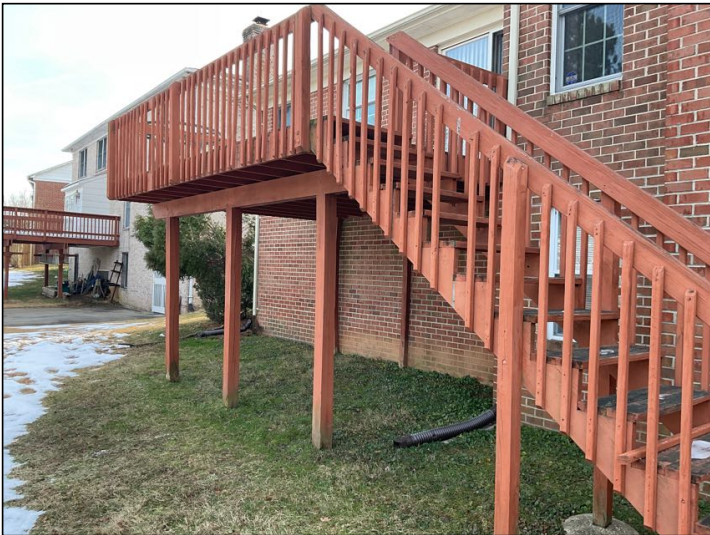
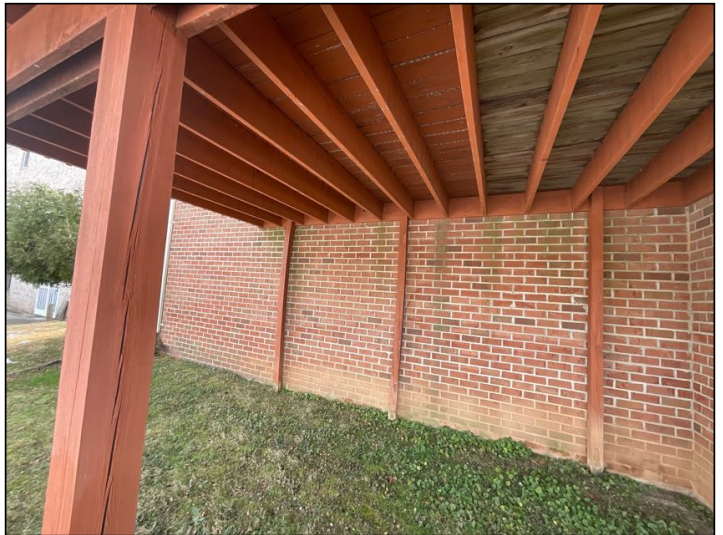
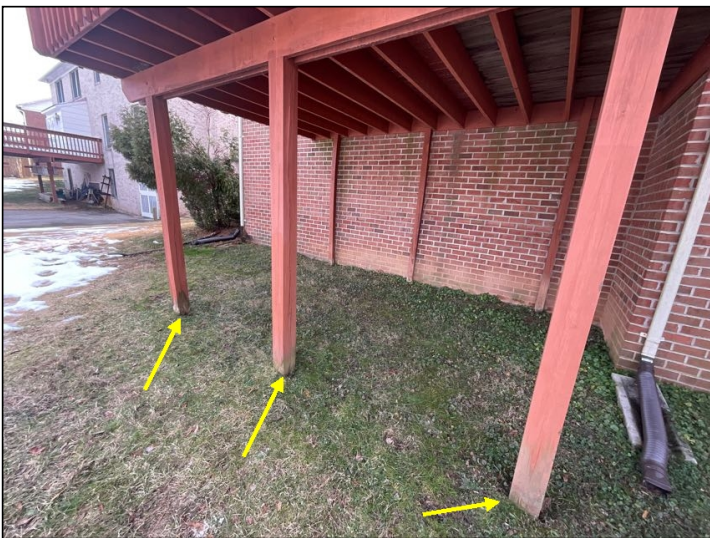
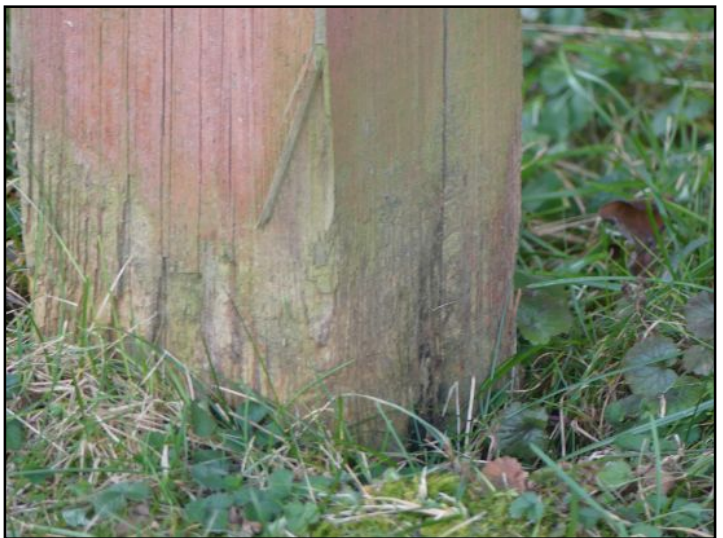
4. Deck

- There is wood and soil contact at deck columns. Some wood deterioration was noted, repair as needed.
- Missing damaged balusters recommend repair/replacement by qualified contractor.

Wood soil contact (noted)

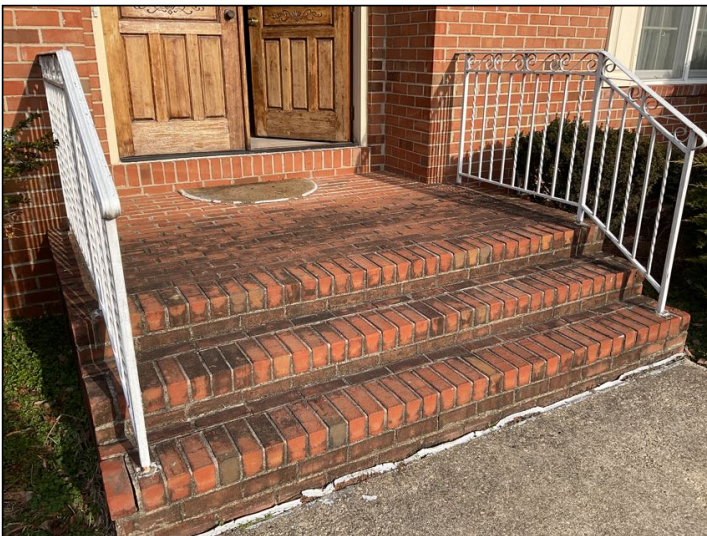
- Loose handrail noted. Recommend repair/secure as needed for safety.

Loose balusters

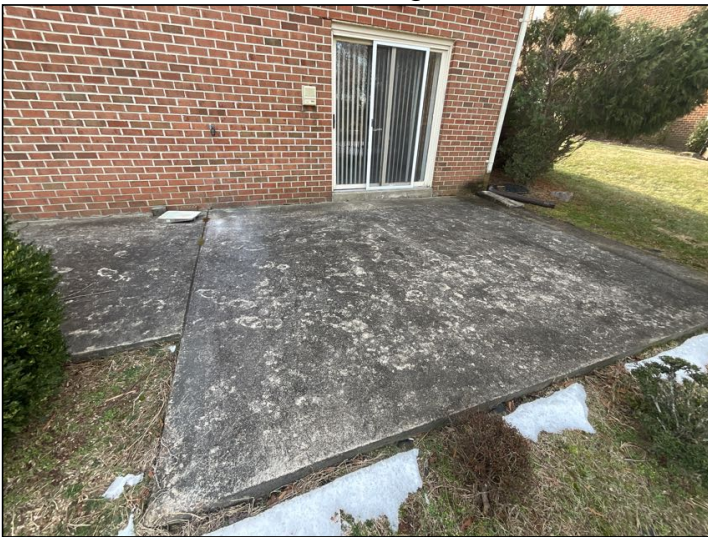
6. Patio

- Recommend cleaning off all vegetation off patio areas to inhibit further damages and deterioration.

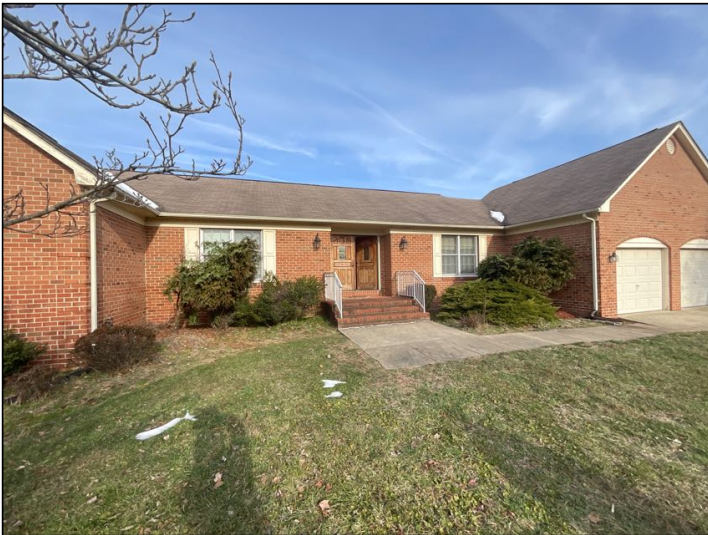
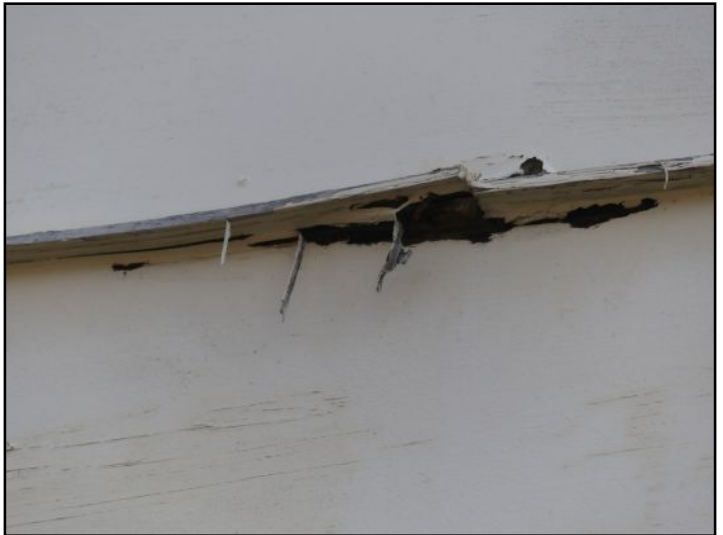
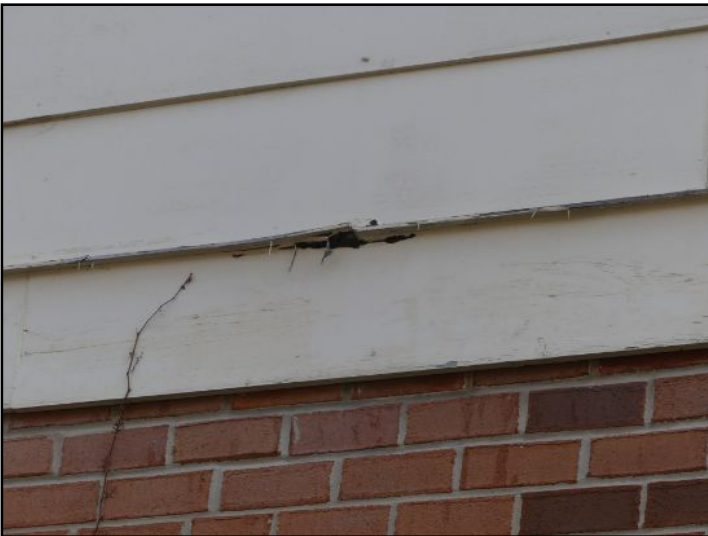
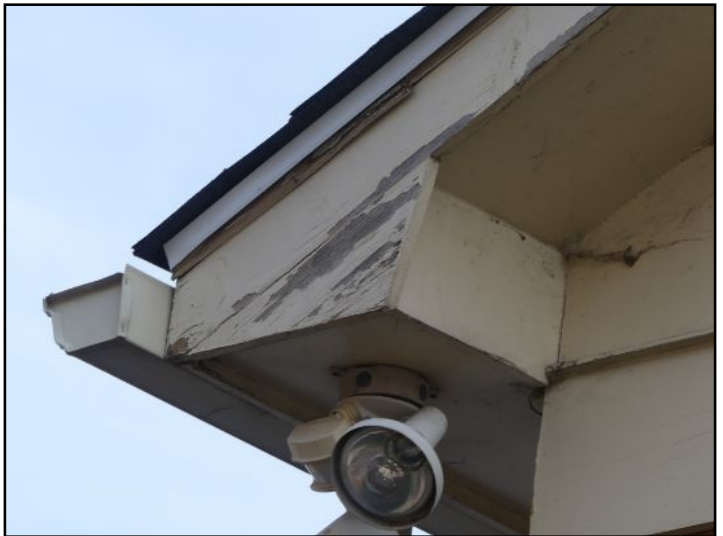
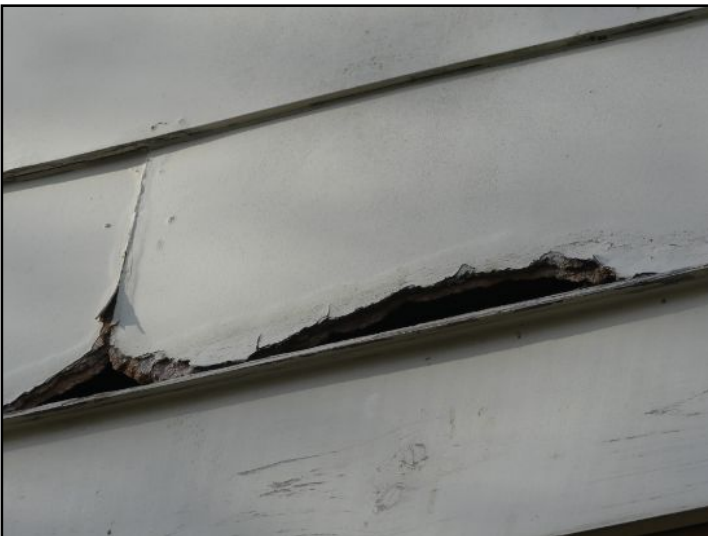
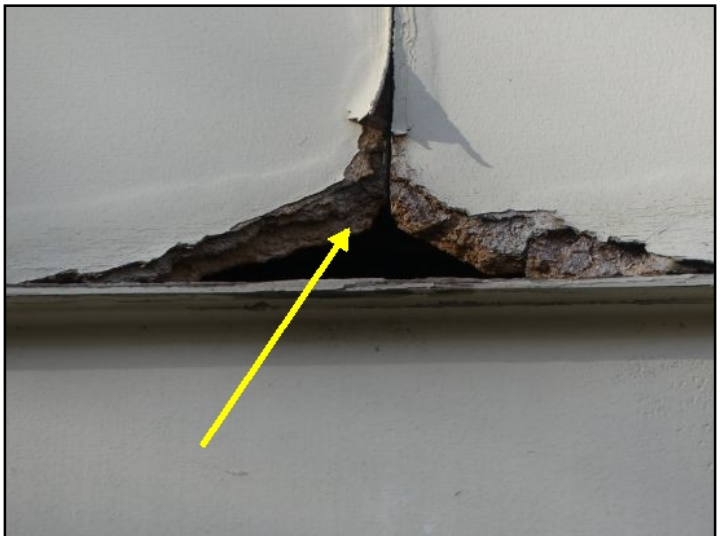
9. Cladding Condition

- Rotting wood observed, suggest scraping, wood repair/replacing and painting as necessary by a qualified siding specialist
- Some areas need priming and repainting recommend repair by qualified contractor.
- Major cracks/gaps or holes noted at the brick wall and siding boards. Recommend repair/seal all gaps and holes to prevent water or moisture penetration to the wall structure.

Damaged

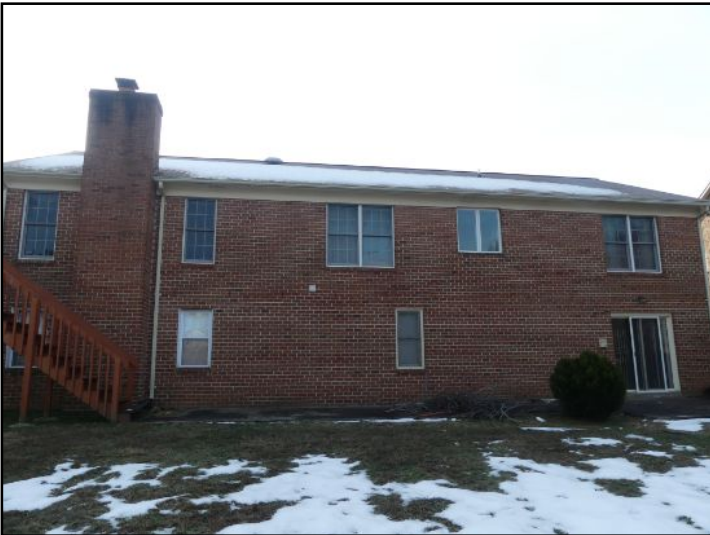
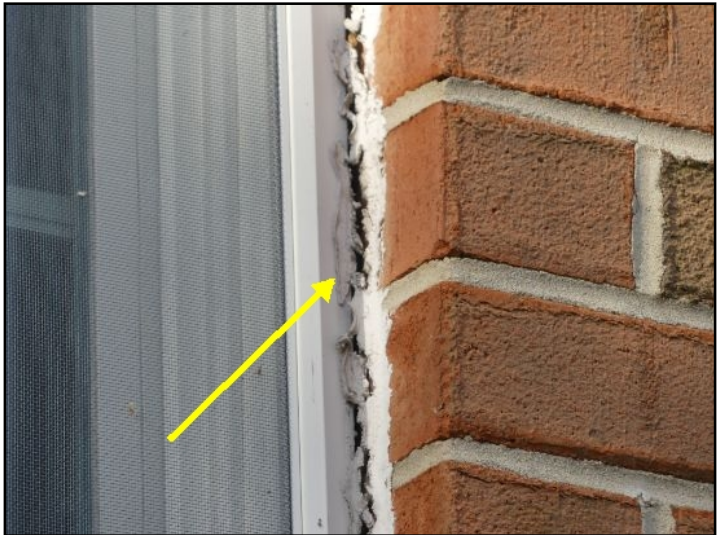
10. Window Condition

- Deterioration, gaps and cracks noted at window frames and/or sills. Recommend repair and seal/caulk as needed.

Need seal

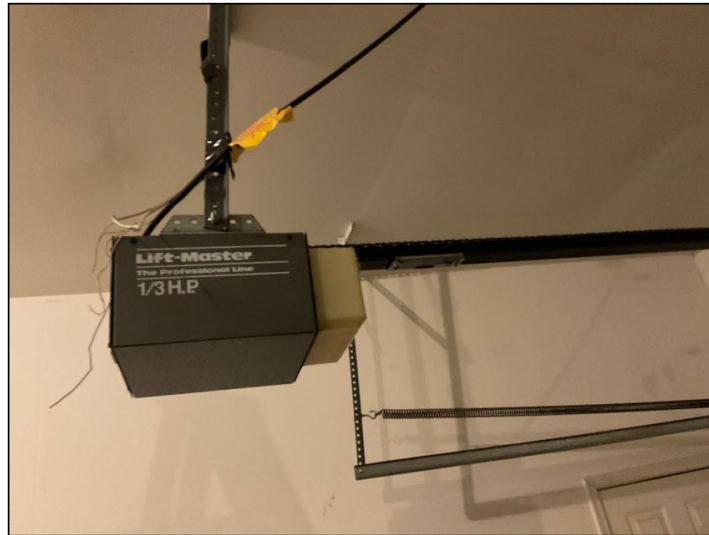
- Chain drive opener.
- Garage vehicle door opener didn't not operate at the time of inspection. Recommend repair/replace as needed.

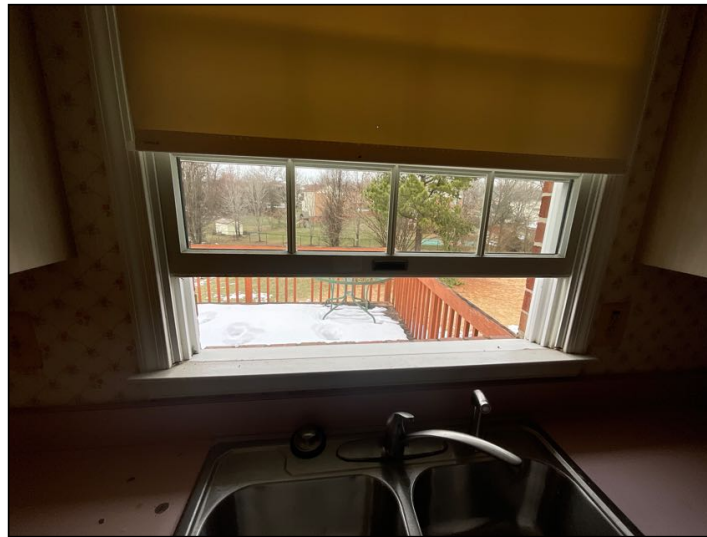
5. Window Condition

Materials: Vinyl • Single Hung Windows
 Observations:
 • Operated windows appeared functional at the time of inspection.
 • Screens were not installed at time of inspection. Recommend replacement

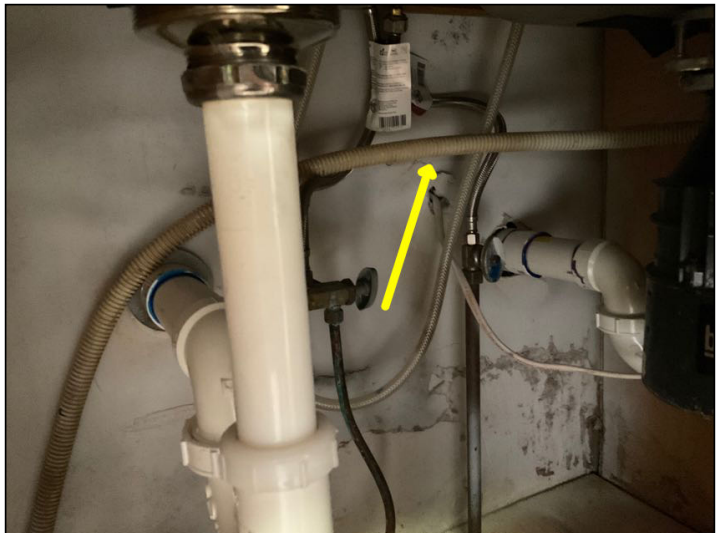
Observations:
• No high drain loop noted. Dishwasher high drain loop is to prevent back flow of water into the dishwasher.

No high drain loop

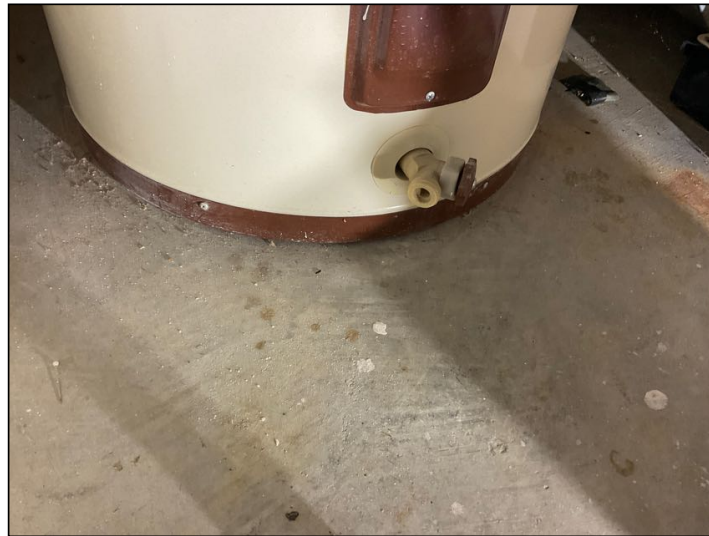
- No drip pan and drain line noted. It's generally recommended to install a drip pan with a drain line beneath the water heater tank, recommend installation.

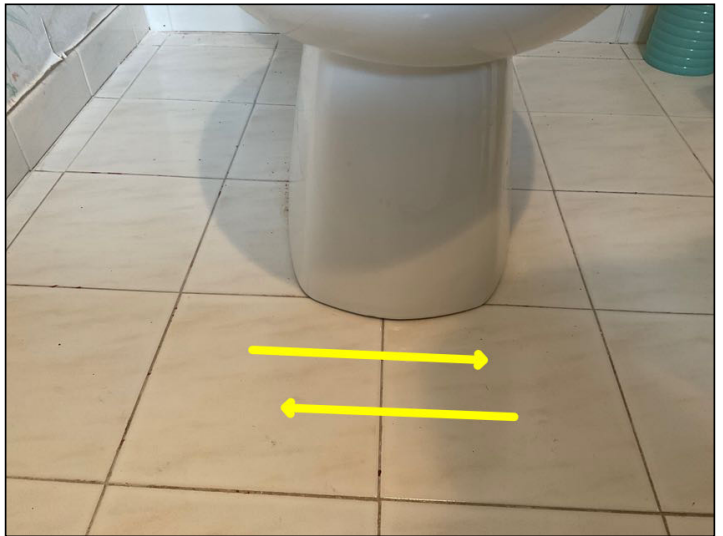
- Gap between toilet base and floor noted. Recommend caulk/seal as needed.
- Toilet loose and may need re-anchoring.

Not anchored

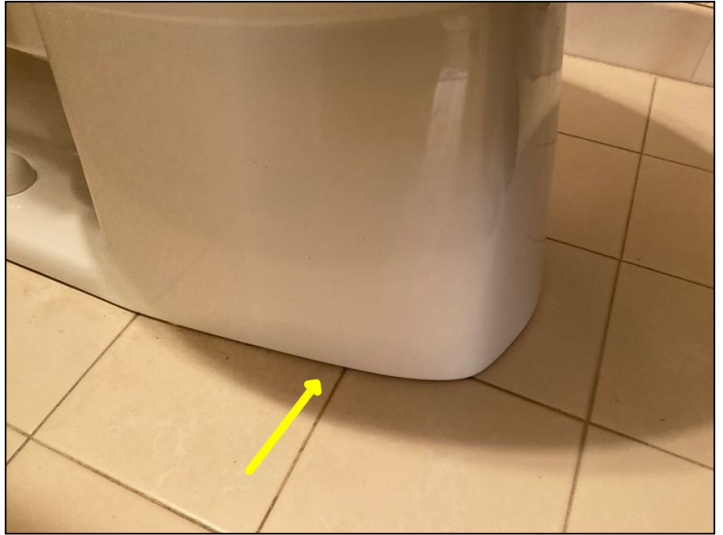
- Gap between toilet base and floor noted. Recommend caulk/seal as needed.

Missing seal

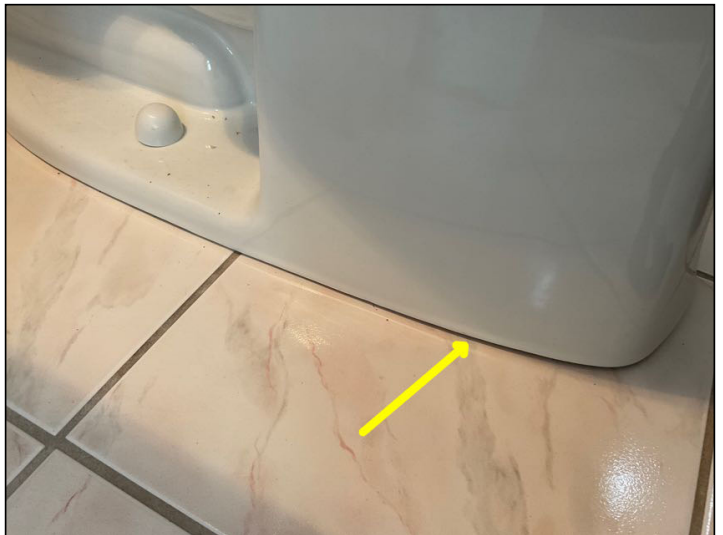
- Gap between toilet base and floor noted. Recommend caulk/seal as needed.

Missing seal

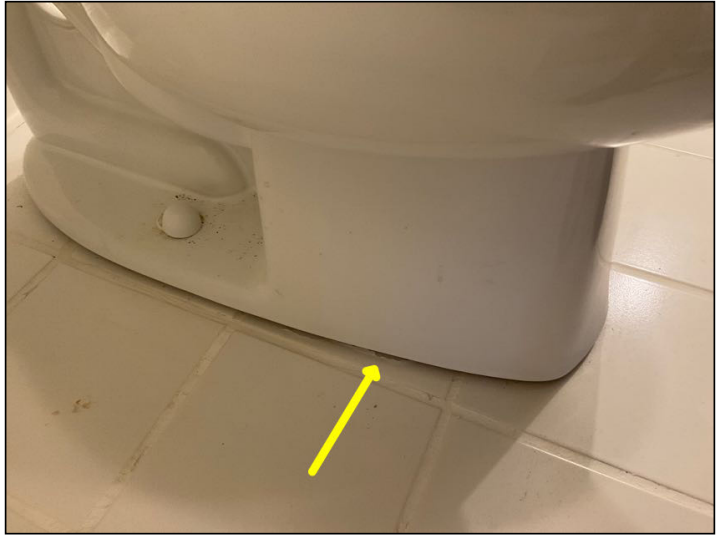
- Gap between toilet base and floor noted. Recommend caulk/seal as needed.
- Toilet loose and may need re-anchoring. Recommend repair by licensed contractor.

Missing seal

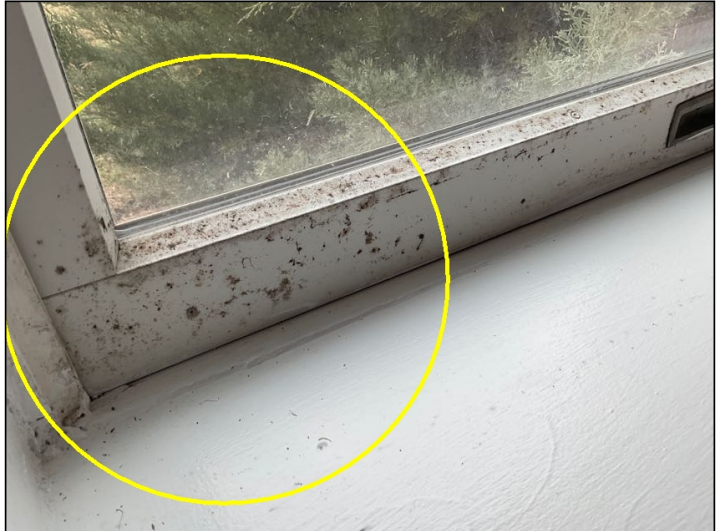
- Missing screen on several windows noted. Recommend installing screen.
- Mold-like bio growth observed. Professional testing & evaluation advised for safety.

Organic substance
