# INSPECTION REPORT

18218 Rolling Meadow Way #45, Olney, MD 20832

Date of Inspection: 1/15/2022 Time: 9:00 AM

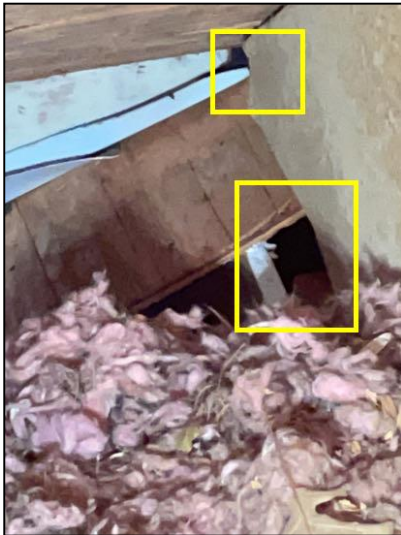
- Large holes and/or gaps in firewall observed. Recommend repair for safety.

Gaps in firewall

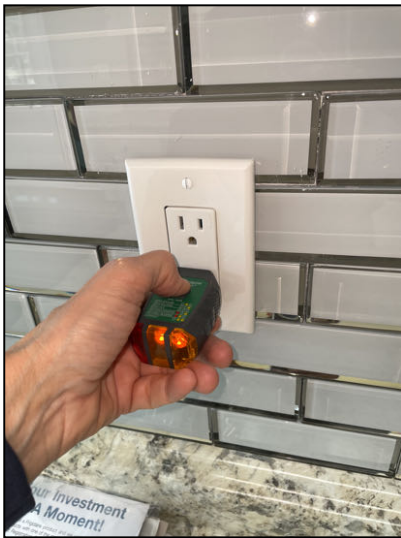
- **GFCI** protected receptacles may not have been required when the house was built. Recommend upgrading with GFCIs at all kitchen counters 12" or wider.
- **No GFCI protection present. Recommend installing GFCI protected receptacles for safety.**

Not GFCI protected

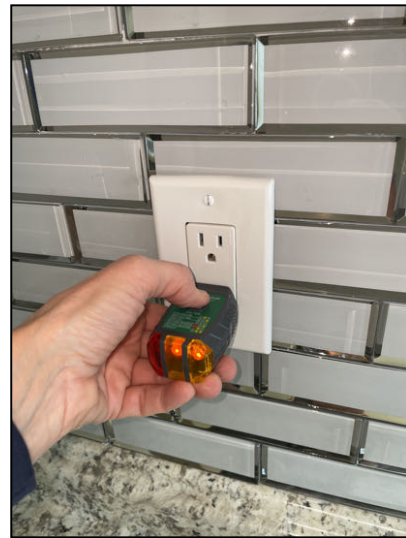
Not GFCI protected

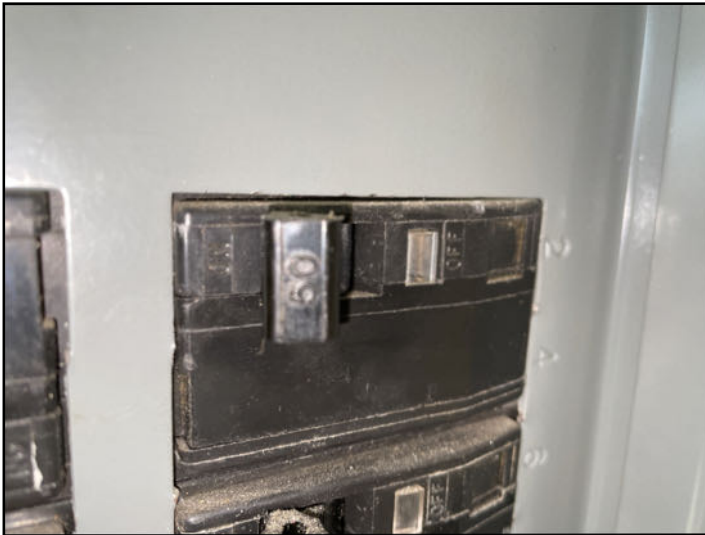
- White wires connected to hot breaker switches observed. White wires are designated to neutral bus connection. Replace or label as needed.
- 50-amp breaker observed for furnace. Max protection for furnace was 15-amps. Repair by a licensed electrician recommended.

50 amp furnace breaker

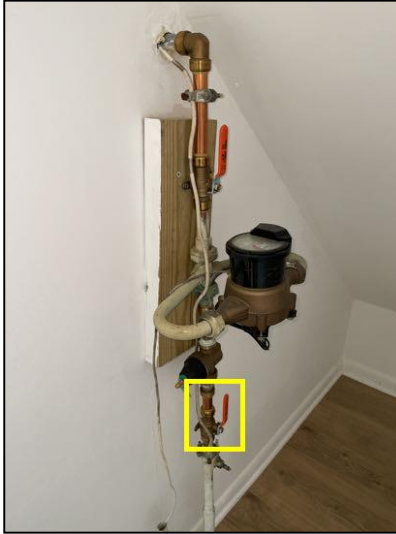
Main water shut off valve

- Public Water
- Copper pipes
- Location: Kitchen pantry
- No deficiencies noted.

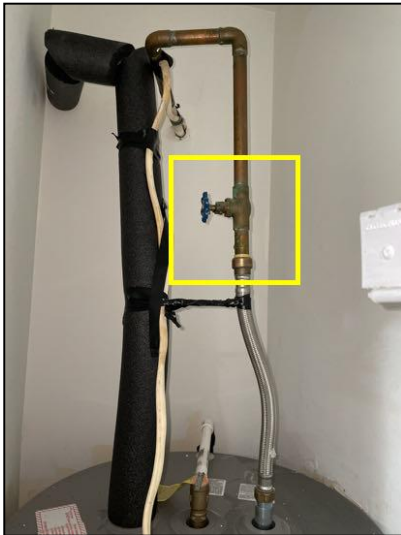
Water shut off valve

- Electrical tape observed as support for water supply hose. Recommend repair by a licensed plumber using approved pipe supports and/or clamps.

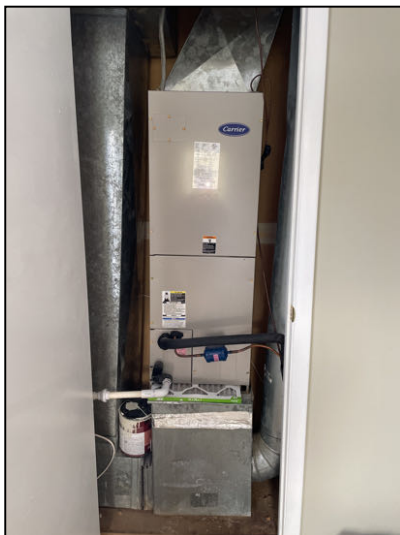
Missing shut off switch

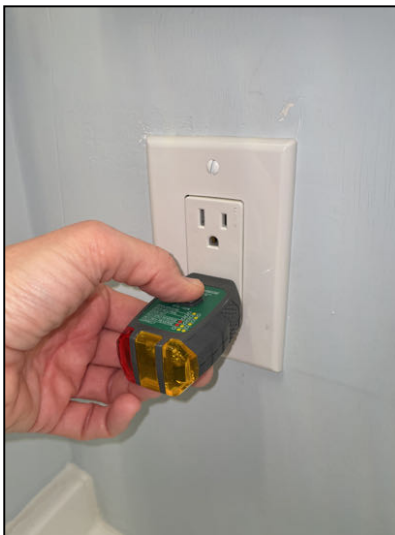
- There was no power to the bathroom outlet. Recommend review and repair by a licensed electrician.

Now power to outlet
