INSPECTION REPORT

10000 Four Point Sample Rd, Sample, VA 10000

Inspection prepared for: Sample Client

Date of Inspection: 11/18/2021 Time: 1:30 pm

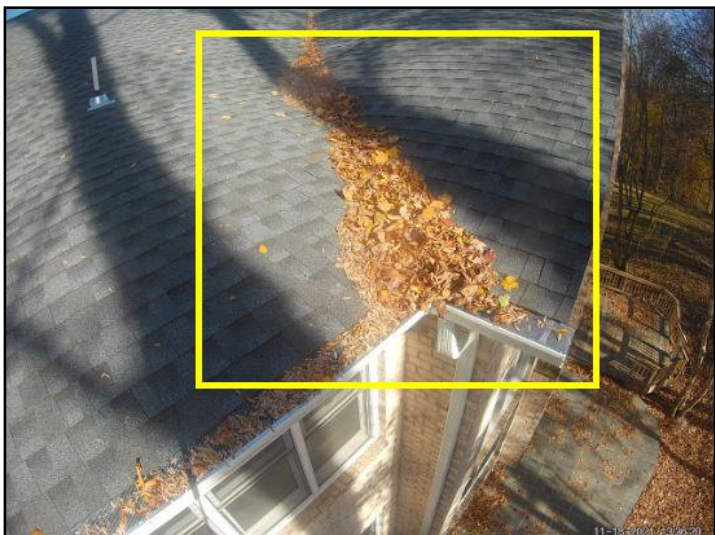
Clean roof areas: Significant amounts of organic debris evident.

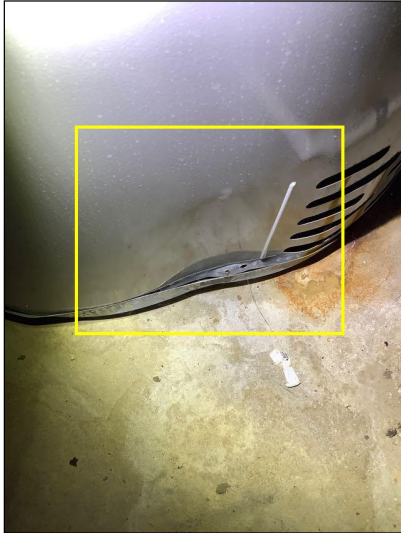
- The water heater enclosure is bent due to prior damage.

Dents observed throughout water heater enclosure

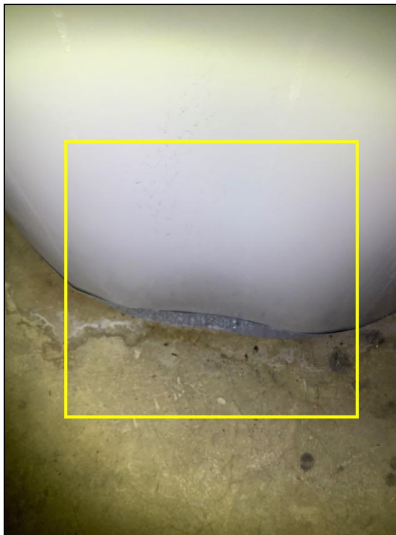
Dents observed throughout water heater enclosure

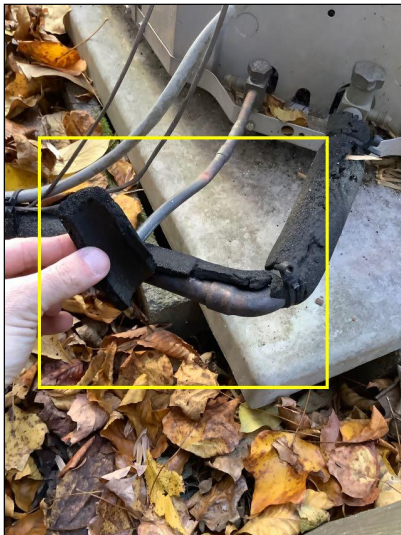
- Deteriorated insulation on the refrigerant lines, replace as needed
- Deteriorated sealant at the pipe wall penetration, repair/seal as needed.

Deteriorated insulation on the refrigerant lines, replace as needed

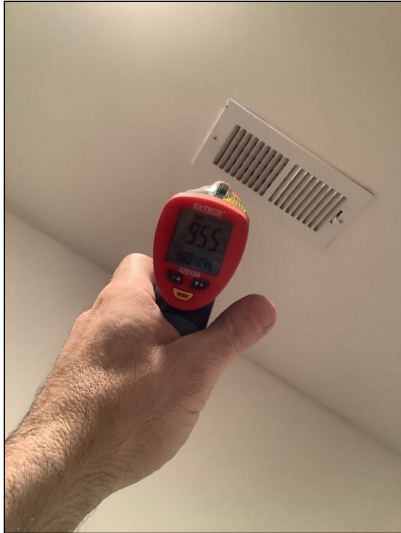
Supply air temp in heat mode 95 degrees

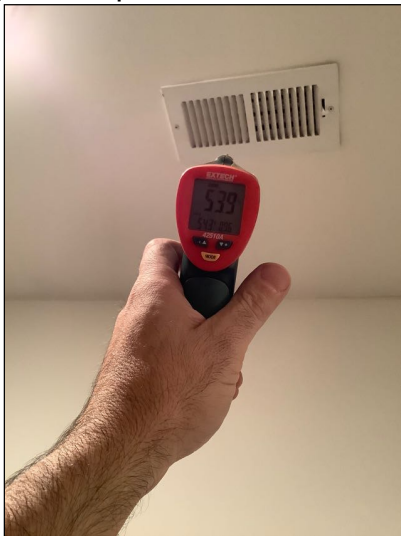
Supply air temp in cooling mode 53 degrees

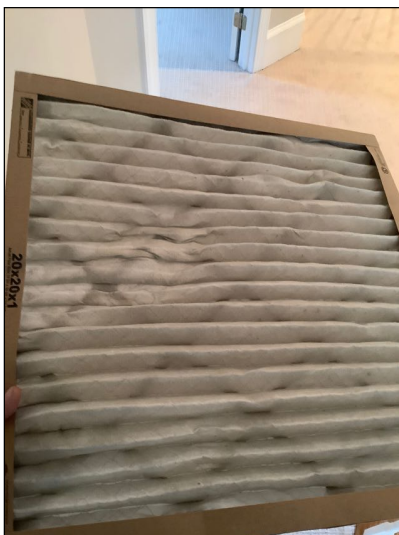
The filter is dirty. Needs replacement.

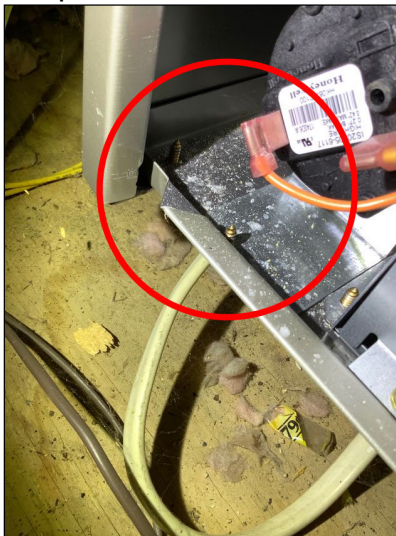
The air handler is dirty and appears to have a bio growth (mold like substance), we recommend testing for mold.

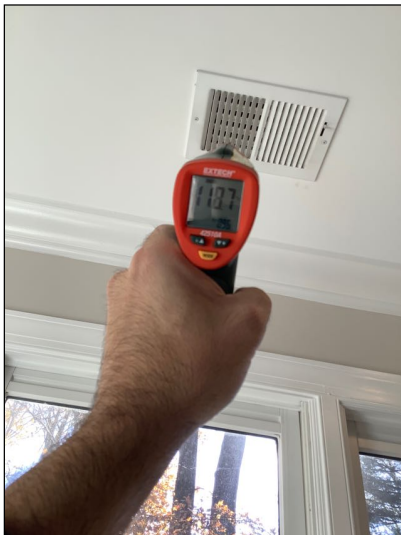
Supply air temp in heat mode 118 degrees

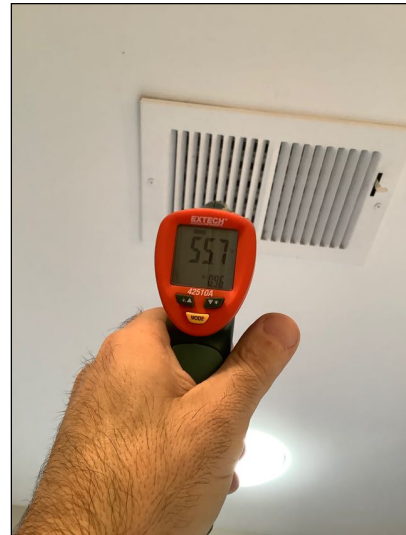
Supply air temp in cooling mode 55 degrees
