INSPECTION REPORT

10000 Sample Street, Sample City VA 10000

Date of Inspection: 5/7/2022 Time: 2:00 PM

Note: Inspection of damaged area of roof

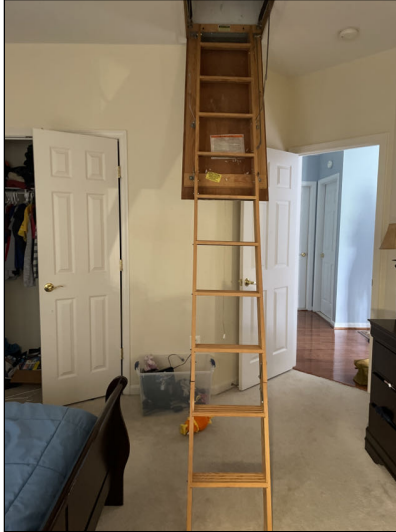
- Observations:
- Bedroom ceiling access.
 - Pull down steps
