# INSPECTION REPORT

18218 Rolling Meadow Way #45, Olney, MD 20832

Date of Inspection: 1/15/2022 Time: 9:00 AM

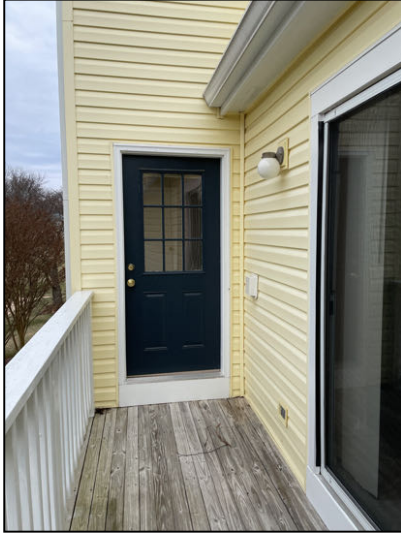
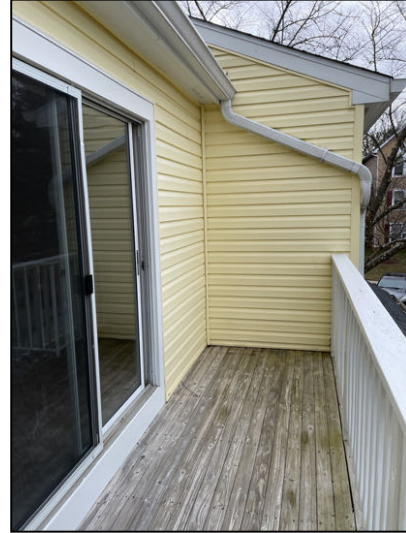
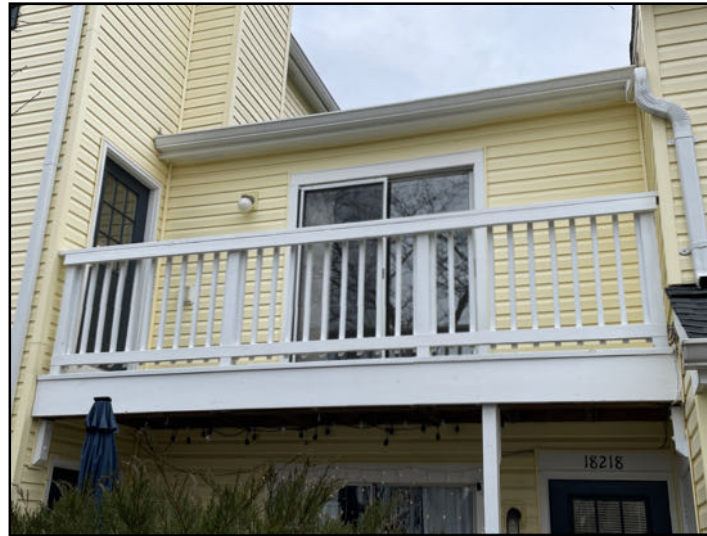
- Vinyl siding damage observed. Recommend repair or replacement of damaged section to keep moisture and insect intrusion.

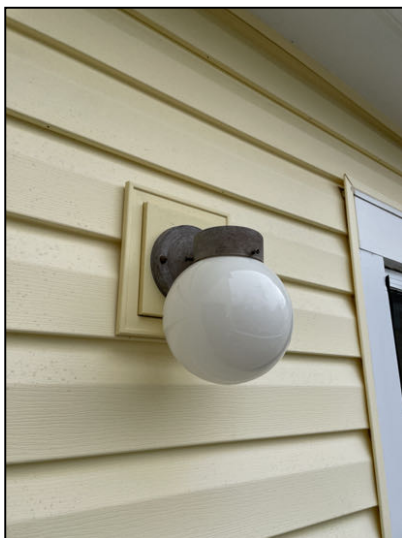
• Exterior lights did not function at time of inspection. Recommend replacing bulbs and checking for operation. Repair by licensed electrician as needed.

Did not work

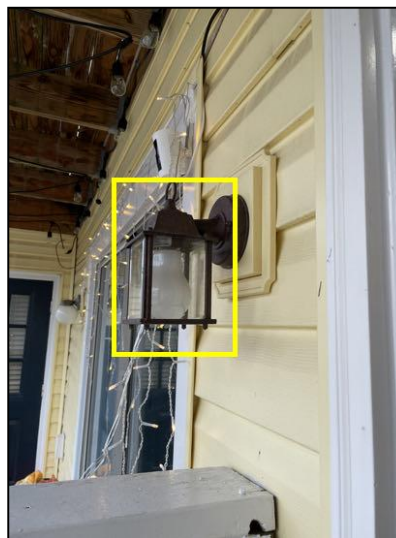
Did not work

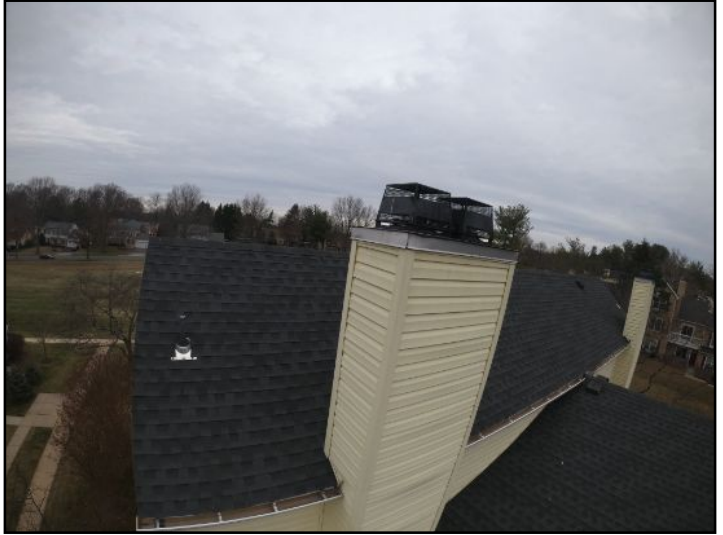
- Deteriorated vent stack collar observed. Recommend repair or replace as needed.

Deteriorated collar

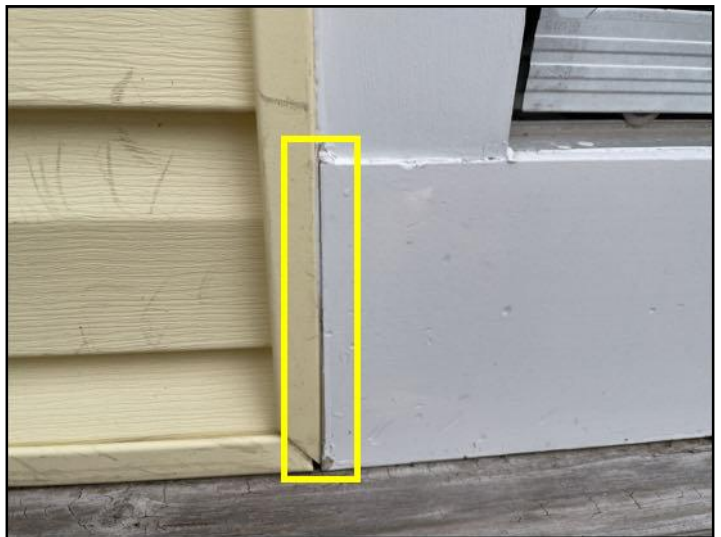
Gap

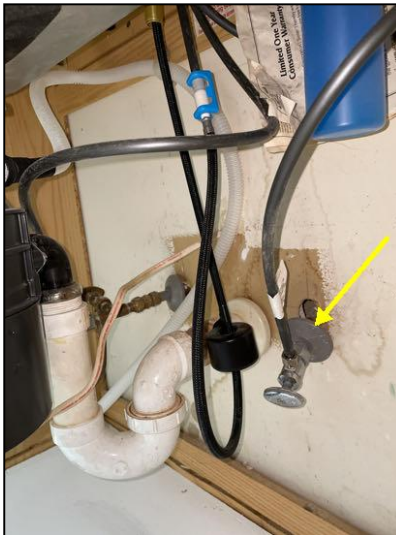
- Loose escutcheon observed on water supply pipe. Recommend securing to cover penetration hole.

Loose escutcheon

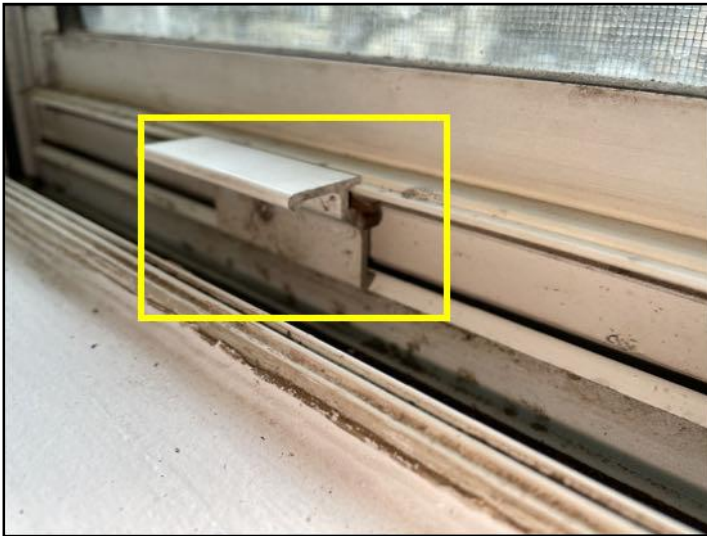
- **Improve:** Windows were original, older type. Consider upgrading to double pane, thermally insulated, newer efficient type.
- **Windows didn't latch due to misalignment or improper installation. Recommend repair or replace as needed.**
- **Deteriorated caulk noted. Recommend sealing or repair as needed.**
- **Damaged screens observed. Repair or replace as needed.**

Did not latch

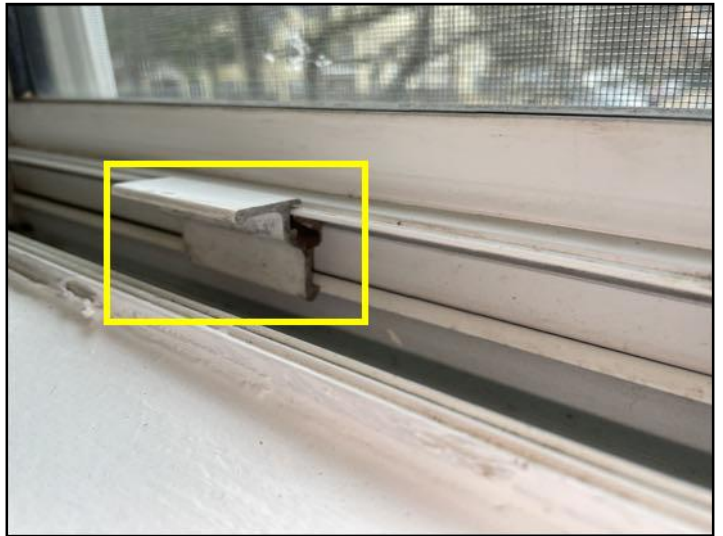
Did nnt latch

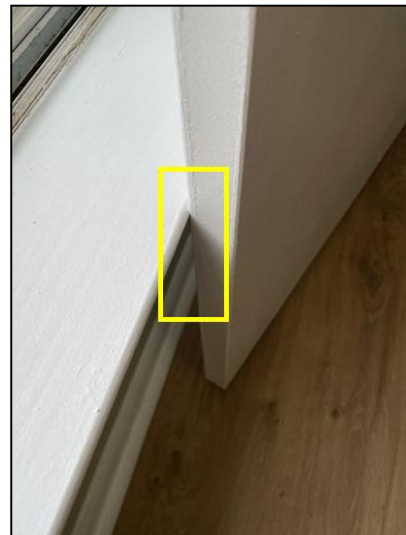
Observations:  
 • Door stop was missing. Recommend installing to prevent damage to door and/or window.

Window sill contact

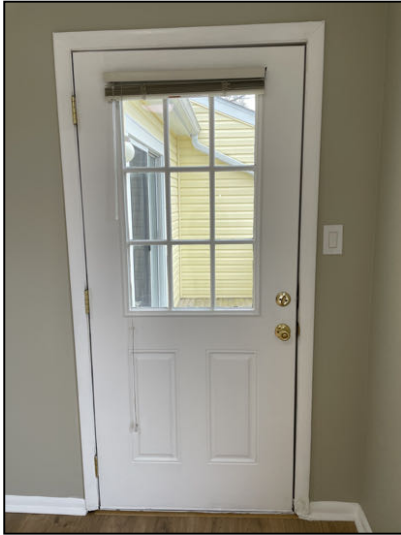
Observations:  
 • Gaps and cracks noted around the door frame. Recommend caulk or seal as needed.

Gap

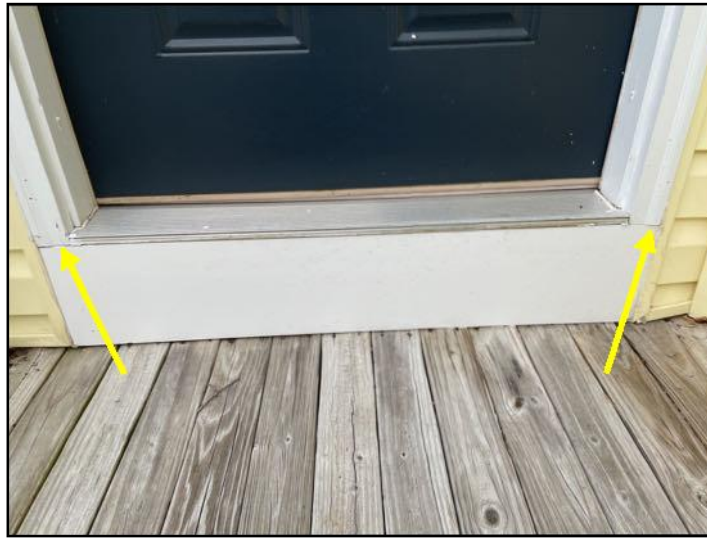
Gaps

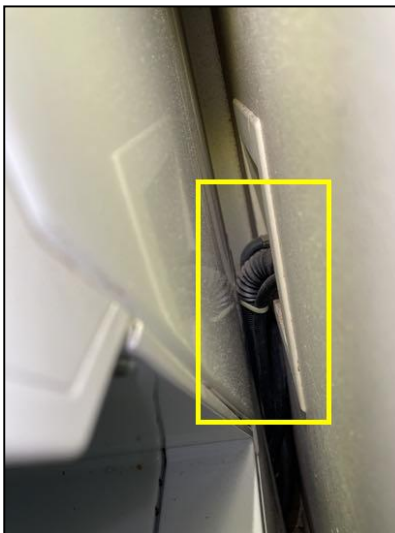
- Appeared to be in good shape at the time of inspection. Access limited.

Limited access

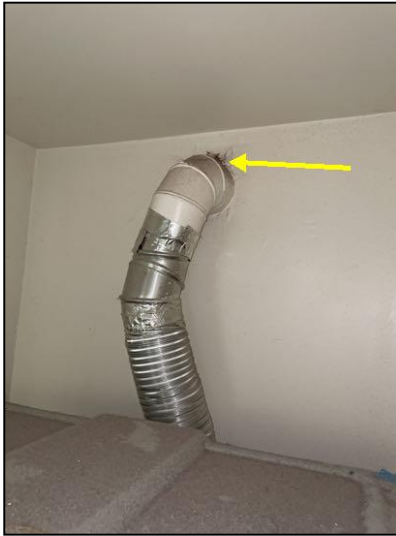
Observations:  
• Gap observed at vent penetration to exterior. Recommend sealing to prevent pest intrusion.

Gap

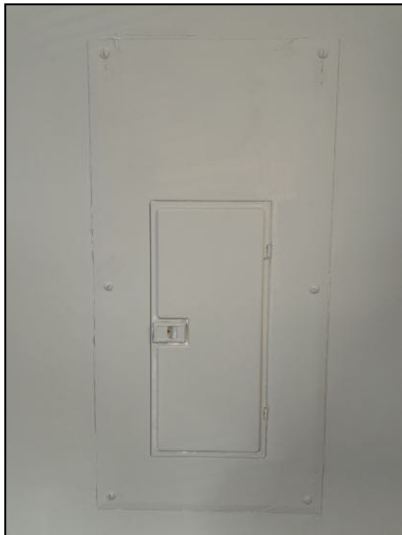
• Some wiring was painted, perhaps during wall construction, and appeared to be white (neutral) rather than black (hot). Recommend cleaning or labeling wiring as needed for safety.

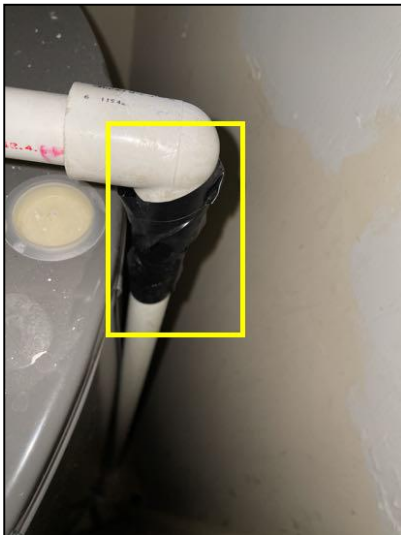
- Non-approved material used for discharge pipe. Recommend replacing with copper or CPVC pipe by a licensed plumber.
- Electrical tape observed as a connector at discharge pipe elbow. Recommend repair by a licensed plumber.
- Unable to view end of discharge pipe due to location. Recommend ensuring it discharges within 6" of overflow pan and is non-threaded.

Electrical tape

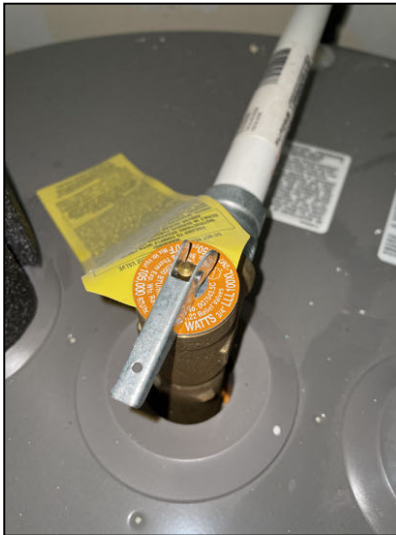
TPR valve

Observations:  
• Appeared to be in satisfactory condition.

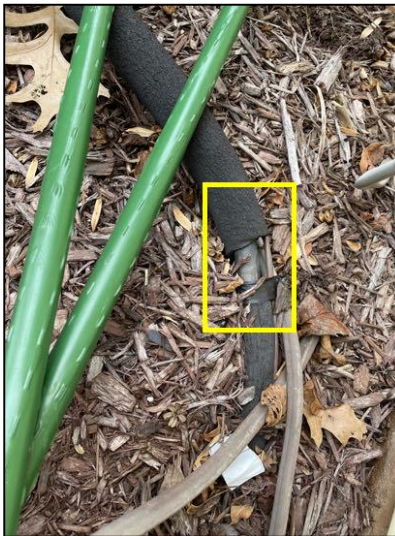
- Deteriorated insulation on the refrigerant line noted. Replace as needed.

Missing insulation

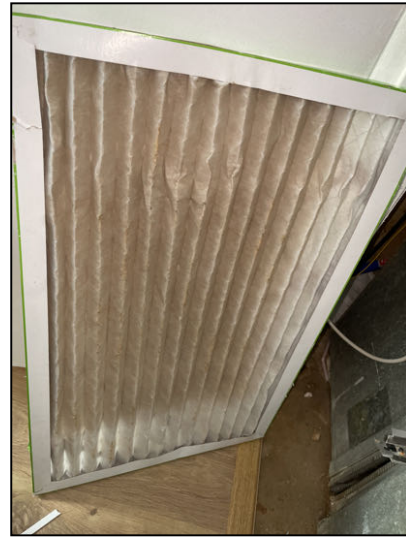
- The filter was dirty and oversized. Recommend replacement.

Dirty filter

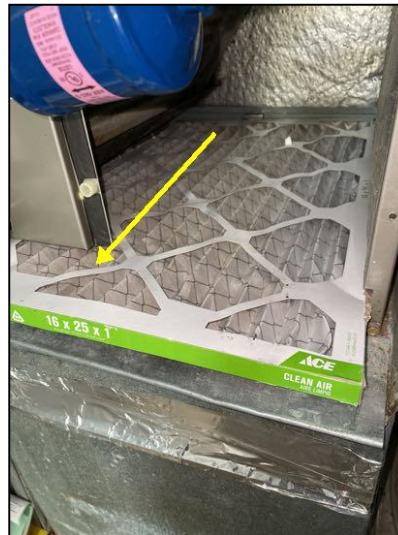
Larger than space

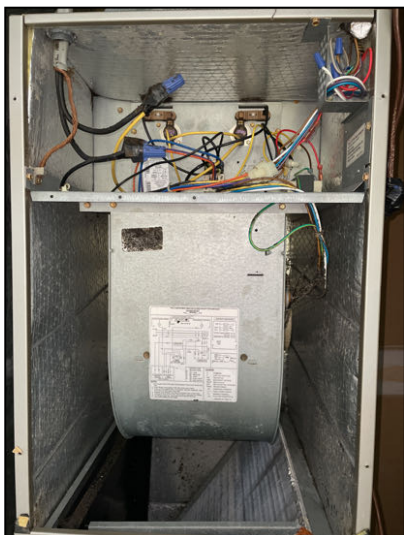
- Some grime was noted inside the enclosure. Recommend cleaning by a HVAC specialist.

Dirty

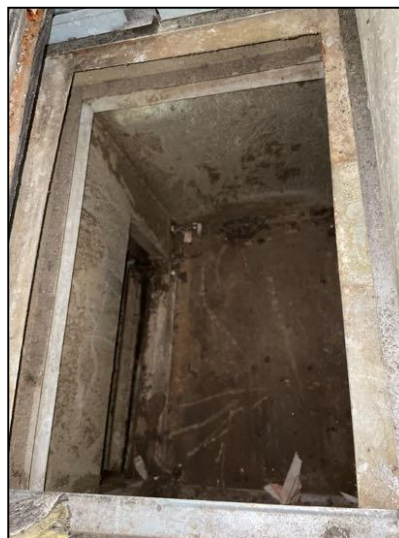
• Dust and corrosion noted in unit. Service by HVAC specialist is recommended.

Dusty

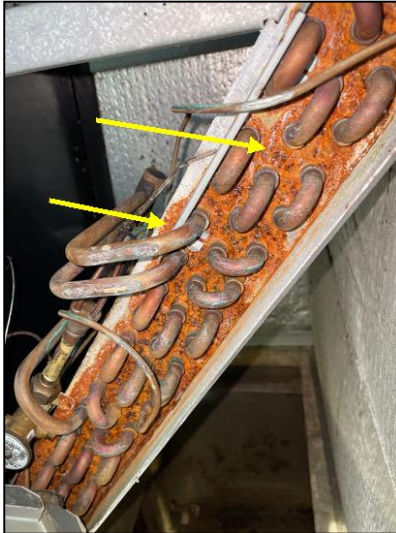
Corrosion

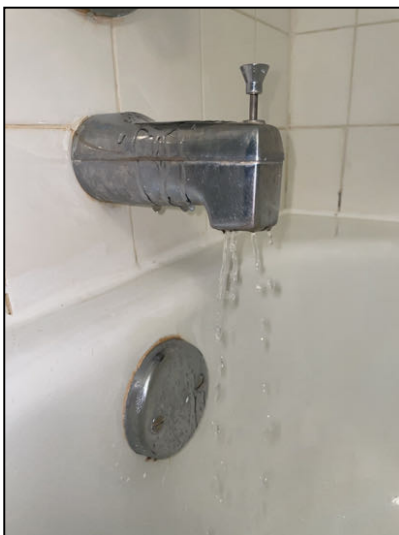
- Shower head leaked. Recommend repair.
- Shower diverter did not engage completely. Repair or replace as needed.

Diverter leaked

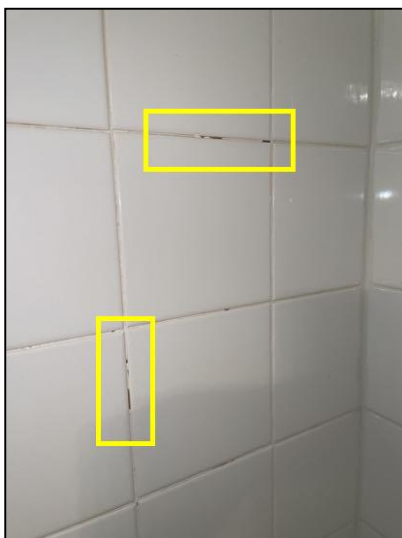
- Ceramic tile.
- Missing or damaged grout observed. Recommend grout or seal as necessary.
- Deteriorated caulk observed. Recommend sealing gaps.

Missing grout

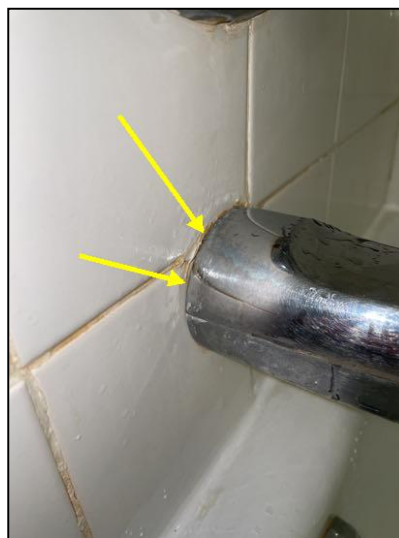
Deteriorated caulk

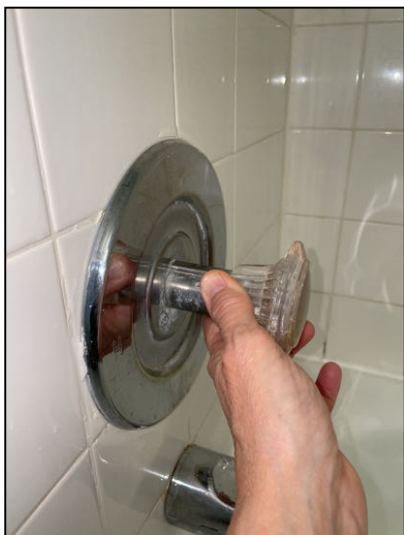
- Loose and leaking regulator handle noted. Recommend repair.

Loose regulator

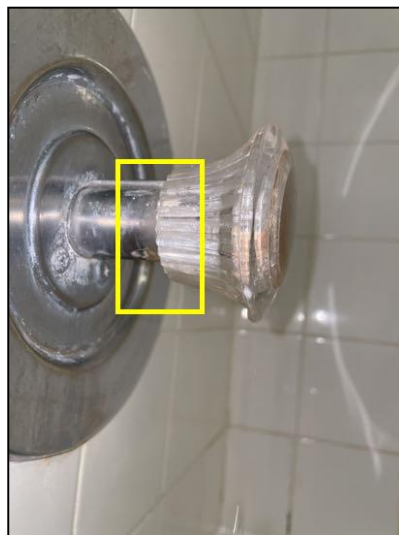
Leaked

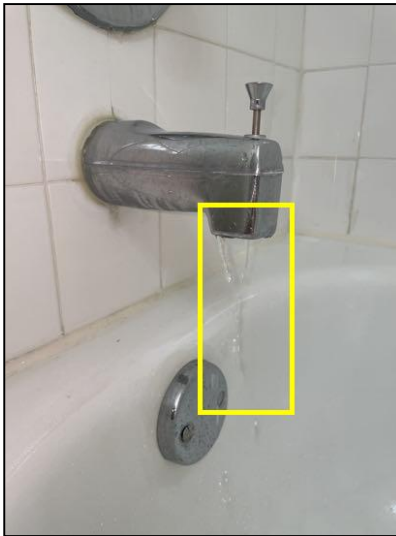
Observations:  
• Shower head leaked. Recommend repair.  
• Shower diverter did not engage completely. Repair or replace as needed.

Diverter leaked

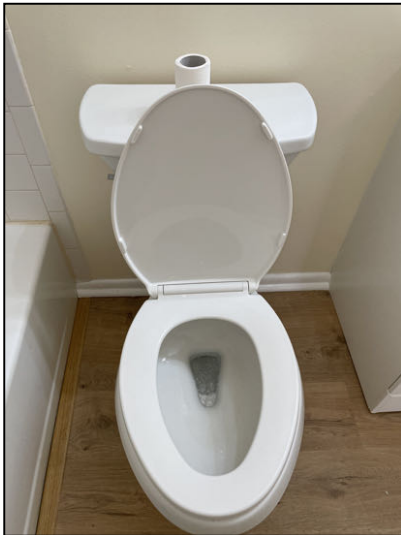
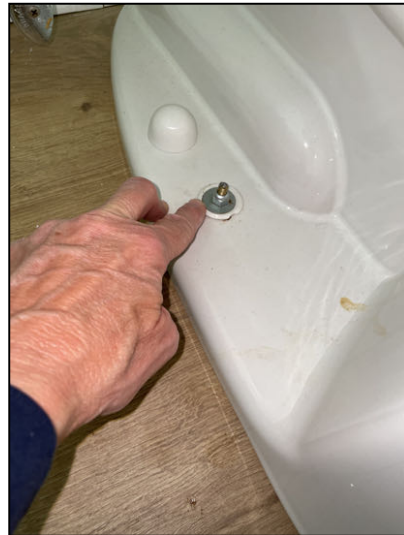
- Loose anchor bolt observed. Recommend securing or replacing as needed.

Loose bolt

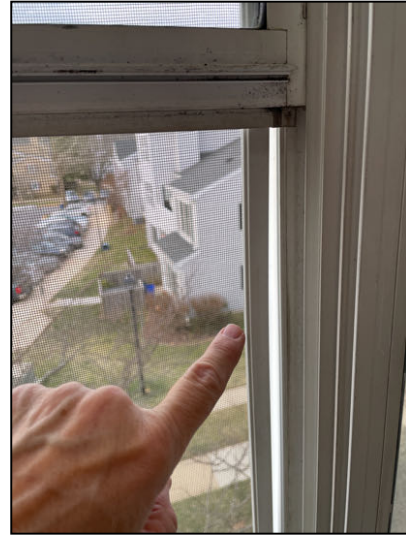
- Some windows were difficult to open. Repair as needed.
- Broken or cracked glass pane noted. Repair or replace as needed.
- Damaged screens observed. Repair or replace as needed.

Loose screen

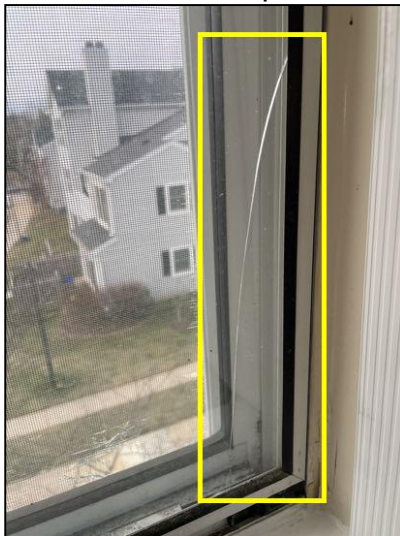
Cracked pane

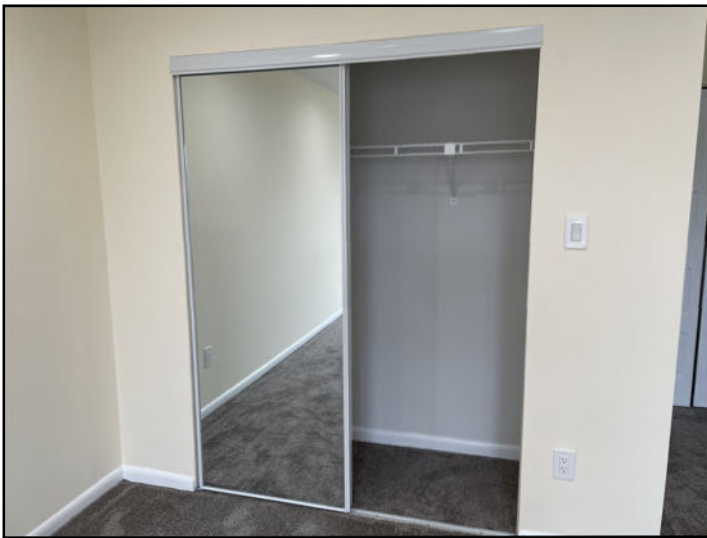
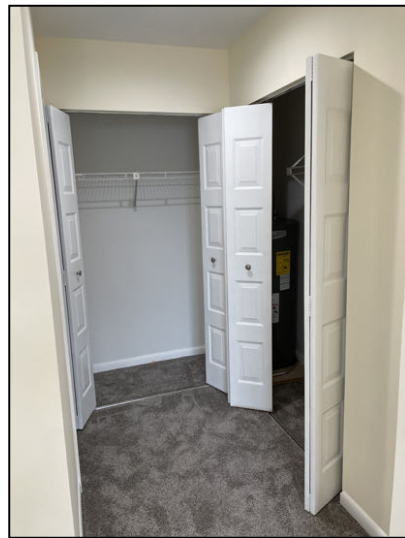
- Broken tile observed in water heater closet. Recommend repair or replace as needed.

Cracked tile

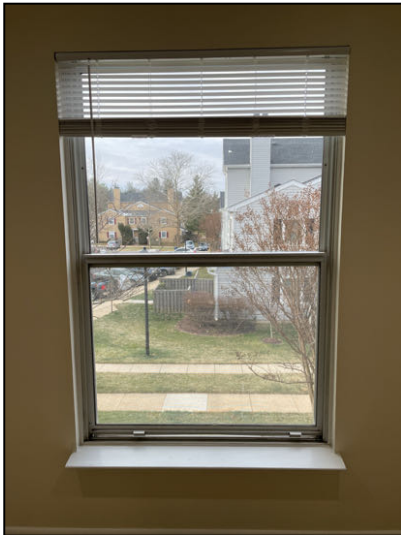
- Damaged screens observed. Repair or replace as needed.
- Deteriorated glazing bead observed. Recommend repair or replace as needed.

Damaged screen
