INSPECTION REPORT

10000 Sample Street, Sample MD 10000
Inspection prepared for: Sample Client
Real Estate Agent: Sample Agent

Date of Inspection: 12/20/2021 Time: 9:00 AM
Year Built: 2021 Size (sqft): 2800
Weather: Clear 25 to 30 degrees F
Order ID: 9086

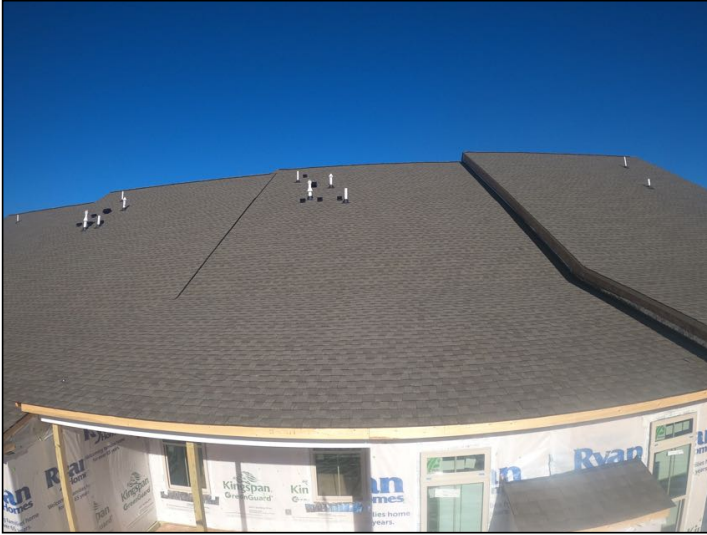
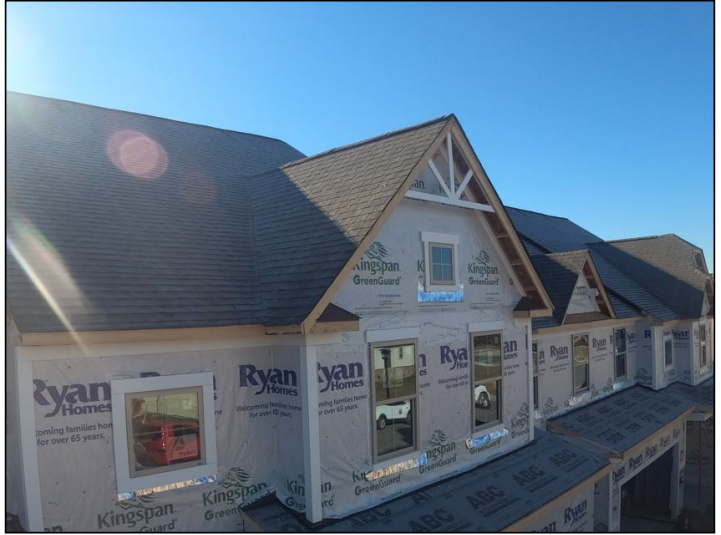
1. Roof Condition

- No major system safety or function concerns noted at the time of inspection.

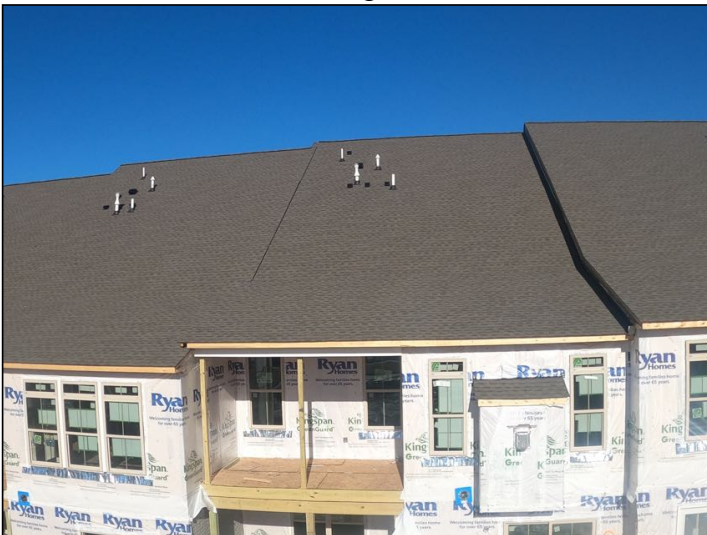
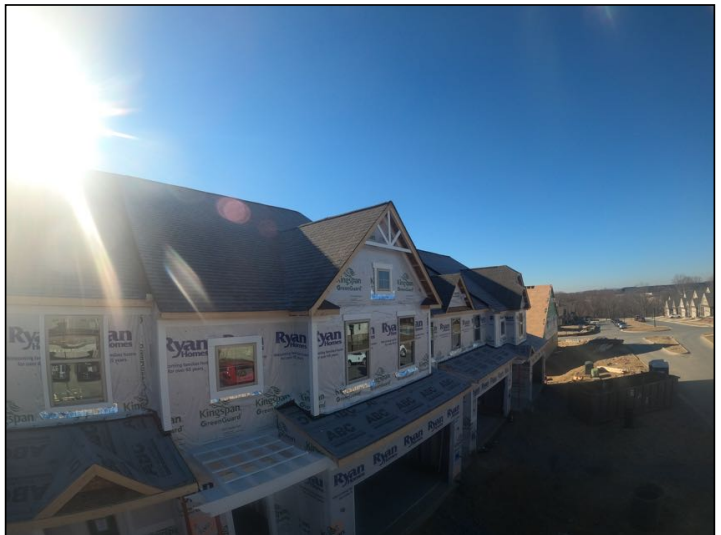
2. Eave and rake

- The rough framing for the fascia boards were in place and appeared to be in good condition.

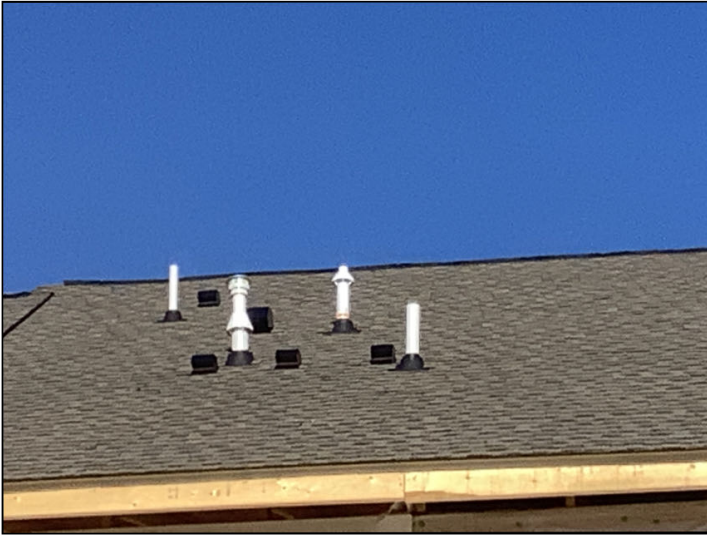
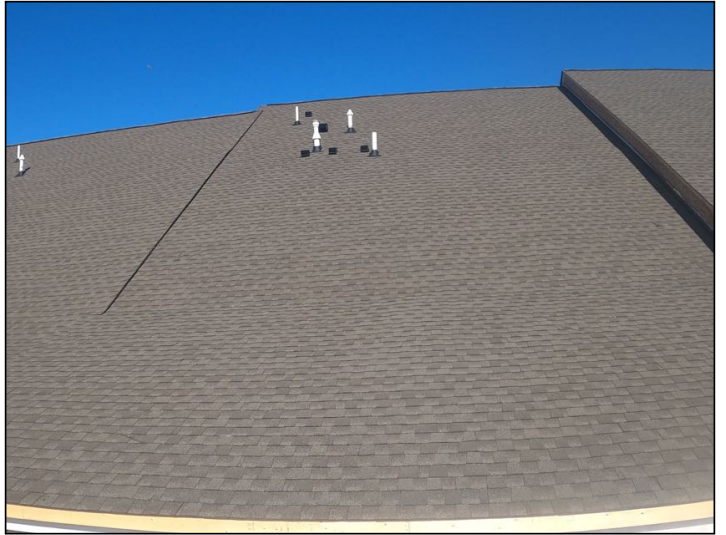
3. Vent Stack

- Appeared to be in good condition at the time of inspection.

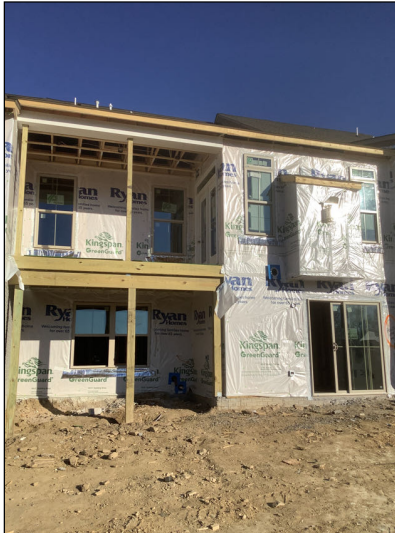
1. House Wrap Condition

- House wrap missing tape noted in the front of the structure, repair as needed.

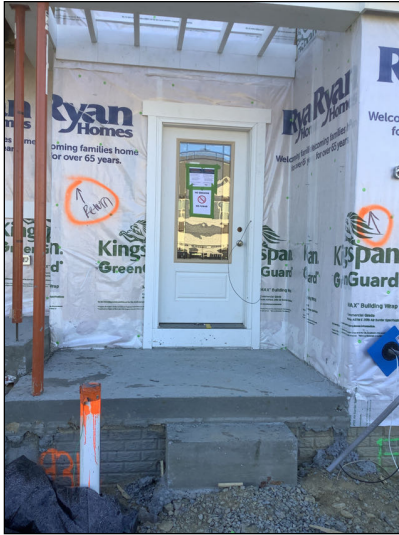
2. Doors

- New construction hardware and other components are not installed yet

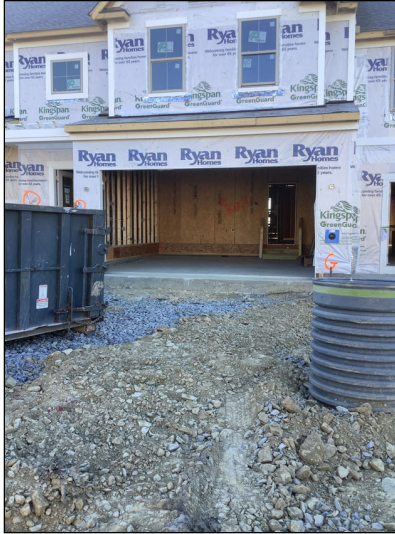
1. Driveway and Walkway Condition

- New construction, the driveway is not finished. It appears acceptable for this stage of construction. No major system safety or function concerns noted at the time of inspection.

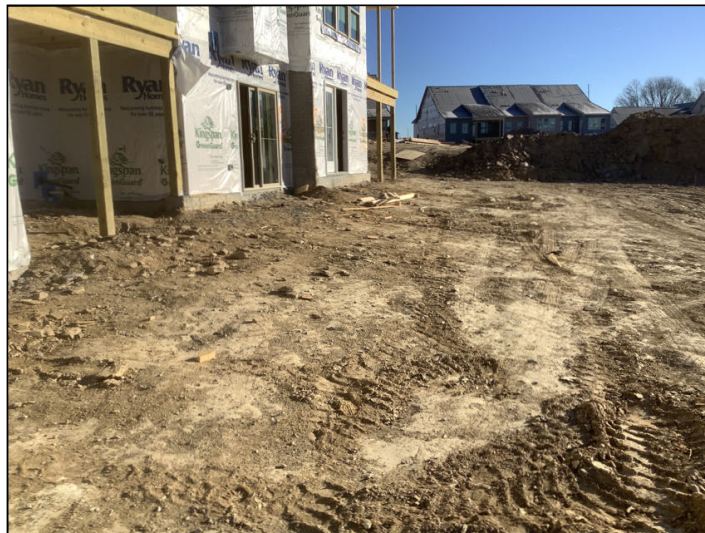
2. Grading

- New Construction - Some, if not many components have not been built/installed or completed/finished yet.
- Lot grading and drainage have a significant impact on the building, simply because of the direct and indirect damage that moisture can have on the foundation. It is very important that surface runoff water be adequately diverted away from the home. Lot grading should slope away and fall a minimum of six (6) inches within the first ten (10) feet around the perimeter of the building.

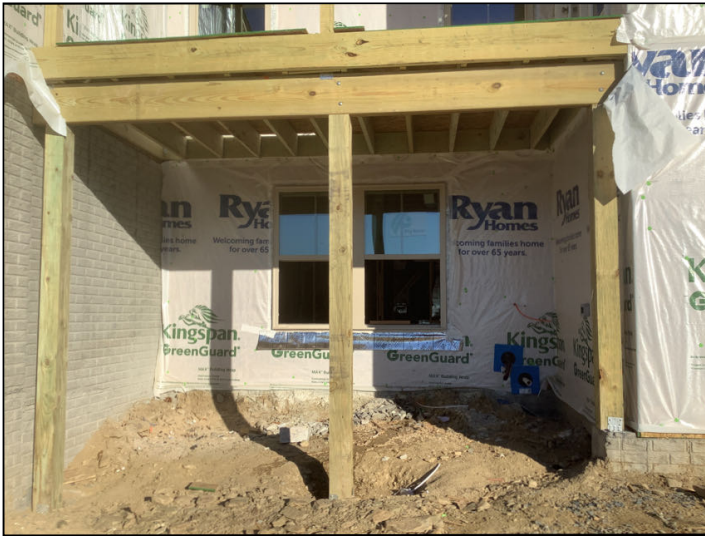
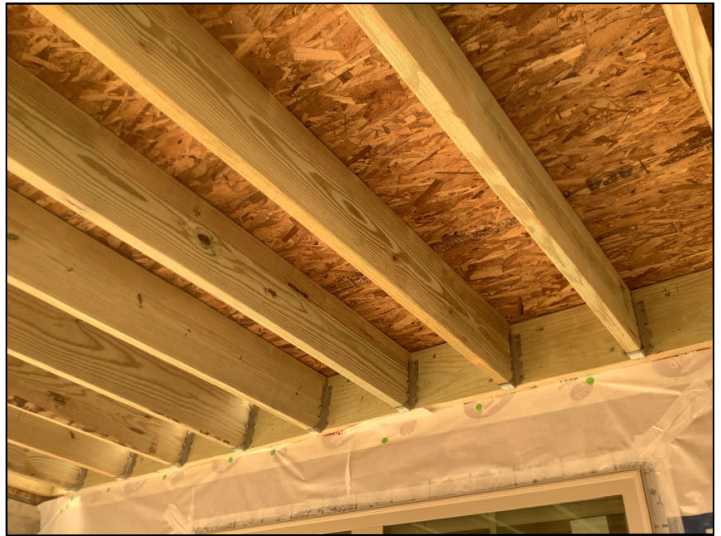
3. Deck

- No deficiencies noted.
- **MAINTENANCE:** Whether treated or not, it is important to keep a wood deck surface free of all forms of fungal growth and debris that retains moisture and will cause the deck to eventually rot. Recommend cleaning and resealing the deck annually. Cleaning can be accomplished by scrubbing the deck with a sodium-hypochlorite (bleach) and Tri-Sodium-Phosphate (TSP) deck wash and then rinsing with a pressure washer. Finally, a wood deck should be re coated with a high quality deck sealant.

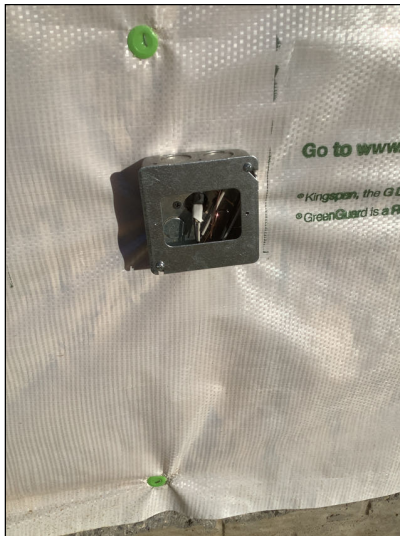
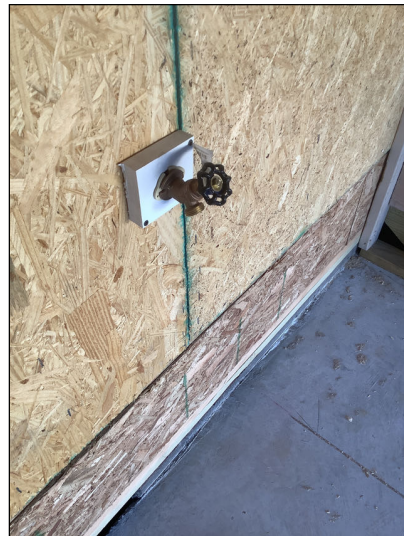
4. Grounds Electrical

- New construction , electrical service is not connected yet, the wiring and fixtures appeared to be proper and there is no cause for alarm.

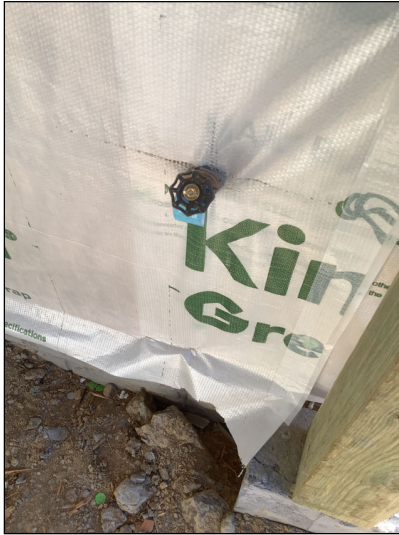
5. Exterior Faucet Condition

- The water is off to structure, all water areas not tested.

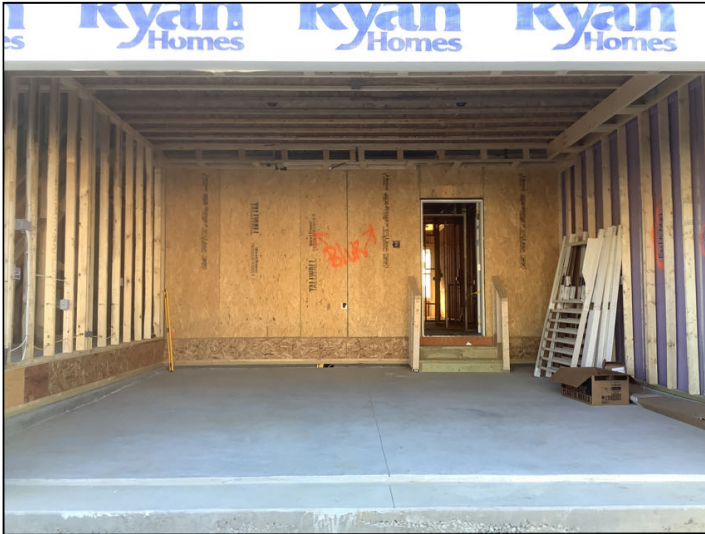
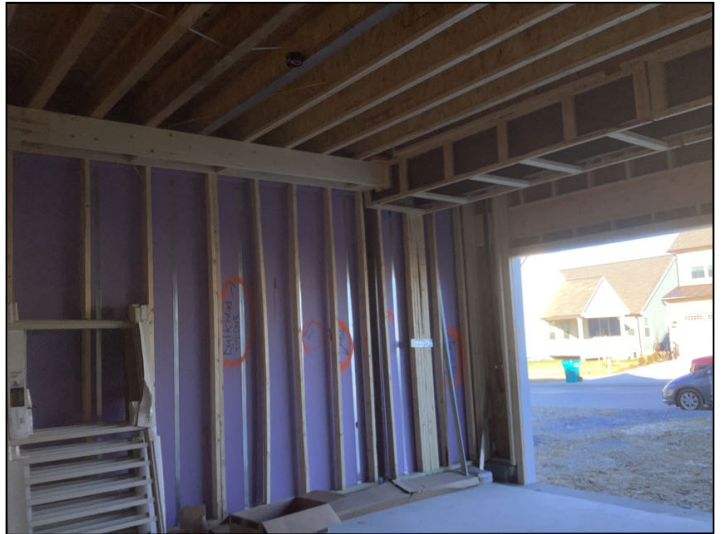
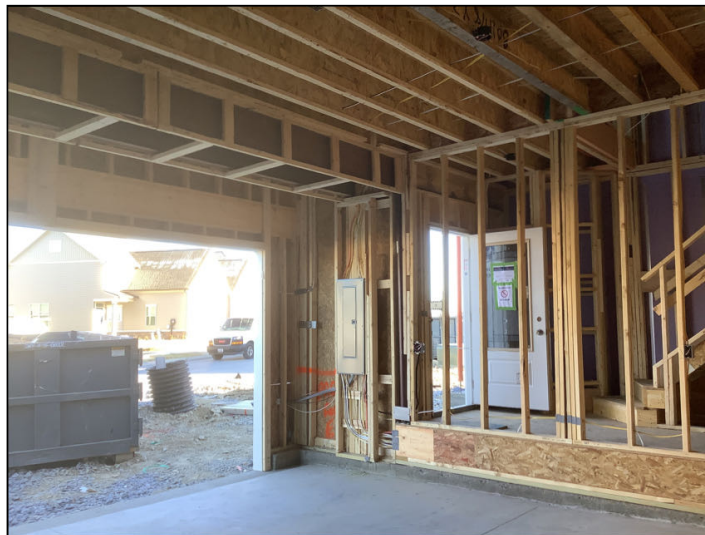
1. General Condition

- New Construction - Some, if not many components have not been built/installed or completed/finished yet.
- acceptable

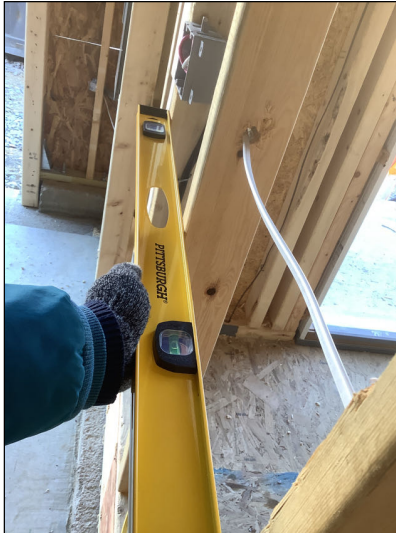
2. Walls & Sill Plate

- Walls framing appear to be satisfactory

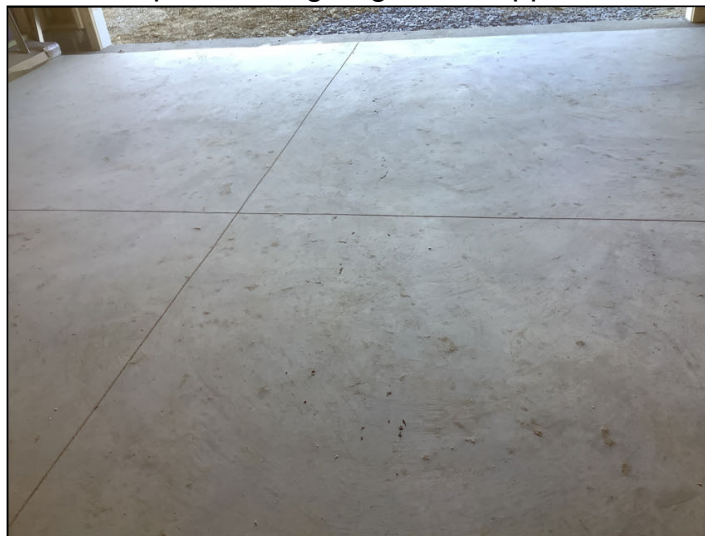
4. Floor Condition

- The visible part of the garage floor, appear to be in good condition

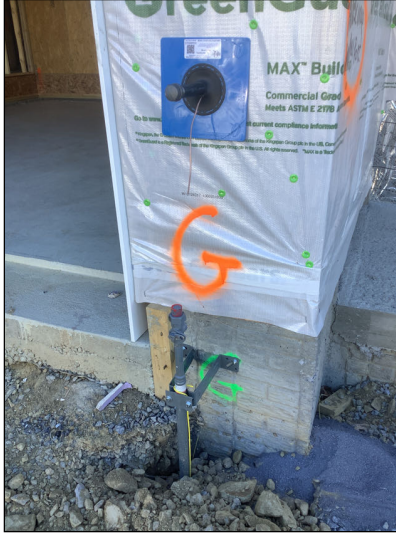
1. Main Gas Valve Condition

- Not present at the time of inspection.

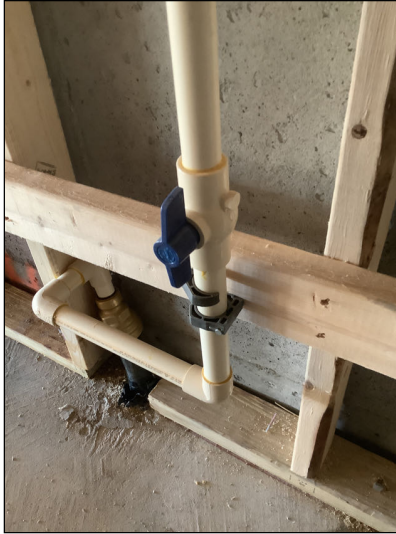
1. Water Main

- 1 inch
- CPVC
- No deficiencies noted.
- Location: Basement

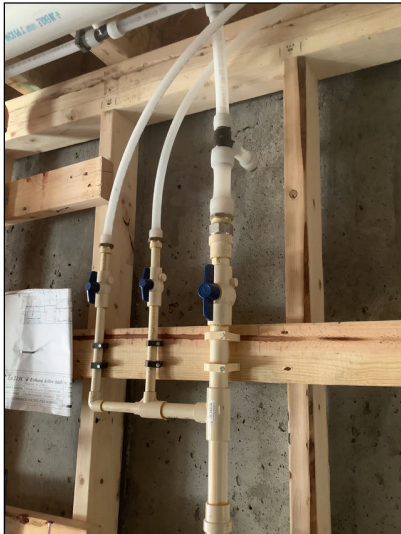
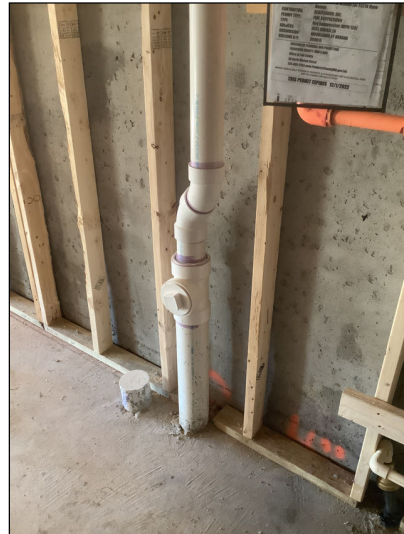
2. Plumbing

- No deficiencies noted.

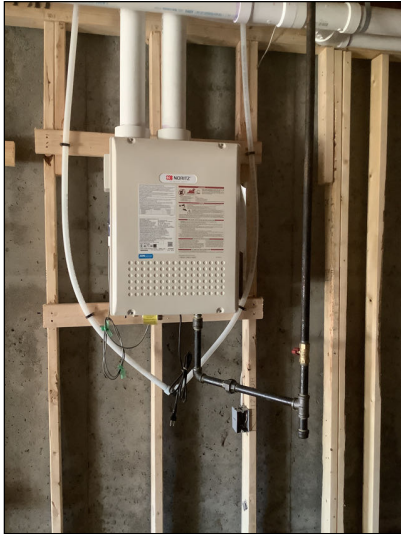
1. Heater Enclosure

- New Construction - Some, if not many components have not been built/installed or completed/finished yet.

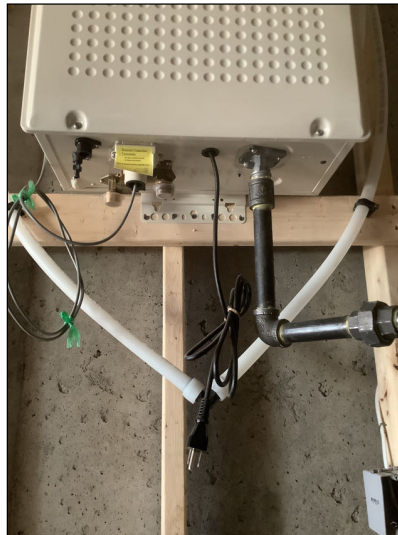
MFD 2021

- No major system safety or function concerns noted at the time of inspection.
- Manufacture date:(2021). Life expectancy around 12 years.

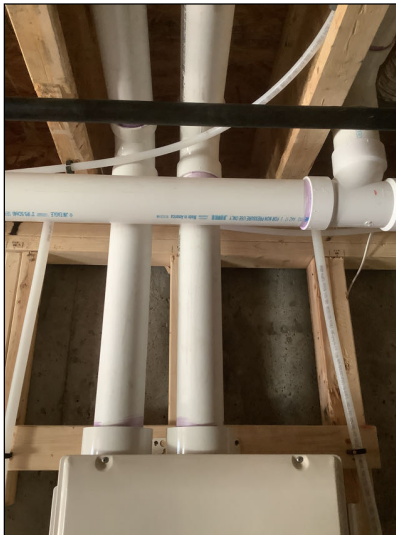
4. Venting

- Appeared in good condition at the time of inspection.

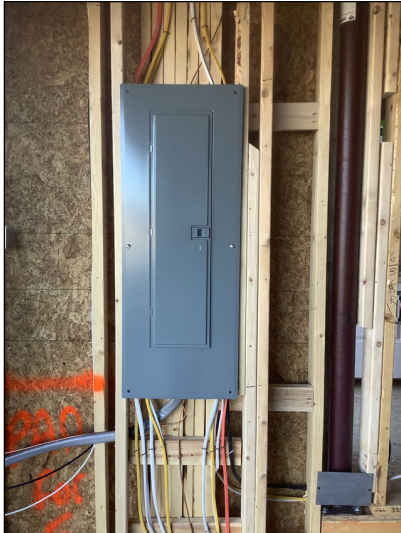
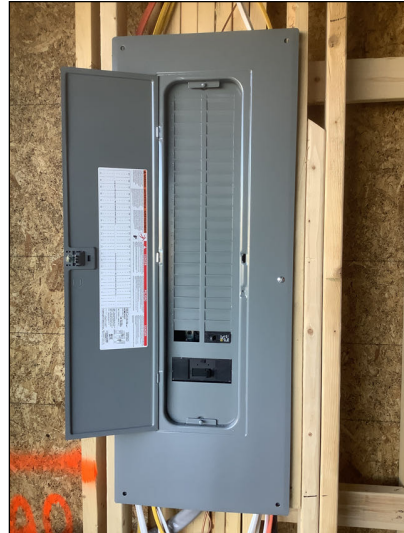
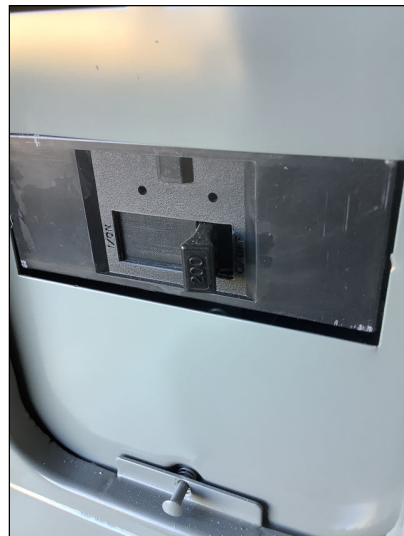
1. Electrical Panel

- New Construction - Some, if not many components have not been built/installed or completed/finished yet.

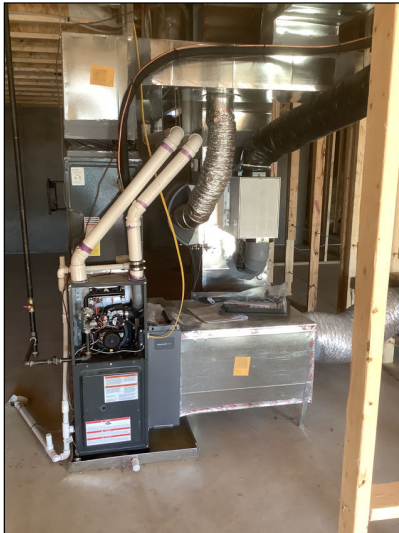
2. Heater Condition

- New Construction - Some, if not many components have not been built/installed or completed/finished yet.
- Manufacture date (2021), life expectancy around 20 years.

MFD 2021

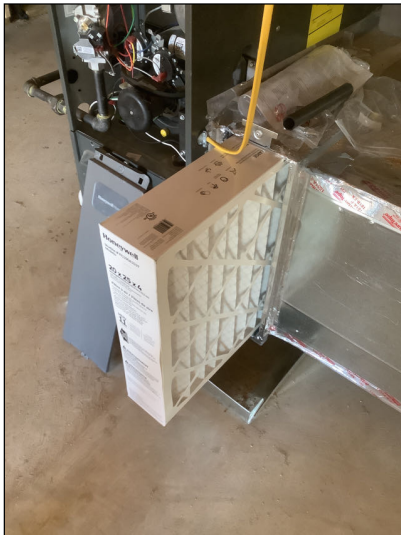
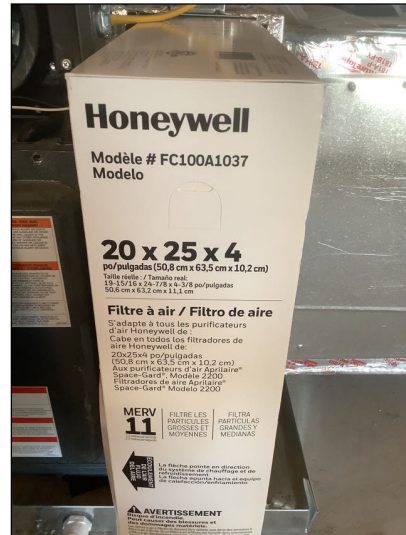
3. Filters

- **MAINTENANCE:** The air filter(s) should be inspected at least monthly and cleaned or replaced as required. Remember that dirty filters are the most common cause of inadequate heating or cooling performance.
- Filters appeared clean at the time of inspection.

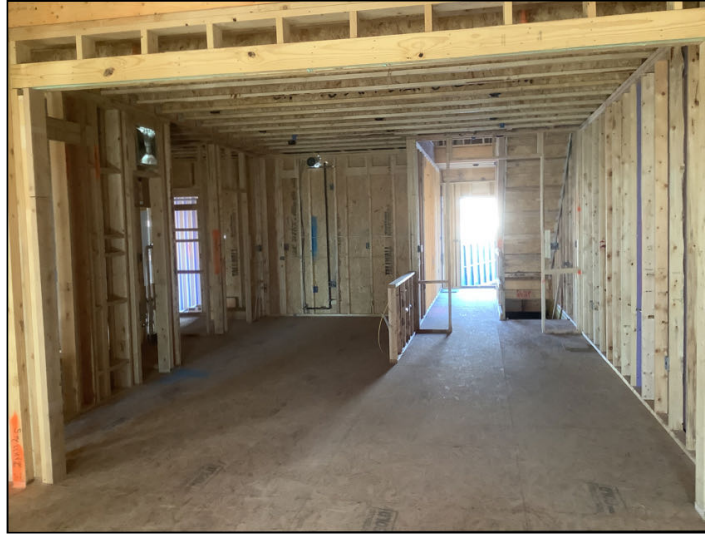
1. Kitchen 1 Condition

- Acceptable
- New Construction - Some, if not many components have not been built/installed or completed/finished yet.

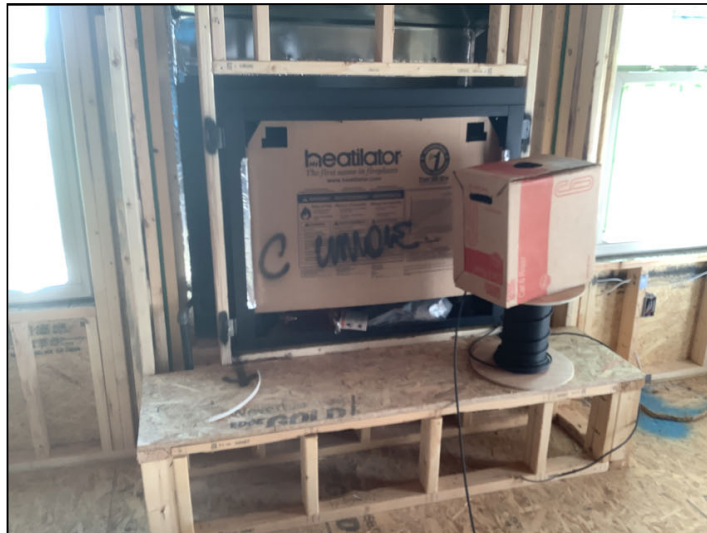
8. Fireplace

- New Construction - Some, if not many components have not been built/installed or completed/finished yet.
- The fireplace appears to be in fair visual condition.

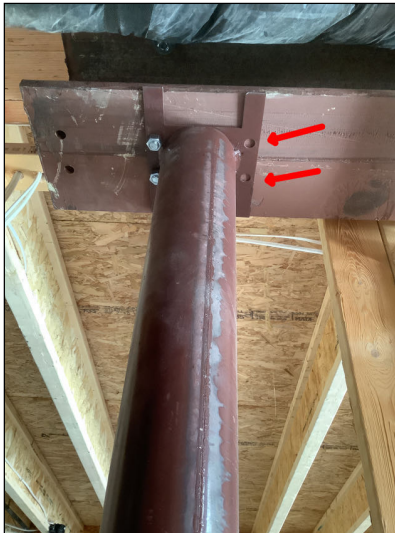
- Steel column top flanges are not properly bolted to the steel beams. Recommend tightened/installed bolts as needed.

Missing bolts

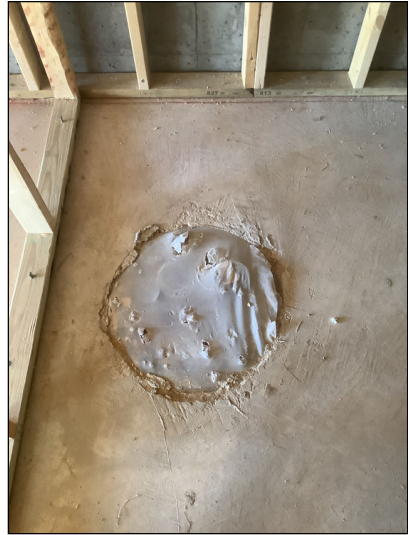
Sump pump discharge pipe

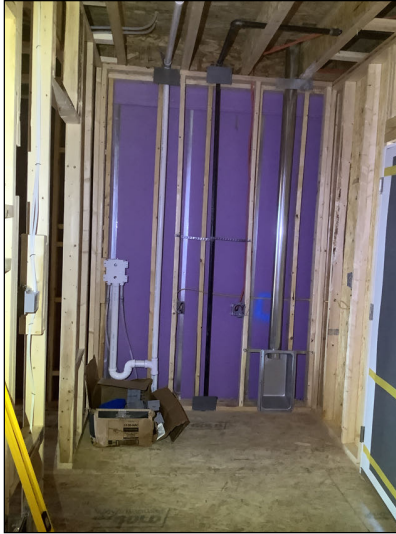
1. General Condition

- New Construction - Some, if not many components have not been built/installed or completed/finished yet.
- Acceptable

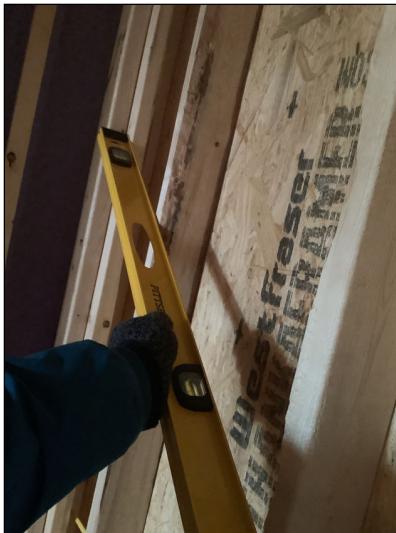
3. Wall Condition

- No deficiencies observed at the time of inspection.

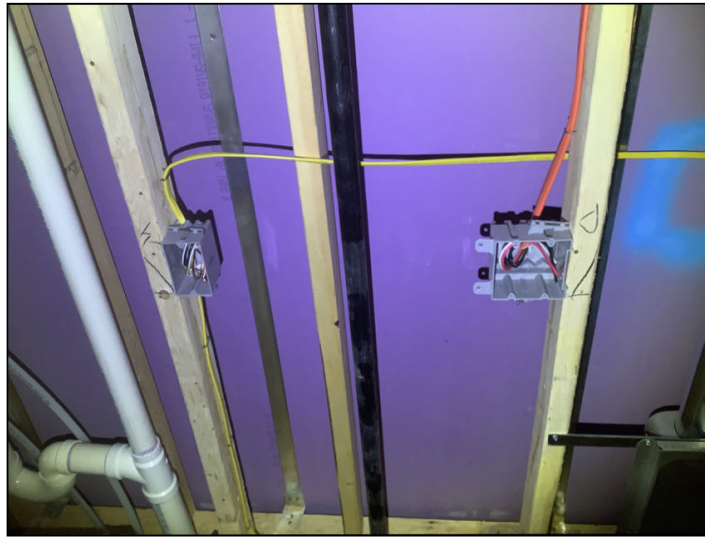
Observations:
• Rough-in only. New Construction - Some, if not many components have not been built/installed or completed/finished yet.

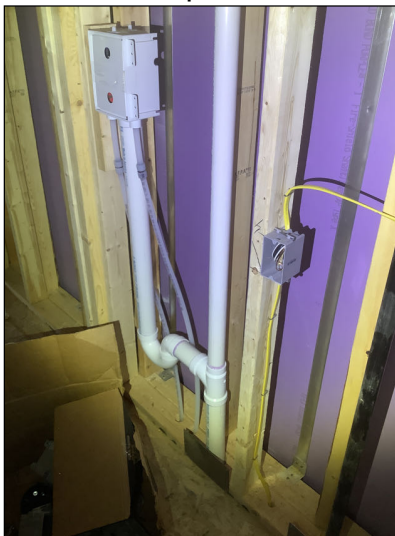
7. Plumbing

Observations:
• Rough-in only. New Construction - Some, if not many components have not been built/installed or completed/finished yet.

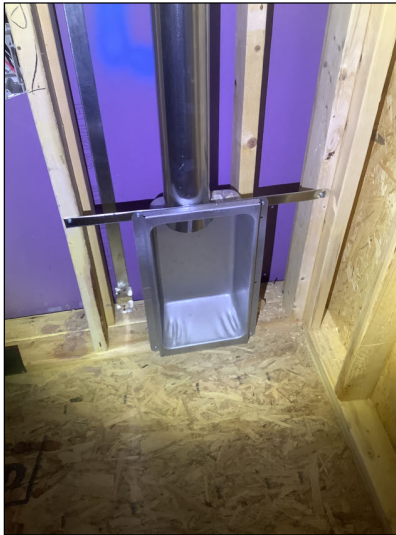
8. Dryer Vent

Observations:
• No deficiencies noted.

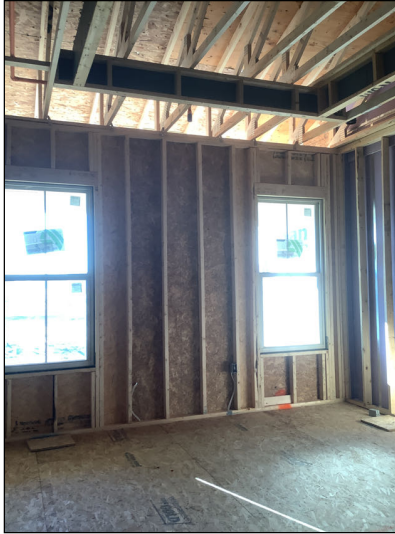
1. General Condition

- New Construction - Some, if not many components have not been built/installed or completed/finished yet.
- Acceptable

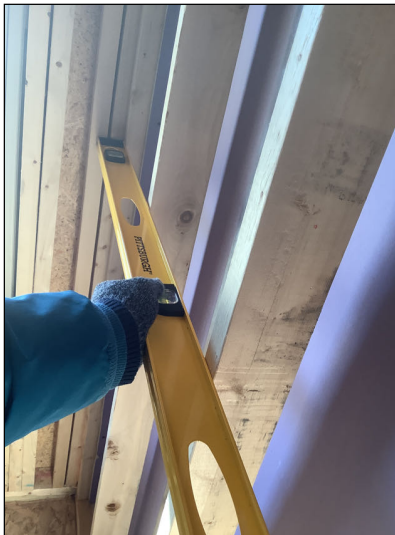
3. Wall Condition

- Walls framing appear to be satisfactory

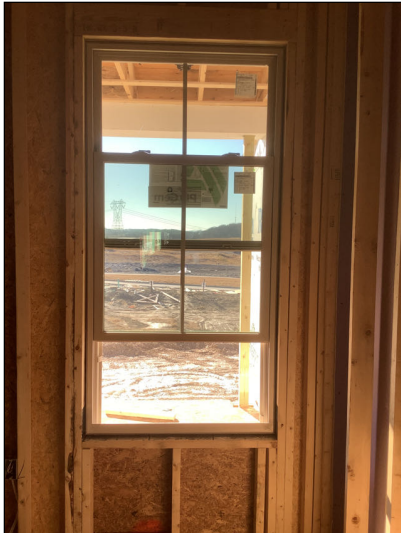
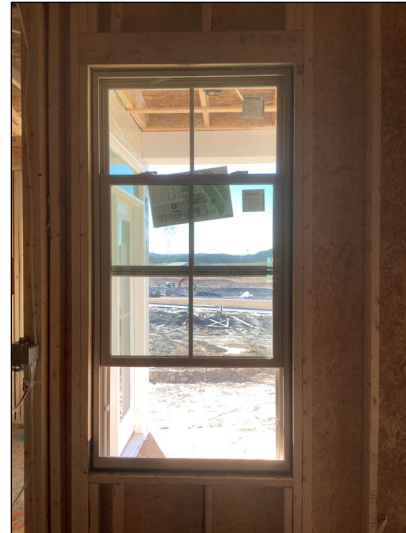
5. Window Condition

- Windows appeared functional at the time of inspection.

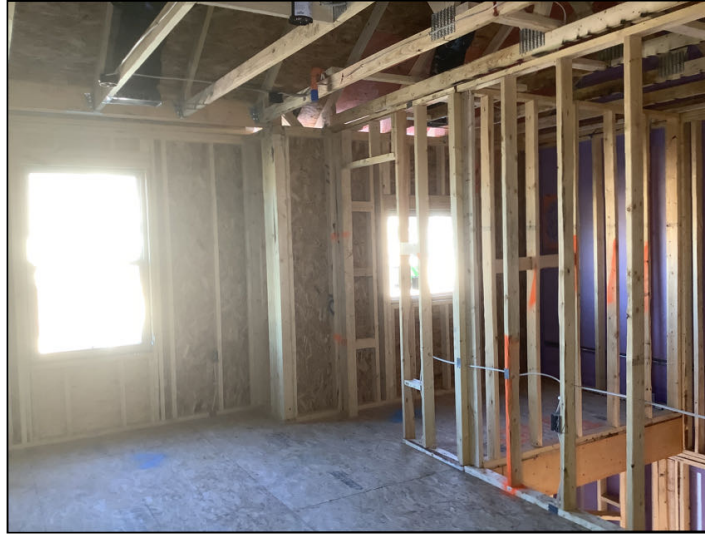
1. General Condition

- New Construction - Some, if not many components have not been built/installed or completed/finished yet.
- Acceptable

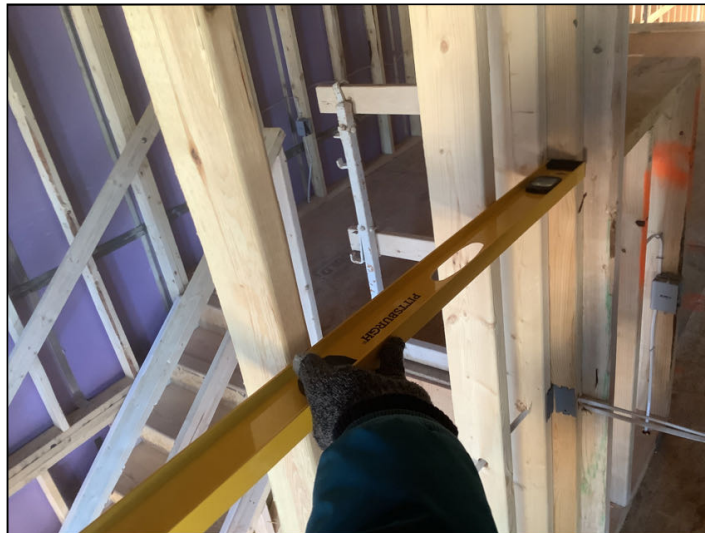
3. Wall Condition

- Walls framing appear to be satisfactory

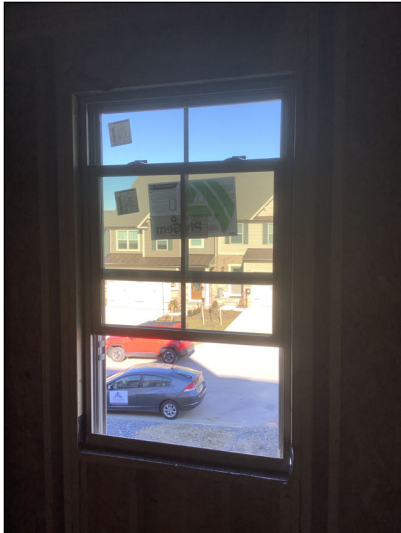
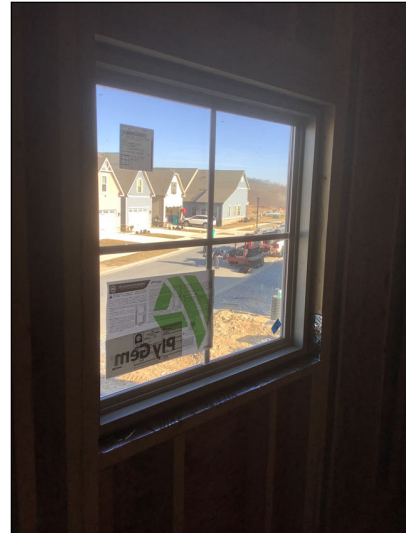
5. Window Condition

- Windows appeared functional at the time of inspection.

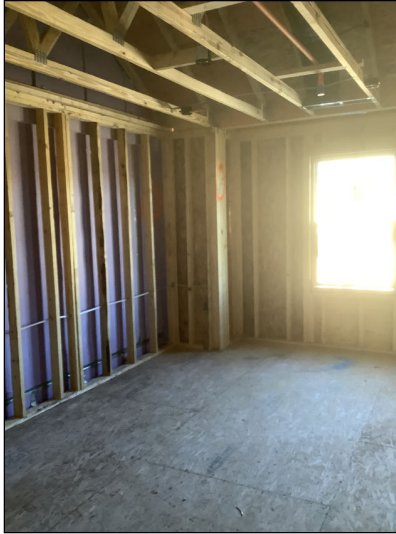
1. General Condition

- New Construction - Some, if not many components have not been built/installed or completed/finished yet.
- Acceptable

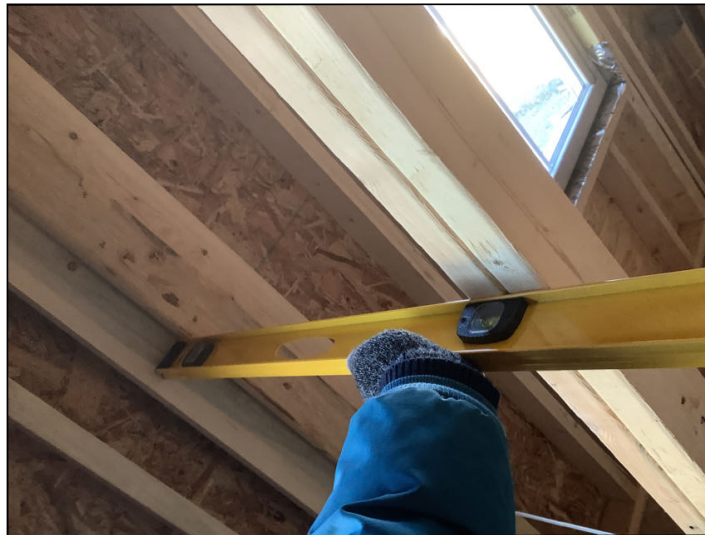
3. Wall Condition

- Walls framing appear to be satisfactory

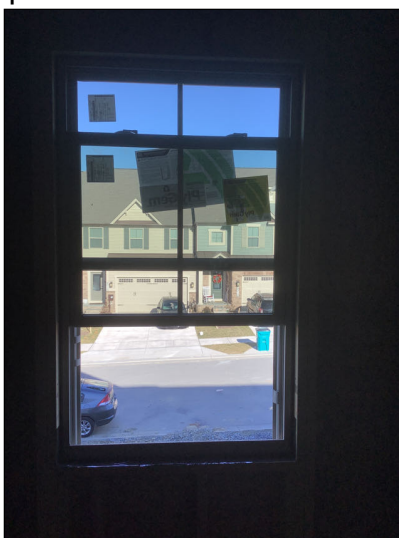
5. Window Condition

- Windows appeared functional at the time of inspection.

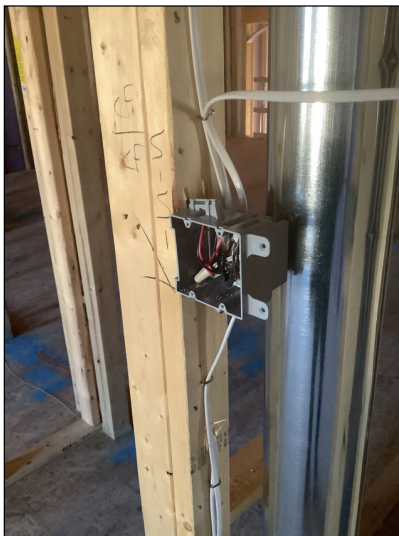
- Electrical wiring and rough-in appear to be acceptable.

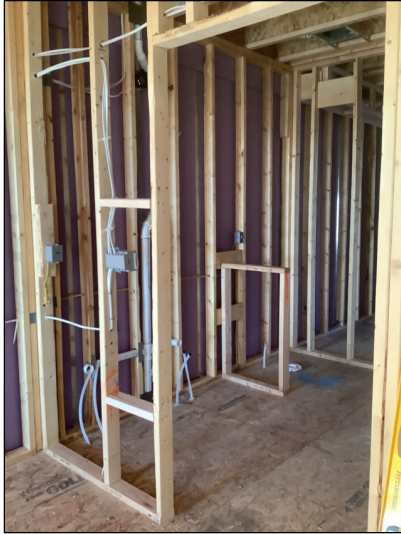
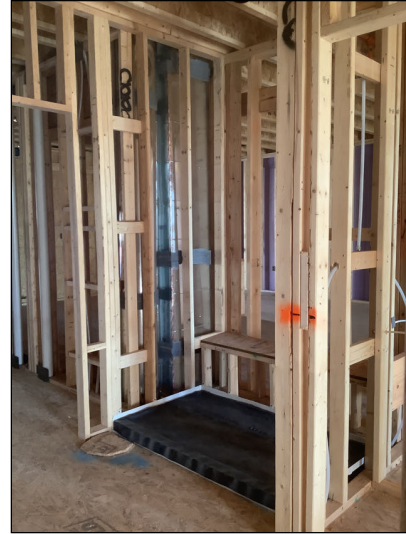
1. General Condition

- New Construction - Some, if not many components have not been built/installed or completed/finished yet.
- Acceptable

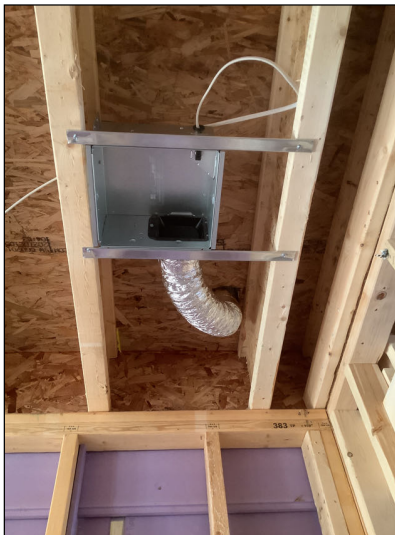
2. Exhaust Fan

- Exhaust fan rough-in is acceptable

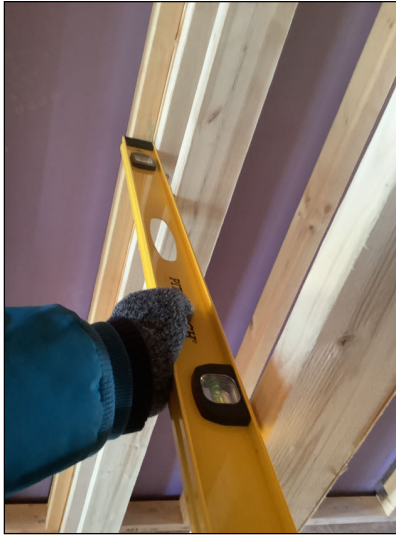
4. Bath Wall Condition

- Walls framing appear to be satisfactory

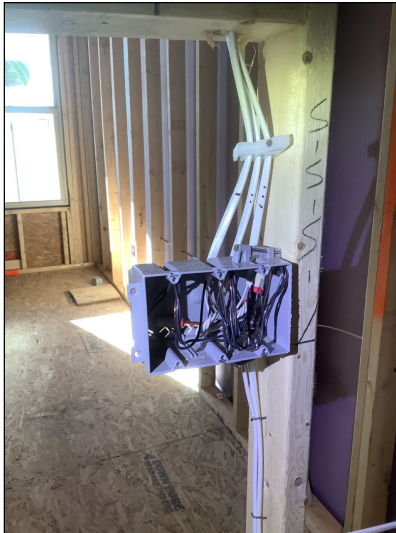
- Electrical wiring and rough-in appear to be acceptable.

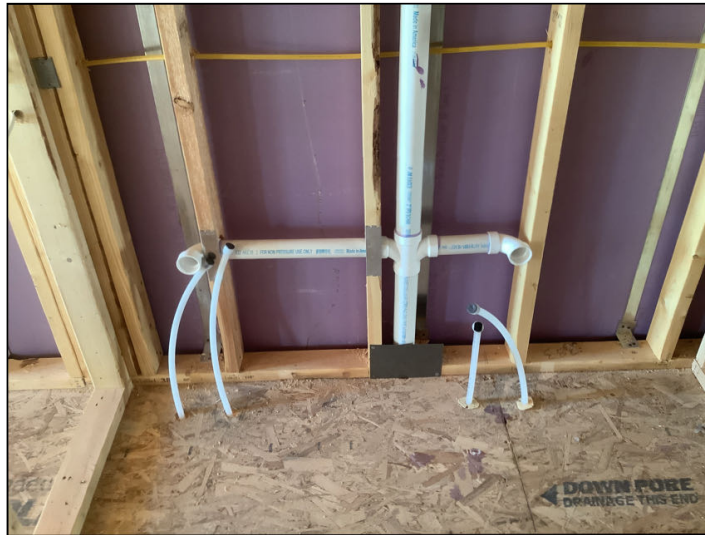
8. Plumbing

- Rough-in; New Construction - Some, if not many components have not been built/installed or completed/finished yet.

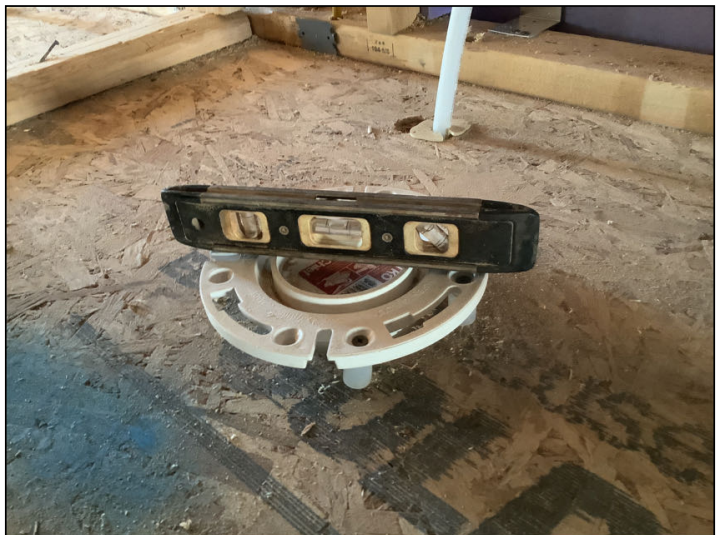
9. Toilets

Observations:
• Toilet rough-in is acceptable

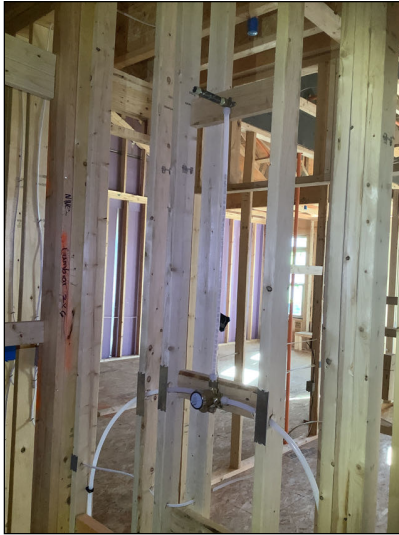
10. Showers

Observations:
• Shower plumbing and rough-in is acceptable

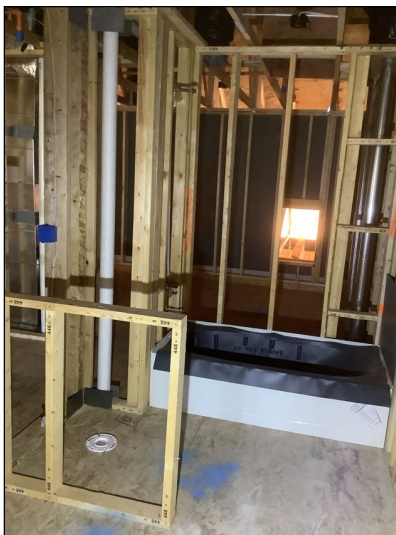
1. General Condition

- New Construction - Some, if not many components have not been built/installed or completed/finished yet.
- Acceptable

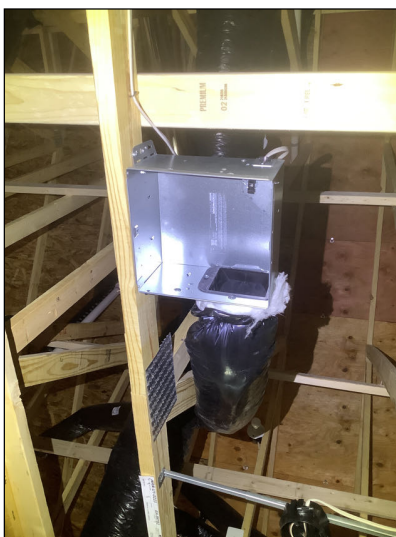
2. Exhaust Fan

- Exhaust fan rough-in is acceptable

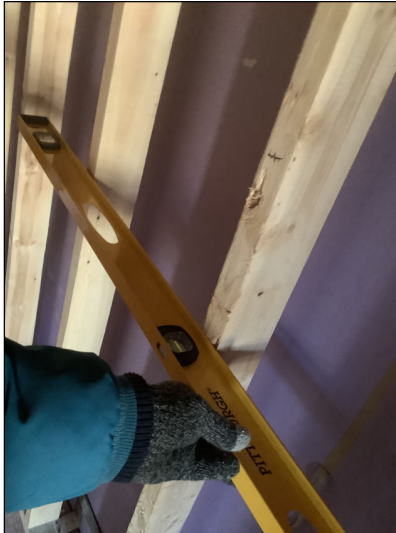
4. Bath Wall Condition

- Walls framing appear to be satisfactory

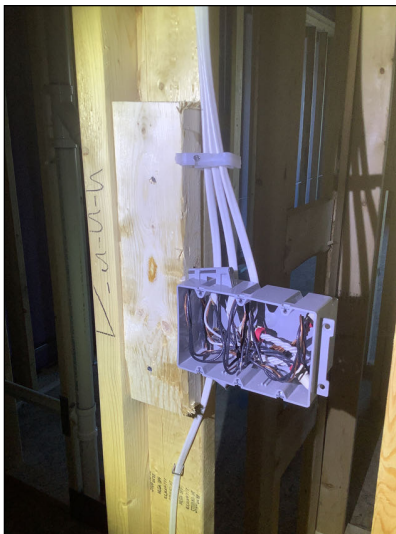
- Electrical wiring and rough-in appear to be acceptable.

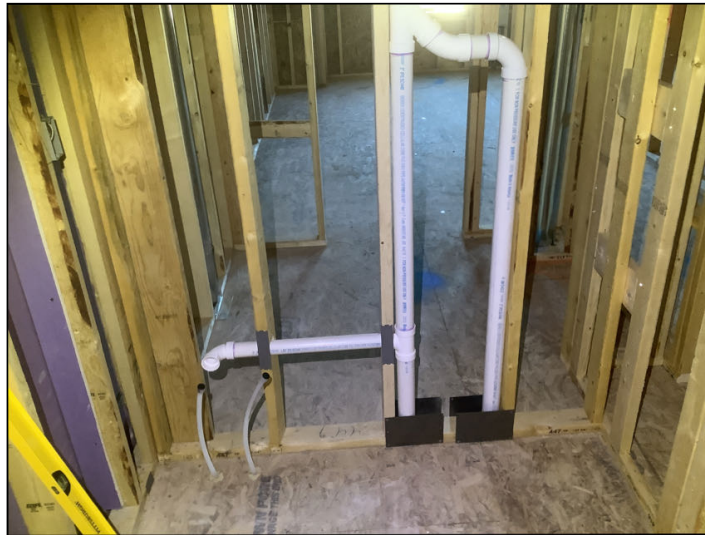
8. Plumbing

- Rough-in; New Construction - Some, if not many components have not been built/installed or completed/finished yet.

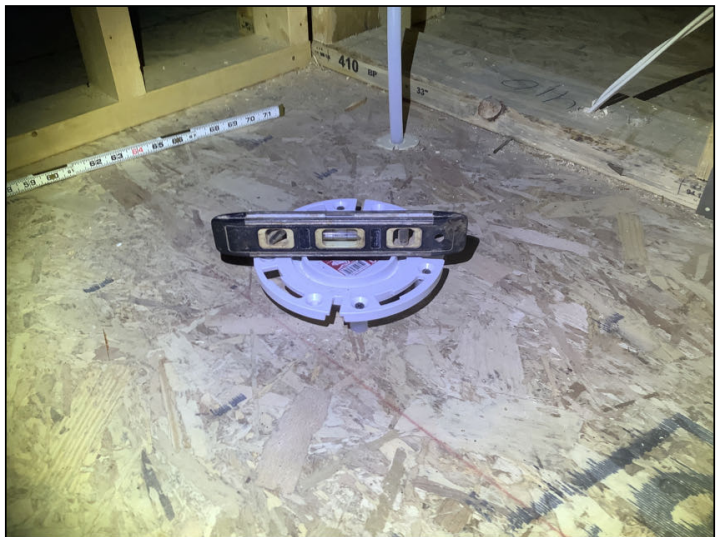
9. Toilets

- Toilet rough-in is acceptable

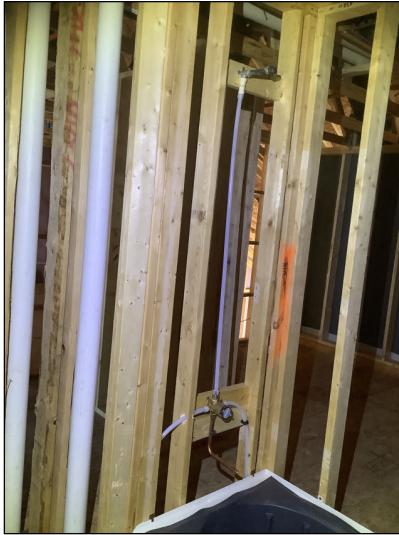
10. Showers

- Shower plumbing and rough-in is acceptable

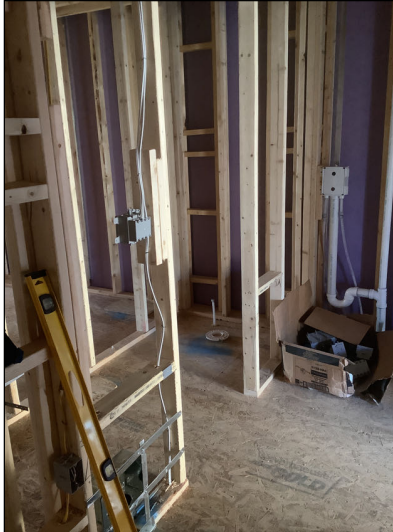
1. General Condition

- New Construction - Some, if not many components have not been built/installed or completed/finished yet.
- Acceptable

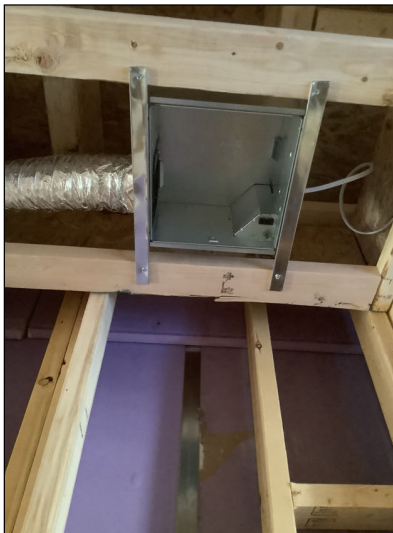
2. Exhaust Fan

- Exhaust fan rough-in is acceptable

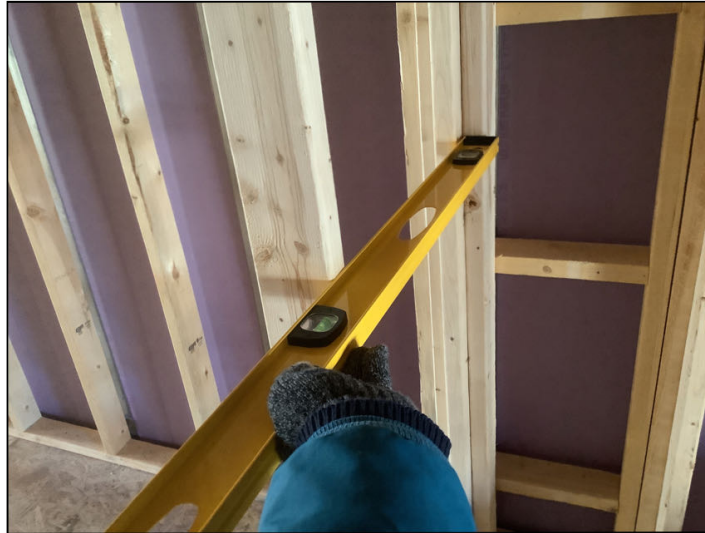
4. Bath Wall Condition

- Walls framing appear to be satisfactory

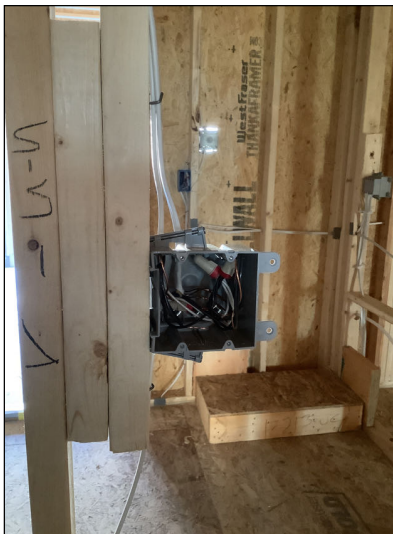
- Electrical wiring and rough-in appear to be acceptable.

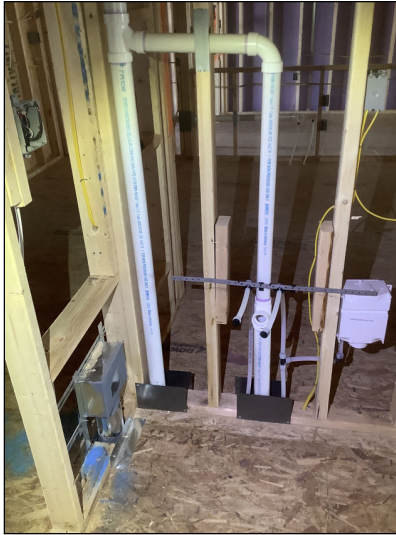
- Rough-in; New Construction - Some, if not many components have not been built/installed or completed/finished yet.

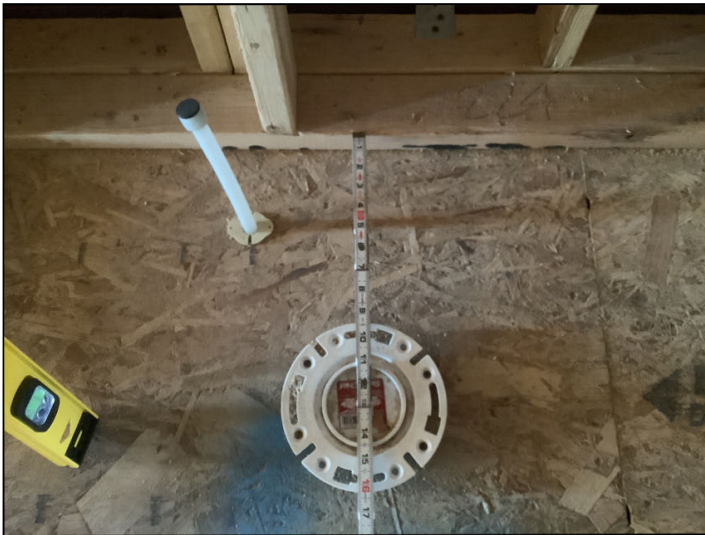
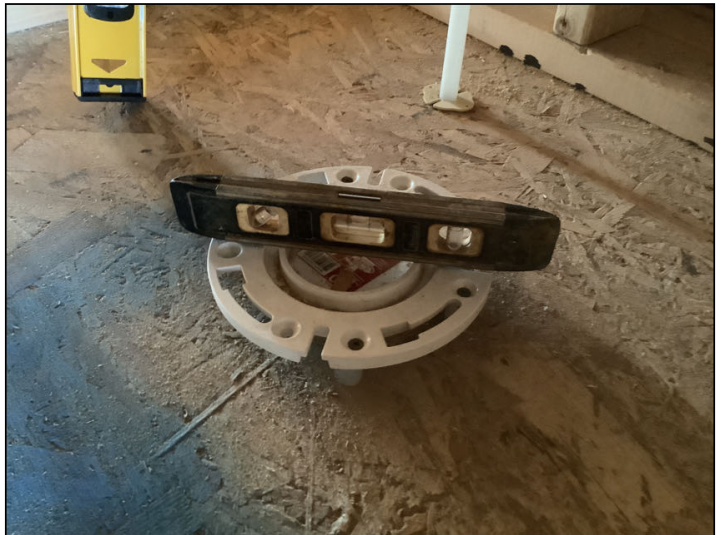
9. Toilets

Observations:
• Toilet rough-in is acceptable
