INSPECTION REPORT

10000 Four Point Sample Rd, Sample, VA 10000

Inspection prepared for: Sample Client

Date of Inspection: 11/18/2021 Time: 1:30 pm

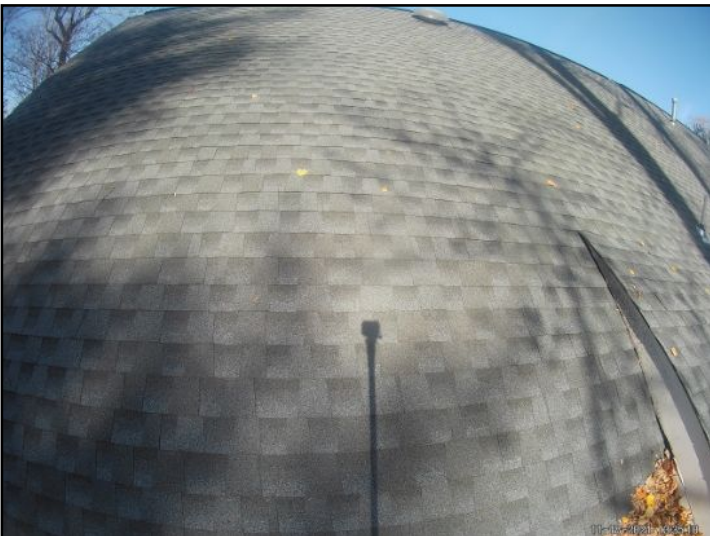
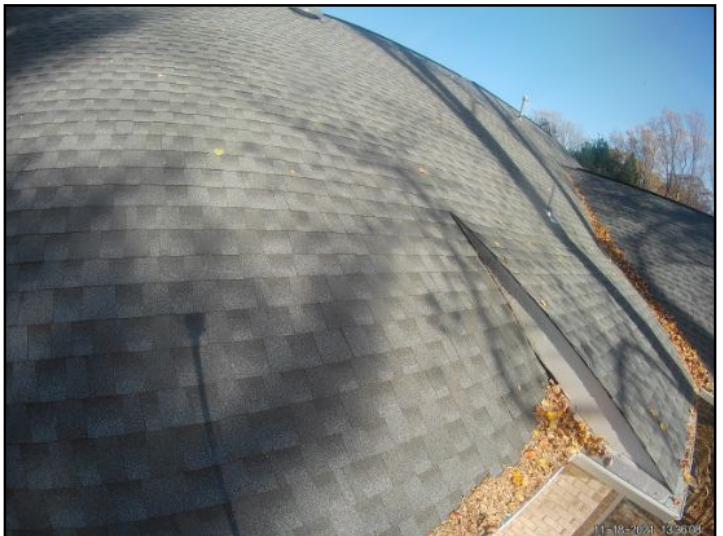
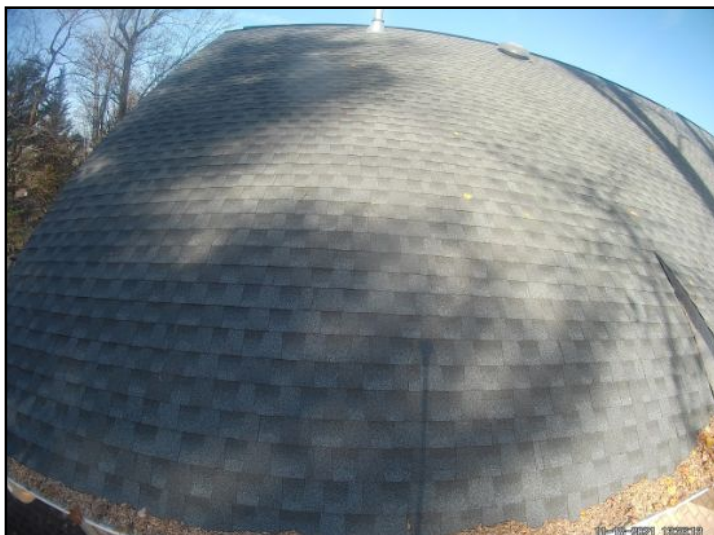
Clean roof areas: Significant amounts of organic debris evident.

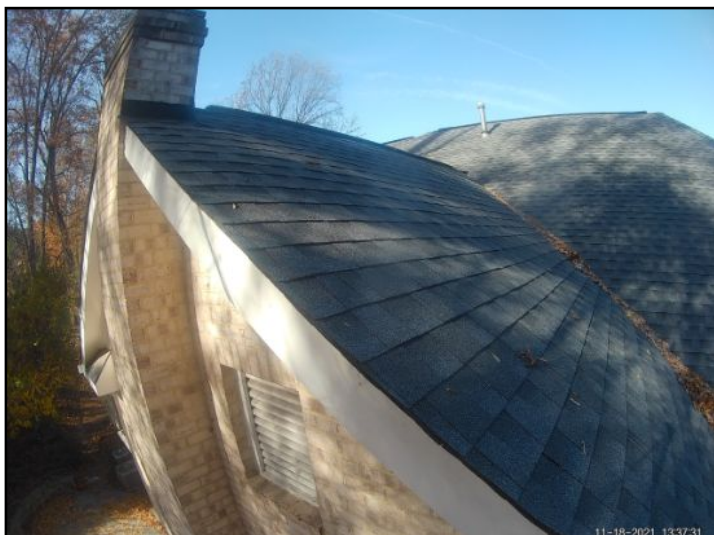
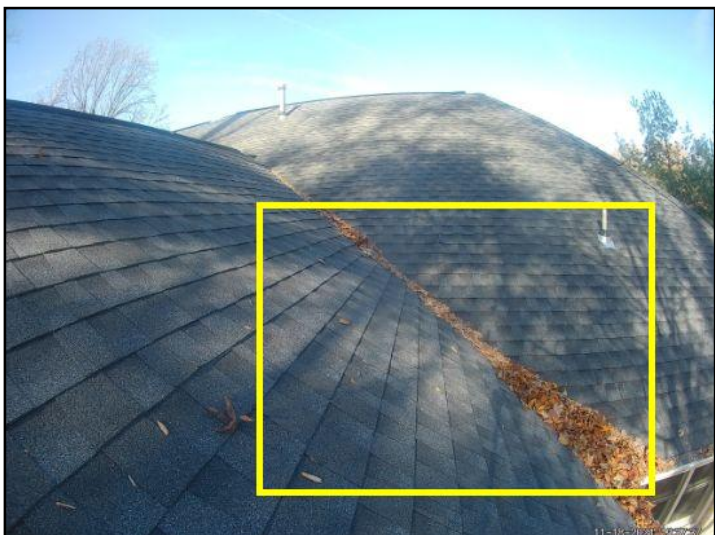
Clean roof areas: Significant amounts of organic debris evident.

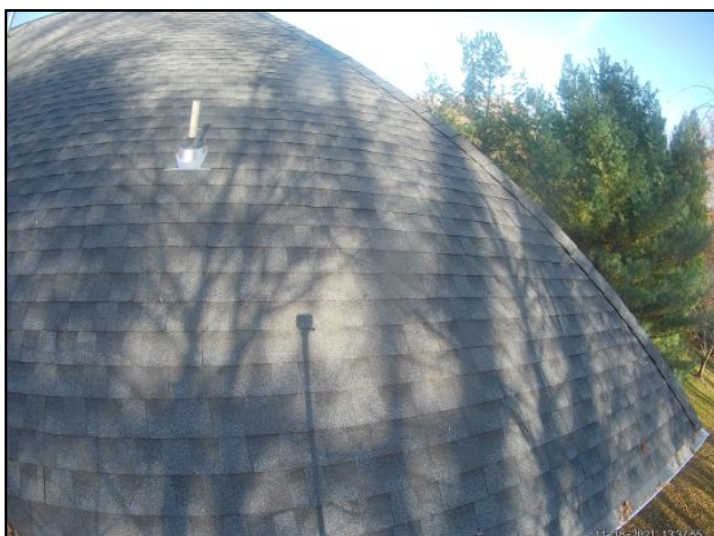
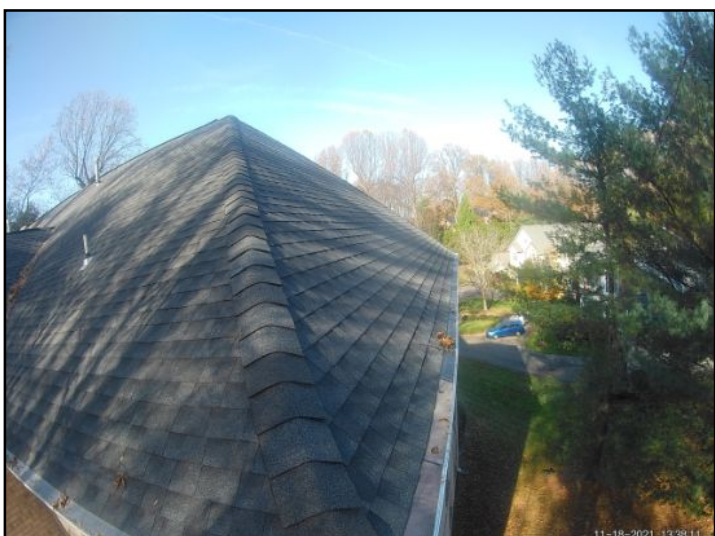
Clean roof areas: Significant amounts of organic debris evident.

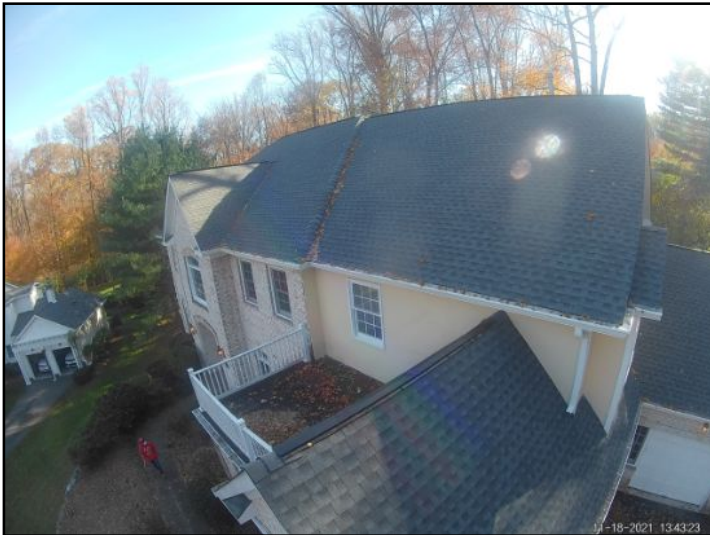
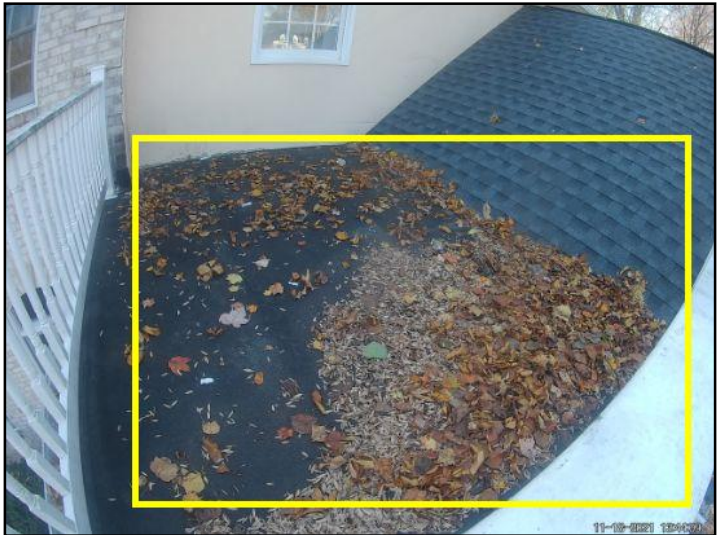
Clean roof areas: Significant amounts of organic debris evident.

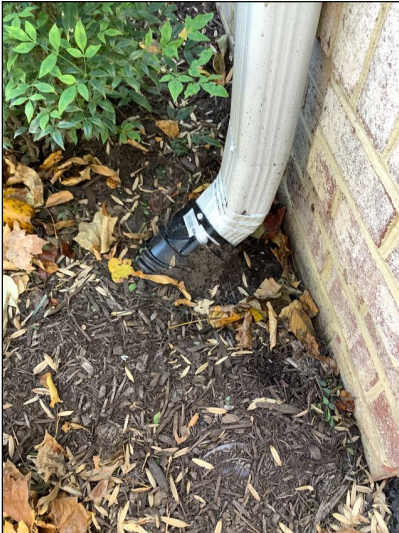
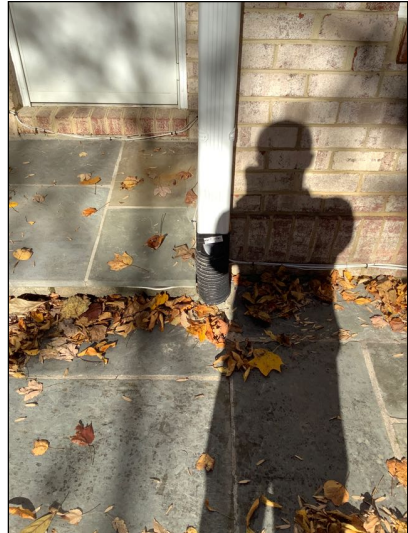
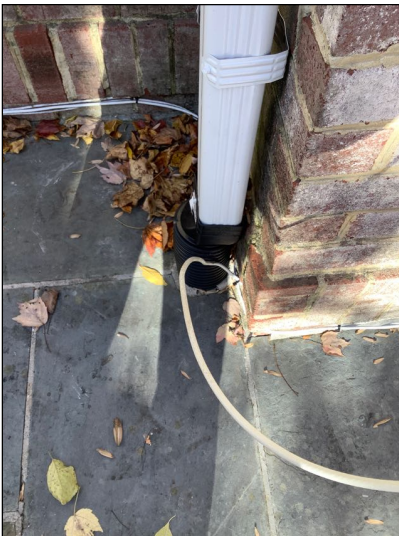
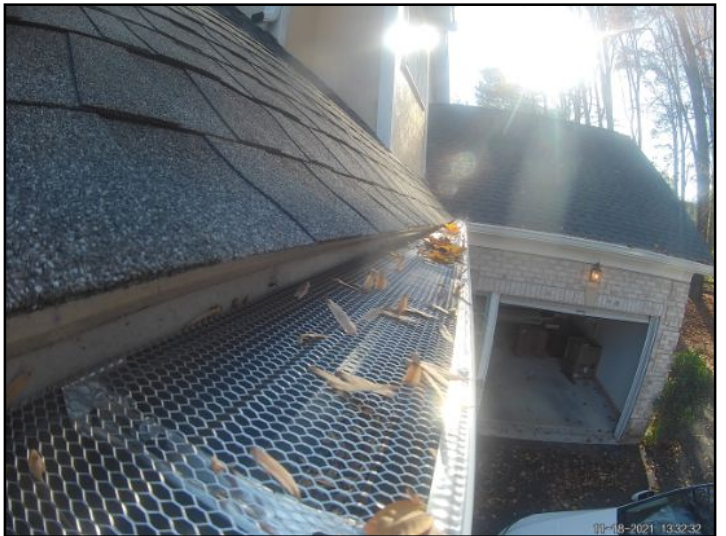
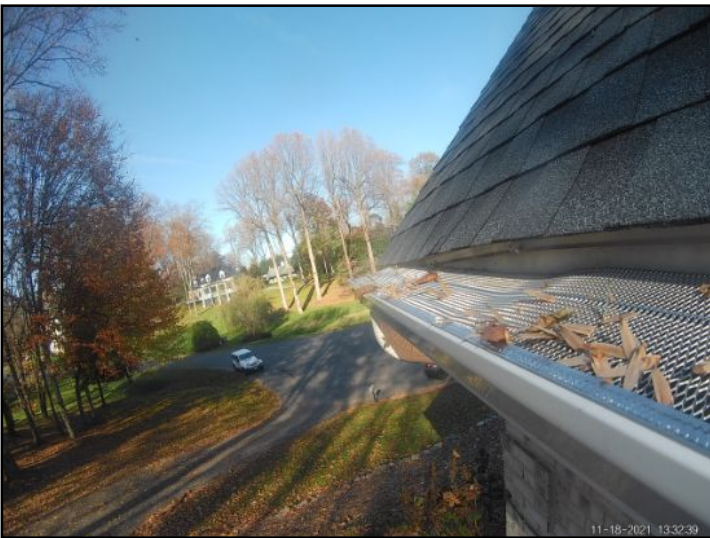
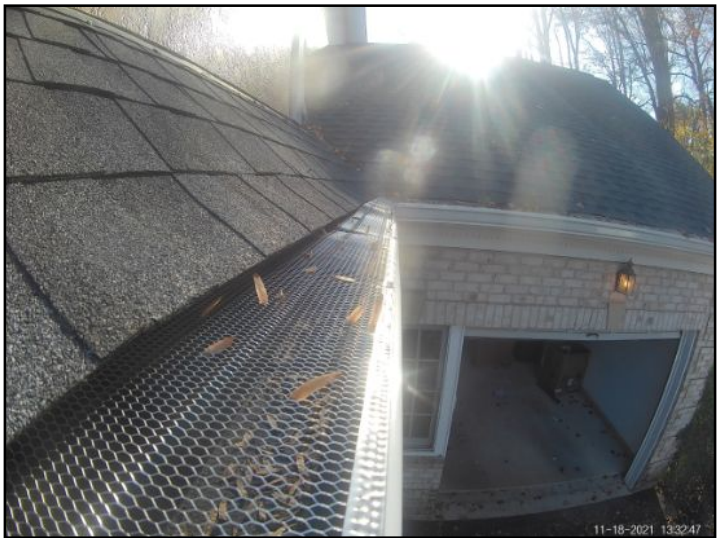
2. Gutter

- Downspouts discharge underground, the points of termination are not visible.
- Downspout drains from one roof section onto another roof section; this will lead to premature wear of the roofing materials and increase likelihood of water damage. Downspouts should drain directly into another gutter or away from the house. Recommend installing/modifying downspout to direct water directly into lower gutter or away from house.
- Debris noted in gutters. Recommend cleaning gutters so that water can properly drain.
- Downspout/s discharging on roof observed.

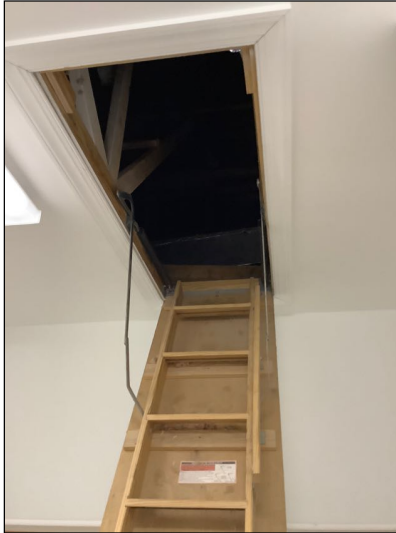
- Bedroom ceiling.
- Pull down ladder located in bedroom.
- Access cover has no insulation. Recommended insulating the access cover to minimize the heat loss.

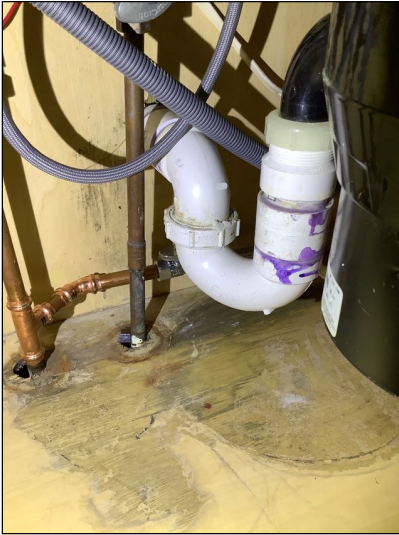
- Evidence of previous/past leak noted, it is dry at the time of the inspection. Recommend monitoring area.

Evidence of previous/past leak noted, it is dry at the time of the inspection.

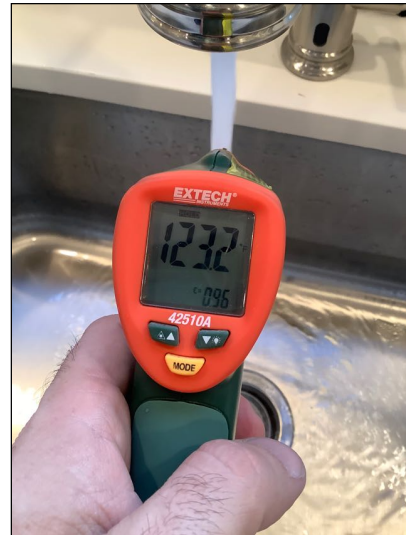
Water temperature 123 degrees @ Kitchen sink

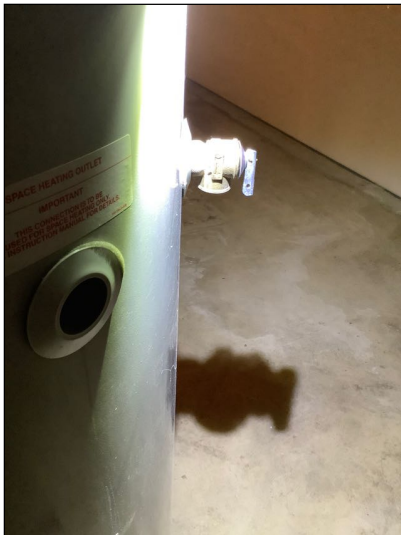
- Missing overflow discharge pipe noted. This is a potential scalding concern as water can discharge improperly. Recommend installing the proper type of relief extension to discharge within 6" from the floor.

Extension missing from water heater TPRV

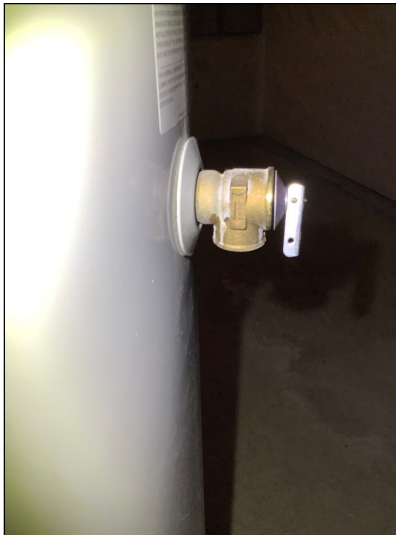
- The extension at the water heater relief valve is missing. This is a potential scalding concern as water can discharge improperly. Recommend installing the proper type of relief extension to discharge within 6" from the floor.

The extension at the water heater relief valve is missing. This is a potential scalding concern as water can discharge improperly. Recommend installing the proper type of relief extension to discharge within 6" from the floor.

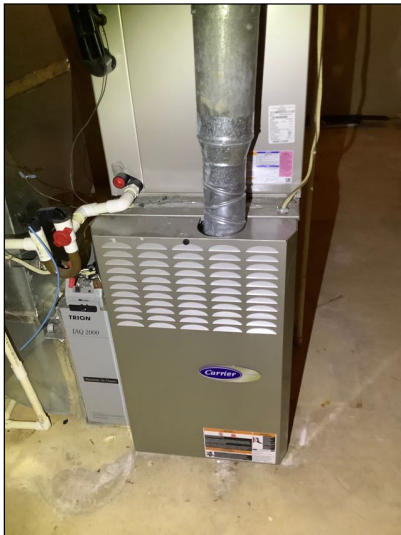
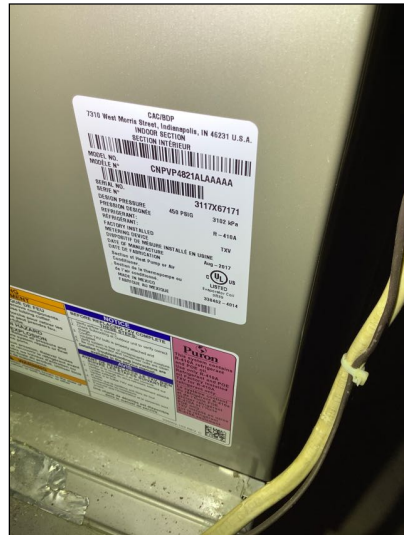
4. Heater Condition

- Manufacture date: 2017. Life expectancy around 20 years.
- Unit appeared to operate properly using normal operating controls at the time of inspection.
- HVAC system service date was over 12 months or not being able to be determined. We recommend the HVAC system be serviced and cleaned by a licensed HVAC specialist.

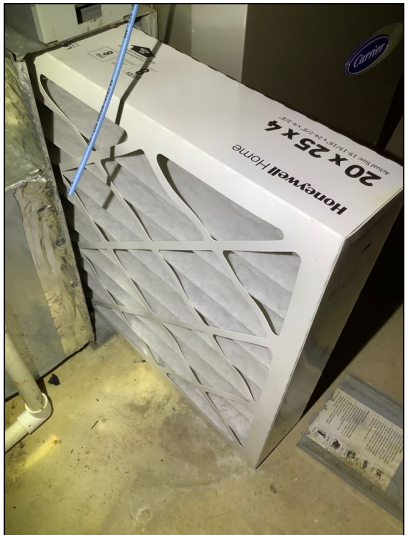
Filter Size: 20x25x4

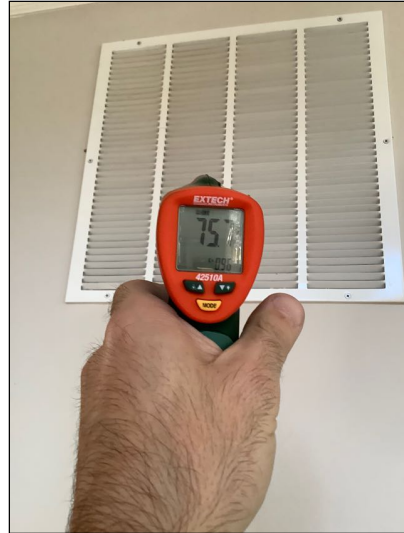
Return air temp in heat mode 75 degrees

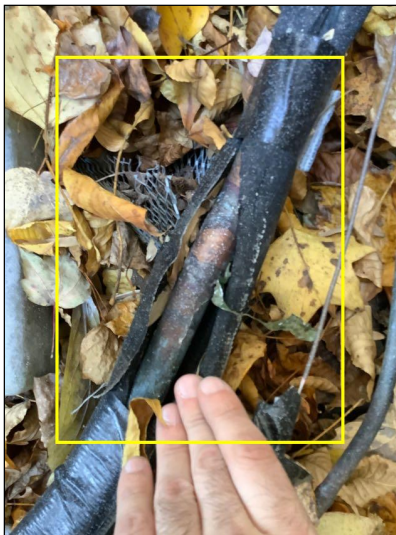
Deteriorated insulation on the refrigerant lines, replace as needed

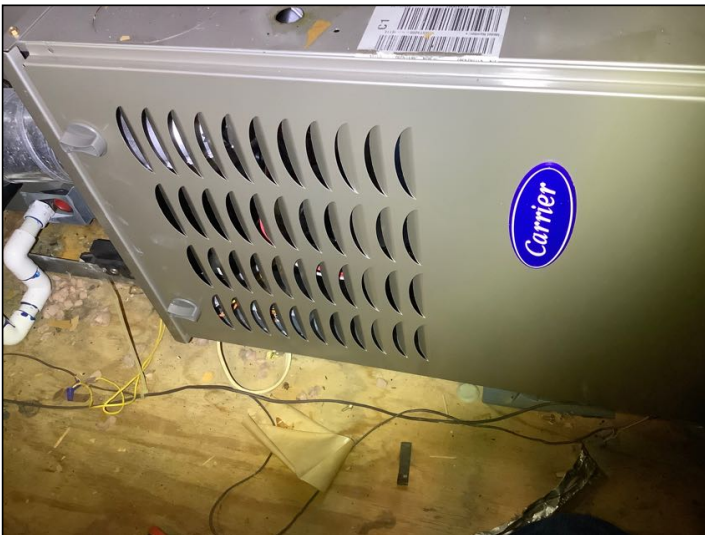
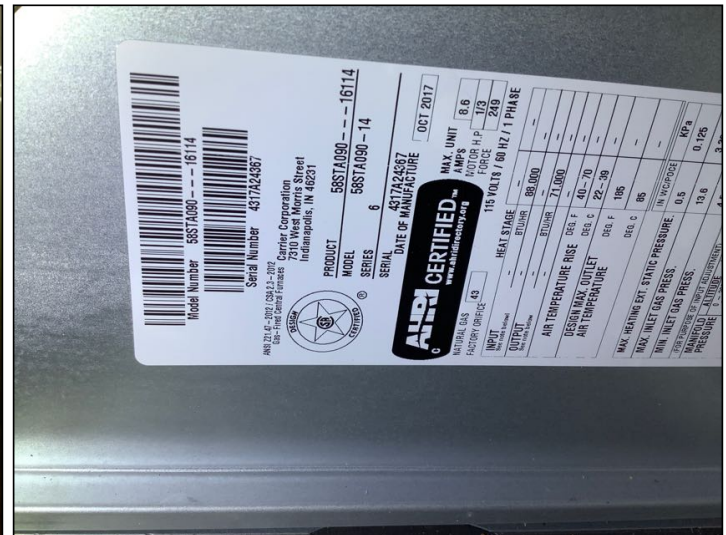
4. Heater Condition

- Manufacture date: 2017. Life expectancy around 20 years.
- Unit appeared to operate properly using normal operating controls at the time of inspection.
- HVAC system service date was over 12 months or not being able to be determined. We recommend the HVAC system be serviced and cleaned by a licensed HVAC specialist.

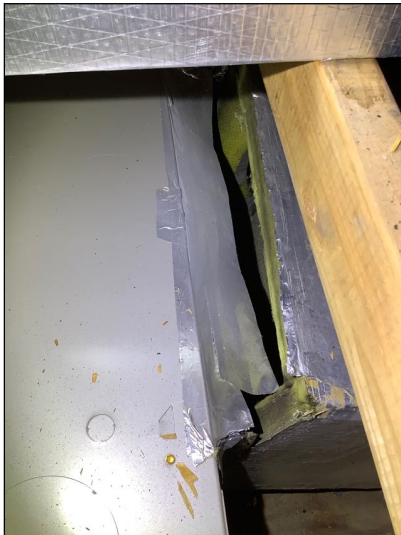
- Return air appears to be detached/leaking at unit. We recommend sealing or patching the ductwork in these areas.

Return air vent detached at furnace in attic

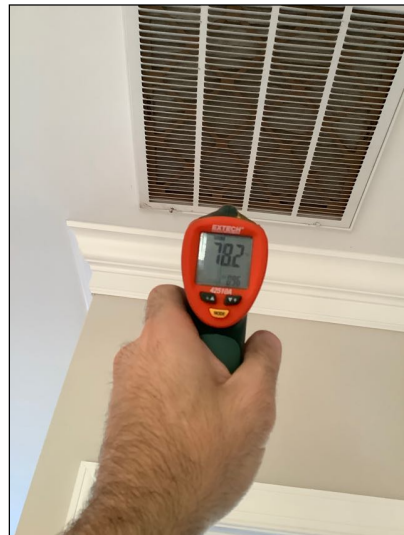
Return air temp in heat mode 78 degrees

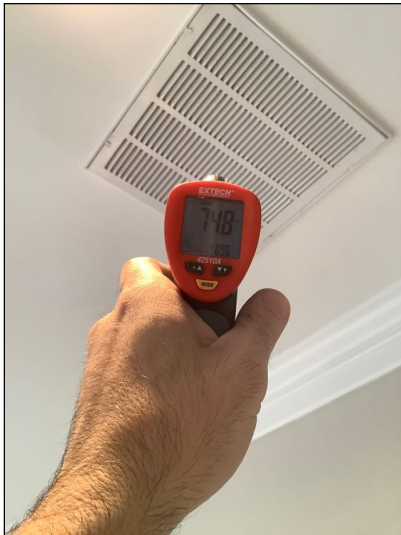
Return air temp in cooling mode 74 degrees
